HOME INSPECTION REPORT

The HomeTeam Inspection Service made a visual inspection of 123 Main Street, Anytown, USA 55555. Enclosed please find a written, narrative report of our findings in accordance with the terms of our Inspection Agreement.

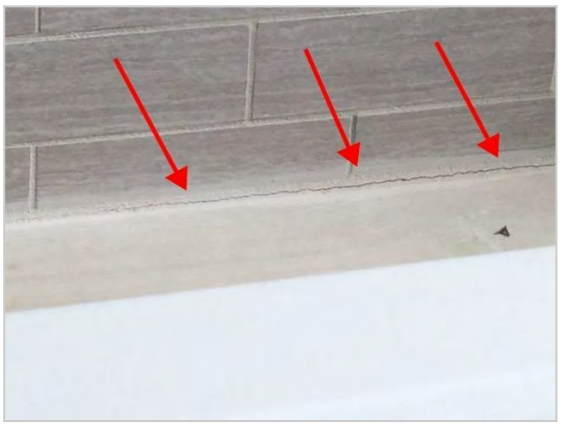
Photo 11

1. Active water leaks were present at supply lines at the time of the inspection.
2. There was no drip leg installed on the T&P valve of the water heater.
3. Bathroom caulk and/or grout requires repair in the bathroom.

Some of the caulk was missing from around the tub in the master bathroom. These areas should be sealed to prevent moisture penetration. Failure to keep walls sealed can cause deterioration and extensive moisture damage including mold growth to the interior walls, which is not always visible at the time of the inspection.

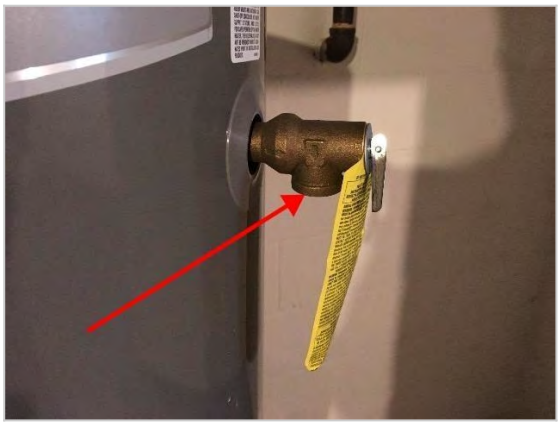
Photo 12

There was no drip leg installed on the T&P valve of the water heater. The drip leg directs water from the T&P valve toward the floor. A drip leg terminating within six-inches of the floor should be installed.

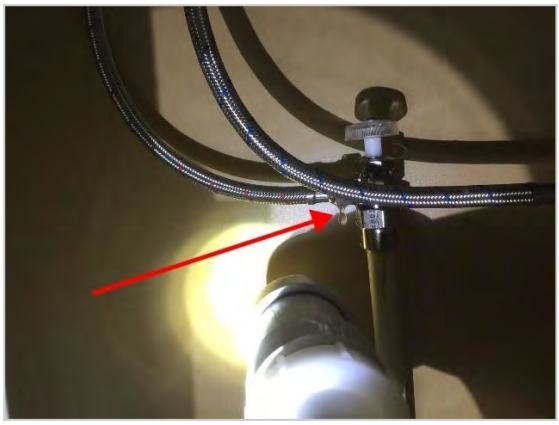
Photo 13

Active water leaks were present at supply lines the time of the inspection. The affected areas should be repaired, and nearby or associated plumbing lines should be further assessed at the time of the repair.

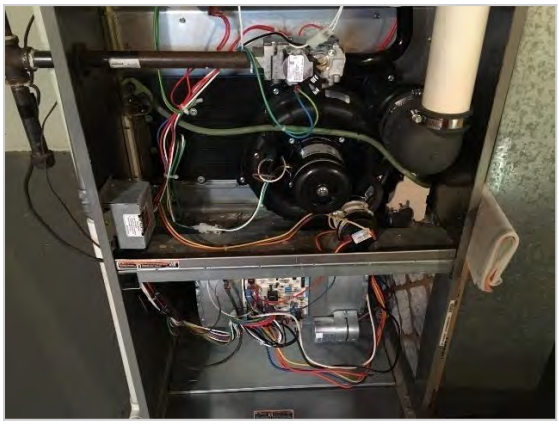
Photo 18

A condensate leak was noted on the air handler drain line. Repairs should be made by a qualified contractor.
