HomeTeam[®]
INSPECTION SERVICE

**123 Main St
Anywhere, NC**

HOME INSPECTION REPORT

File Number: **655439**

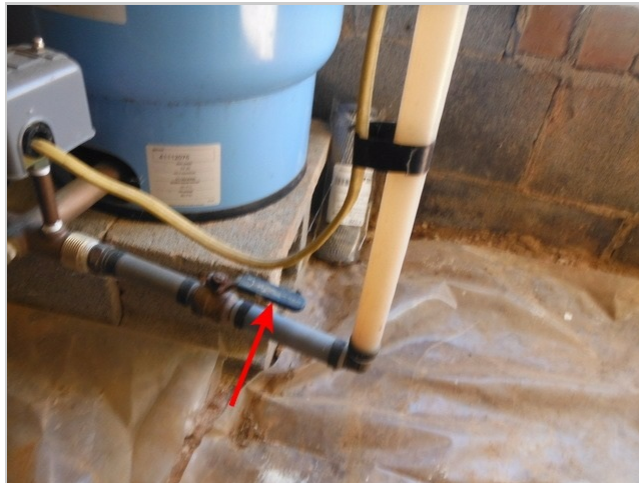
Water shut off-Crawlspace

The main water shutoff valve for the home was located in the crawlspace. Water shutoff valves are visually inspected only. No attempt is made to operate the main or any other water supply shutoff valves during the inspection. These valves are infrequently used and could leak after being operated. This is for your information.
