HOME INSPECTION REPORT

Tom and Sue Brown
123 Main Street
Anywhere, NC 12345

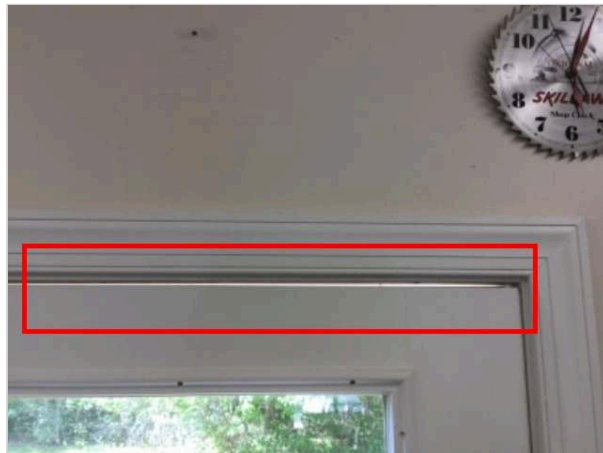
At the garage rear door, daylight can be seen through the weather stripping. This will waste energy and allow pests access to the home. Have a qualified contractor repair as required.

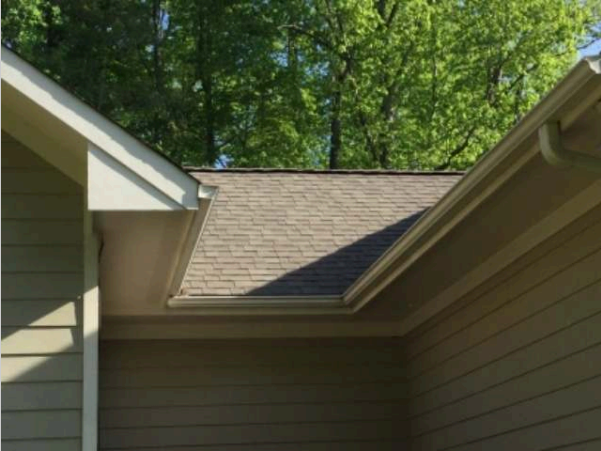
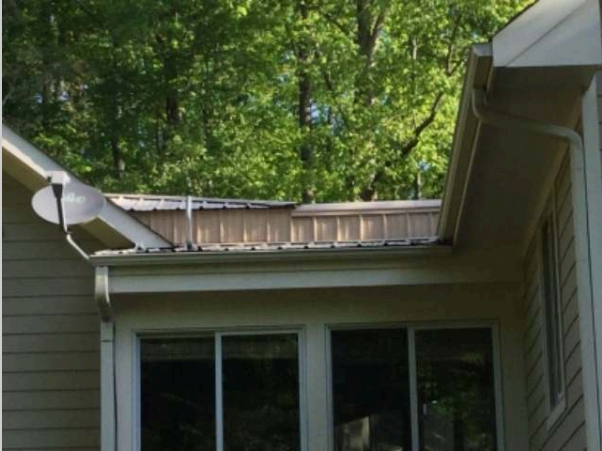
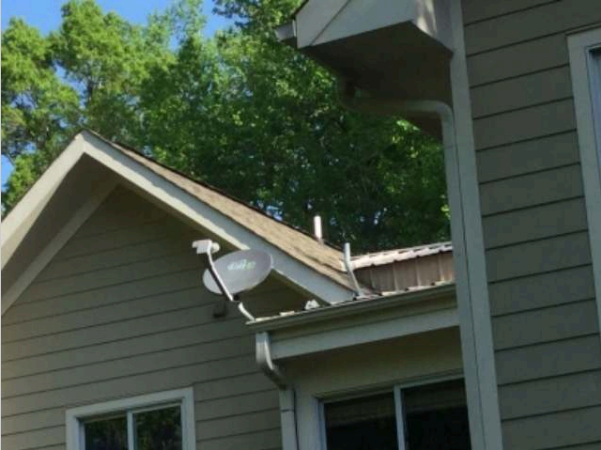
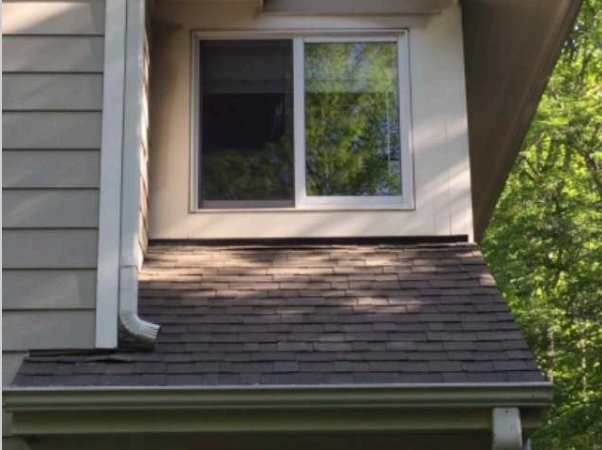
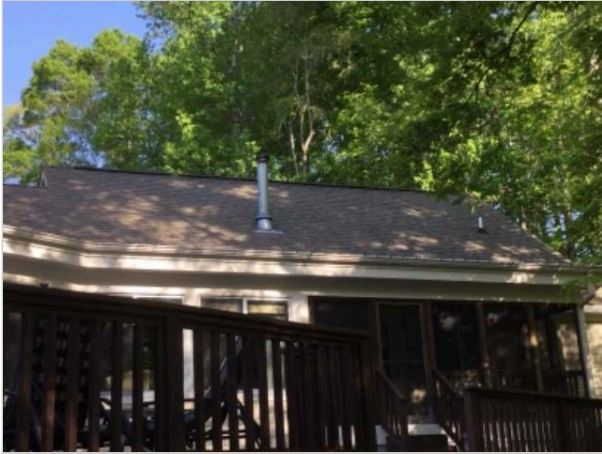
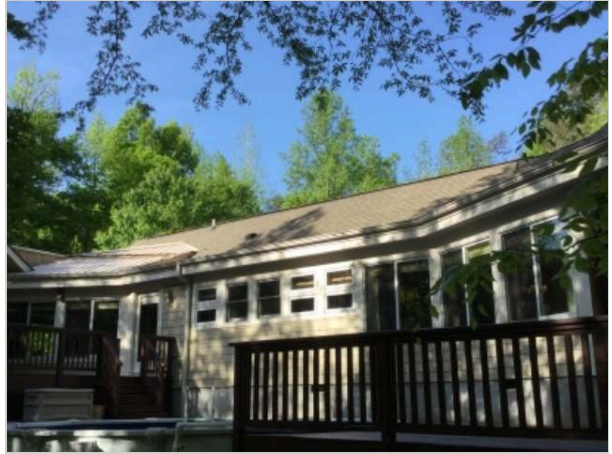
On this roof, one shingle appeared to be in poor condition. Further, there was one curled shingle and one that appeared to be pushed up by a nail. Broken, loose curled and/or cracked shingles can allow the infiltration of water and lead to damaged structural components. Have a qualified contractor to evaluate and repair as required.

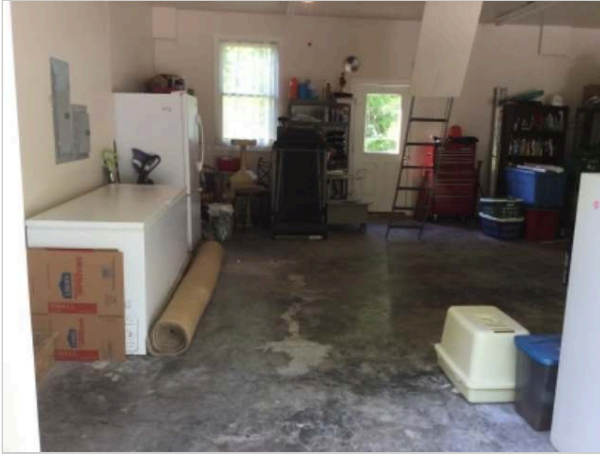
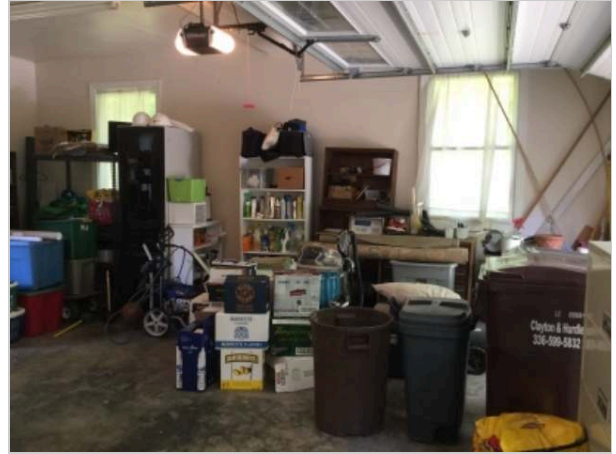
The garage floor and wall inspection was limited by the presence of stored equipment and material. If concerned, once the area is clear, have a qualified contractor evaluate and advise

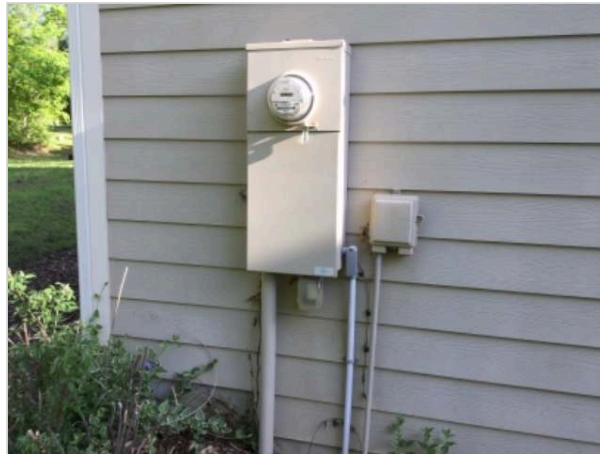
This home has a gas-fired emergency electric generator. These are not part of the home inspection scope. This unit does have an automatic transfer switch. The unit did not cycle on during this inspection. Often, permanently installed generators with automatic functions will be on a test-run cycle (weekly/monthly/etc.). Ask the seller for full disclosure on the set-up and operation of this unit and for all operating and parts manuals or have a qualified electrical contractor evaluate and advise.

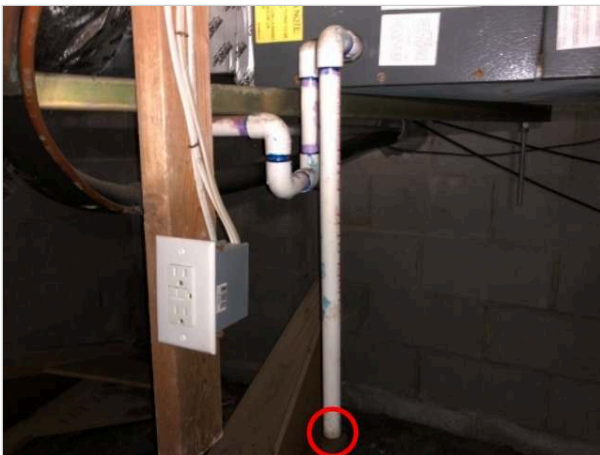
In the crawl space, the right side HVAC indoor unit secondary drain line exits to the vapor barrier. If the primary drain becomes inoperable, this will drain condensate into the crawl space. A functional secondary drain, with a means to drain to the exterior, is essential for proper functioning of this unit. Have a qualified HVAC contractor evaluate and repair as required.

Open to ground

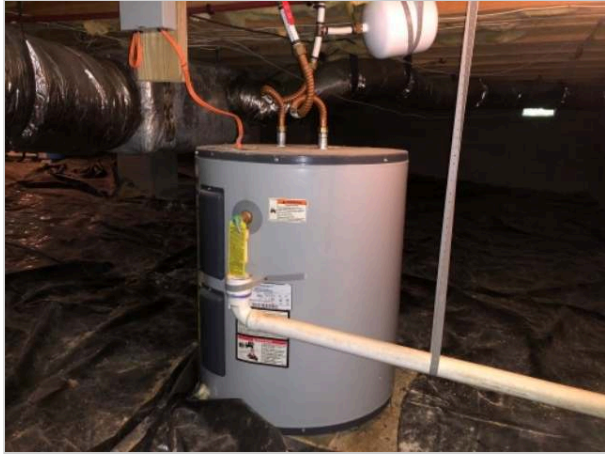
There was a 30 gallon capacity, electric water heater located in the crawl space beneath the living room. The water heater was manufactured by American Water Heater , and appeared to be 13 years old. Client should note that water temperature greater than 120 degrees presents a scalding/burn concern.

There were no concerns observed with the hot water heater.

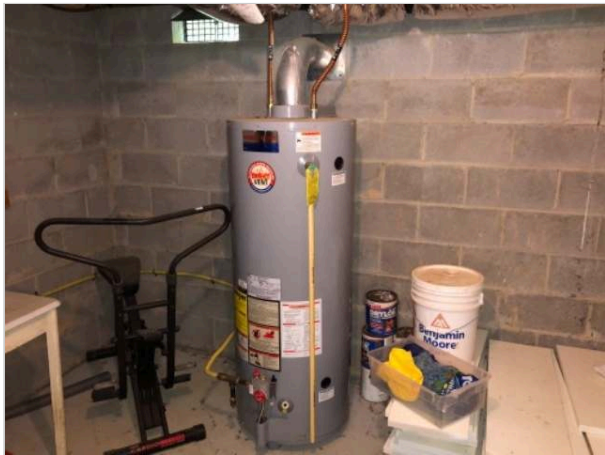
RIGHT WATER HEATER

There was a 50 gallon capacity, LP gas water heater located in the storage room under the guest room. The water heater was manufactured by American Water Heater , and appeared to be 13 years old. Client should note that water temperature greater than 120 degrees presents a scalding/burn concern.

There were no concerns observed with the hot water heater.
