HOME INSPECTION REPORT

On Thursday, February 9, 2023 The HomeTeam Inspection Service made a visual inspection of 123 Sample Street, Myrtle Beach, SC 29572. Enclosed please find a written, narrative report of our findings in accordance with the terms of our Inspection Agreement.

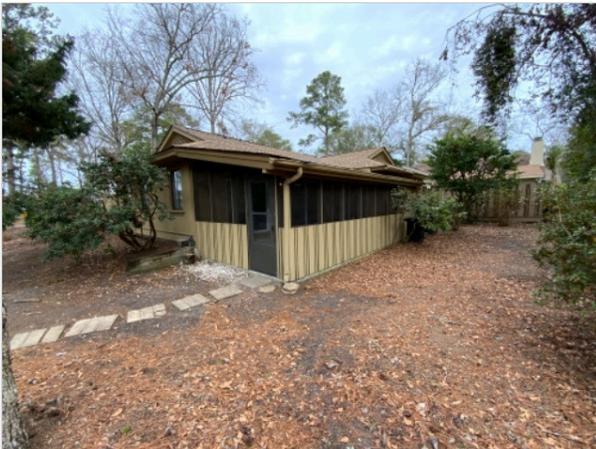
Photo 1

The structure was situated on a level to lightly sloped lot. The general grade around the structure appeared to be adequate to direct rain water away from the foundation, assuming normal drainage and downspout, gutter, and other systems are functioning properly.

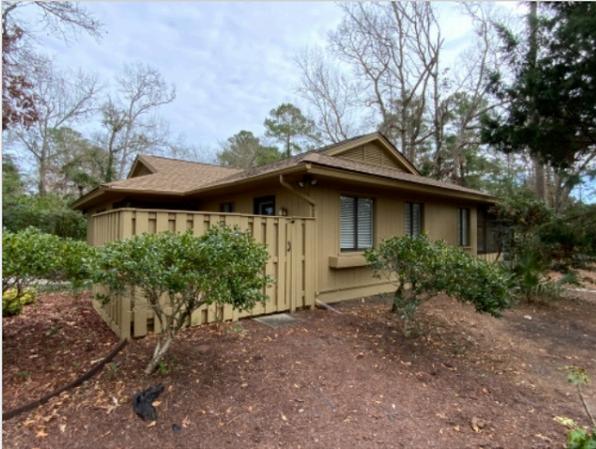
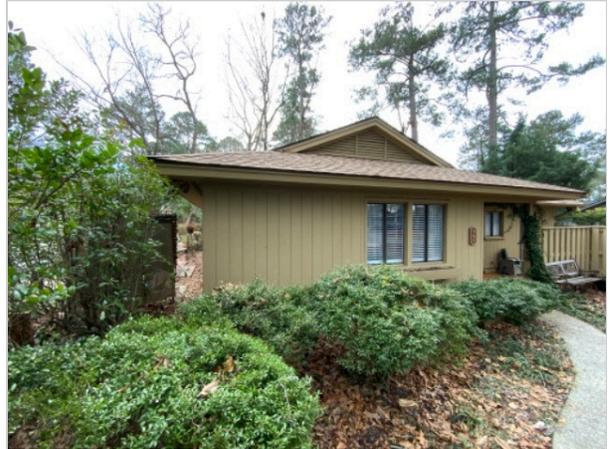
The inspected property consisted of a single story wood-framed structure with wood cladding that was vacant at the time of the inspection.

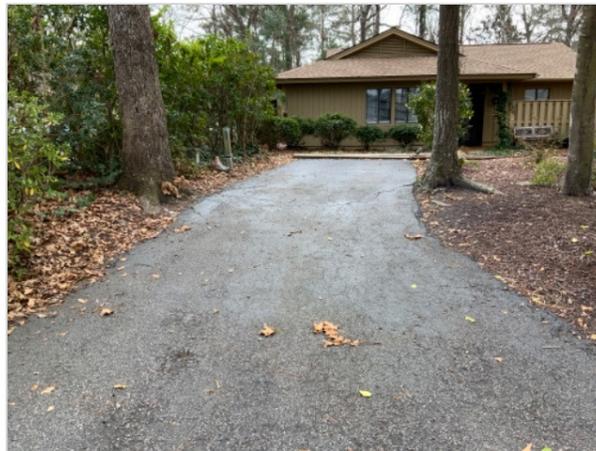
Photo 31

An asphalt driveway is present in the front of the structure. Cracks and spalling were observed on the driveway. Surface defects in driveways develop and progress with age and are considered normal as long as they do not create a safety hazard. Sealing defects may help slow the rate of deterioration.

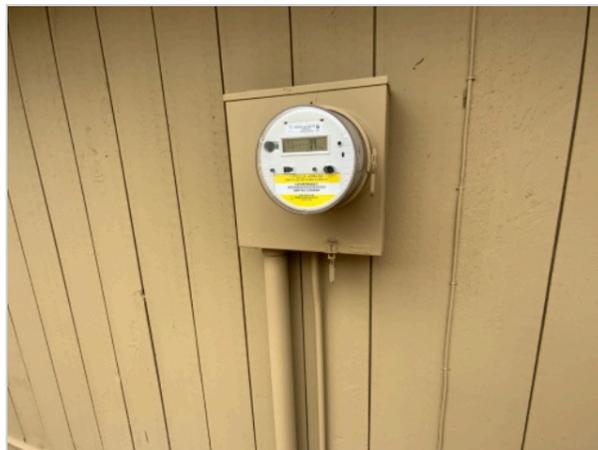
Photo 42

The underground electric service wire entered the structure on the left wall. The electric meter was located on the exterior wall.

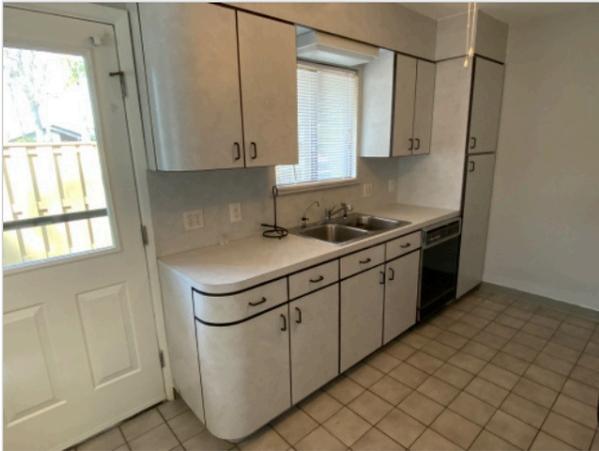
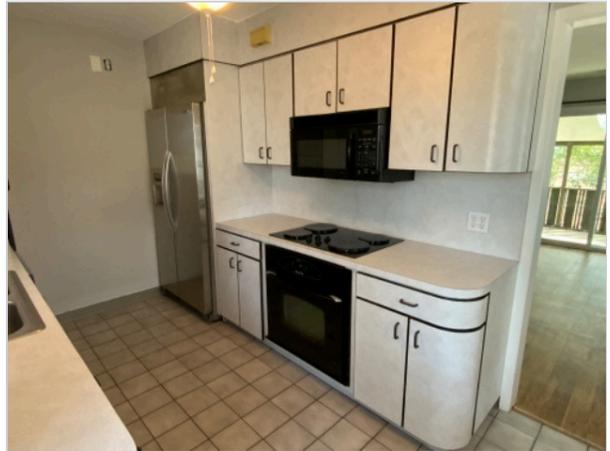
The visible portions of the kitchen cabinets and counter tops were in good condition. The appliances were operated to check basic operational function only. No consideration is given regarding the age or components that may be worn or otherwise affected by wear and tear or use. The kitchen contained the following appliances:

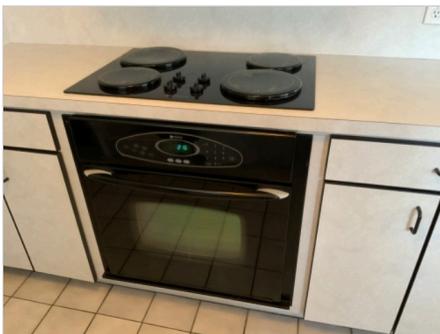
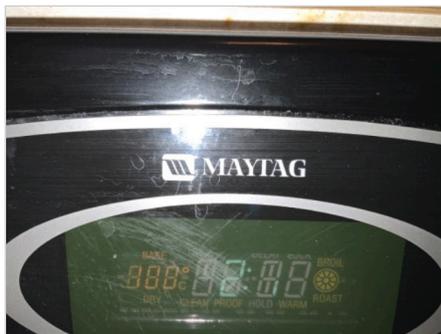
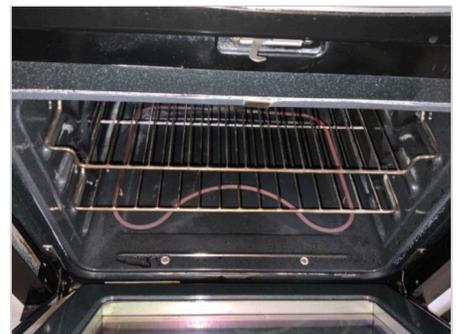
The electric oven was inspected and did appear to be functional. The accuracy of the clock, timers and settings on ovens are not within the scope of this inspection.

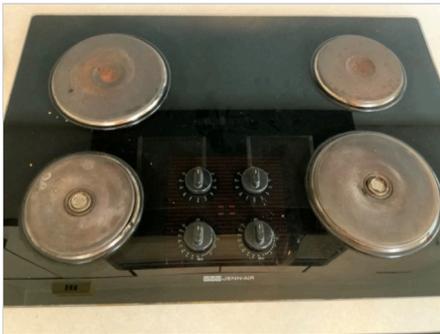
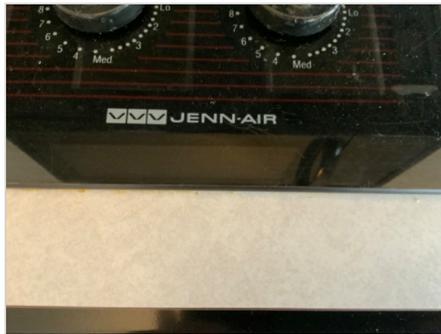
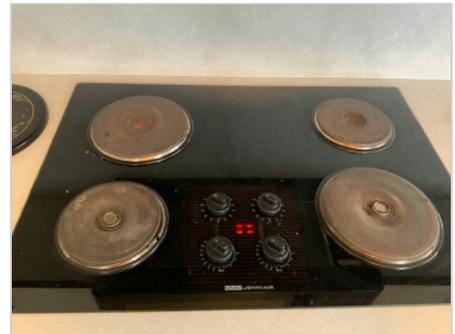
The built in cooktop was tested and found to be functional.

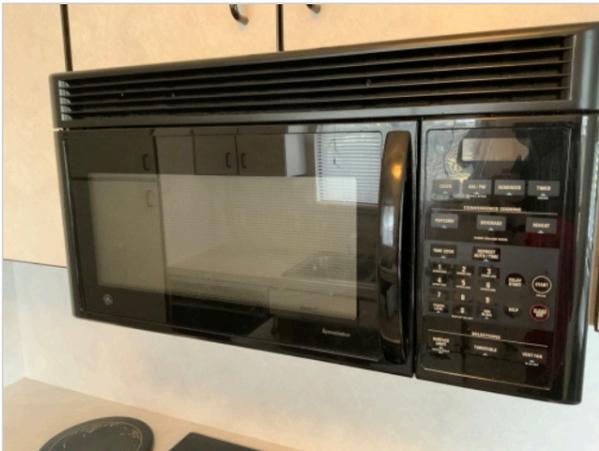
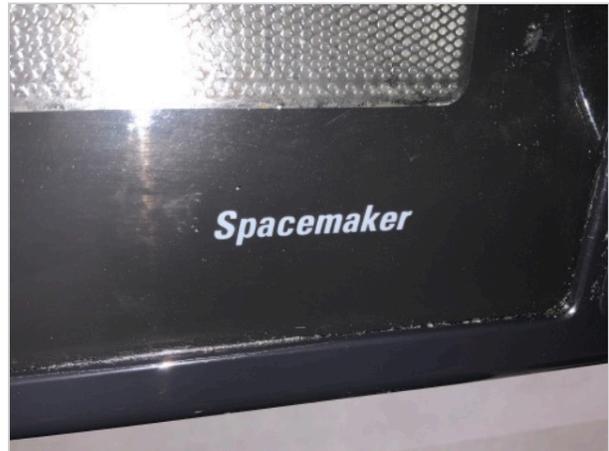
The range hood and microwave combination was inspected and did appear to be functional. The exhaust capacity is not within the scope of this inspection. Cleaning the fan and filter may increase the exhaust capability.

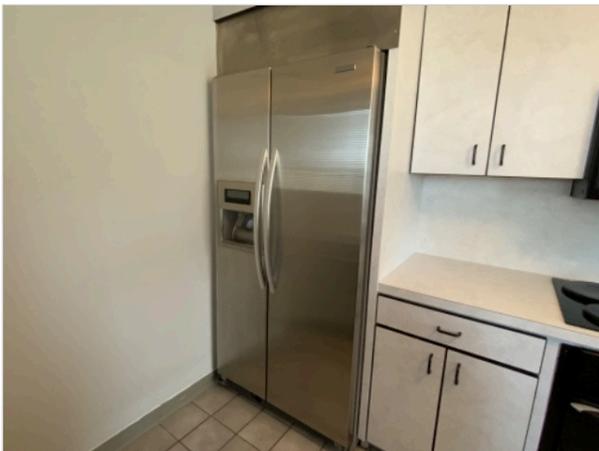
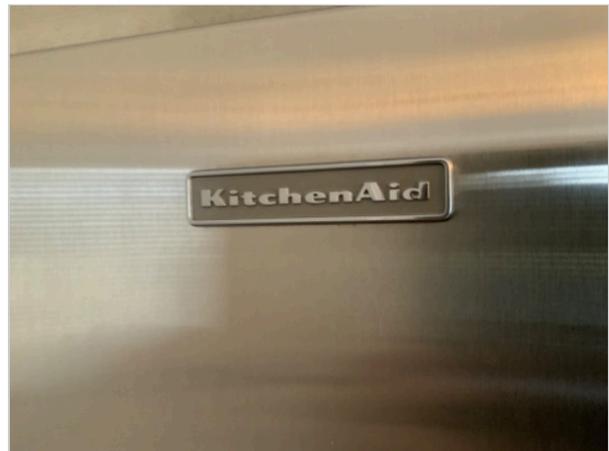
The refrigerator was inspected and did appear to be functional. The ice maker operation and hookups, if present, are not within the scope of the inspection.

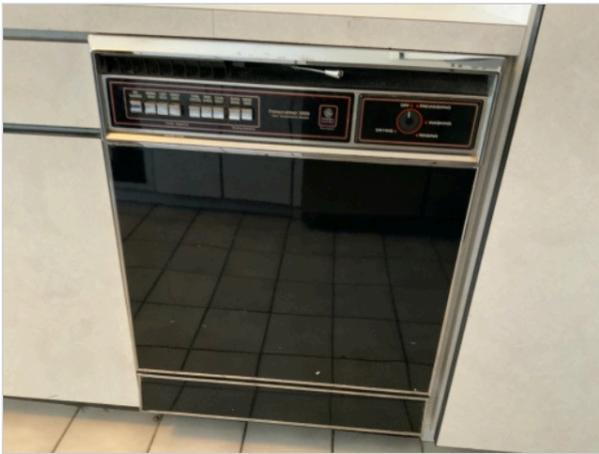
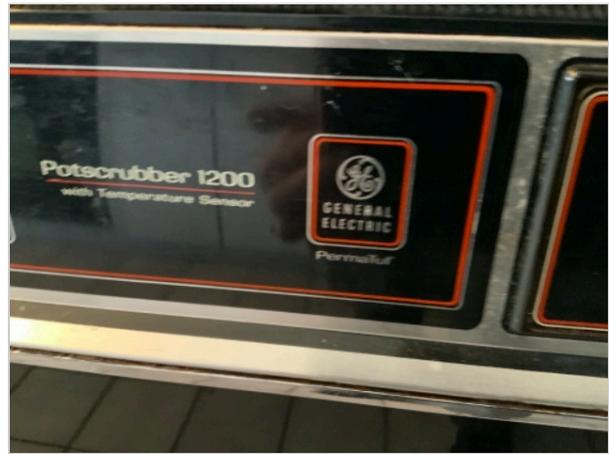
The dishwasher was tested and did appear to be functional.

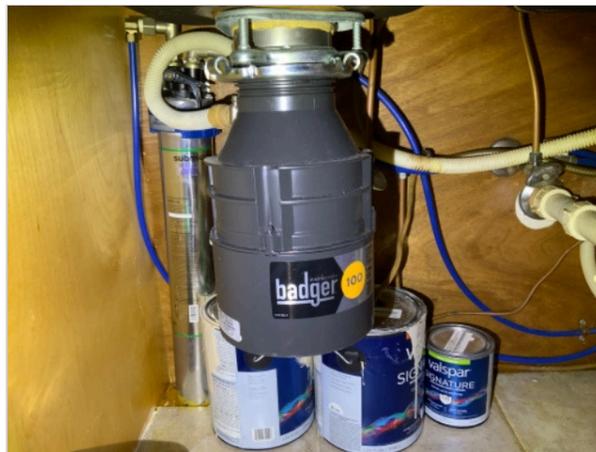
Photo 98

The disposal was inspected and did appear to be functional. The efficiency rating and chopping / grinding ability of the unit is not within the scope of the inspection.

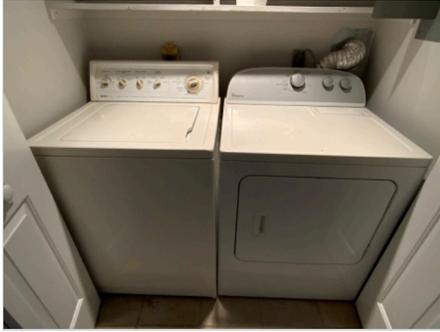
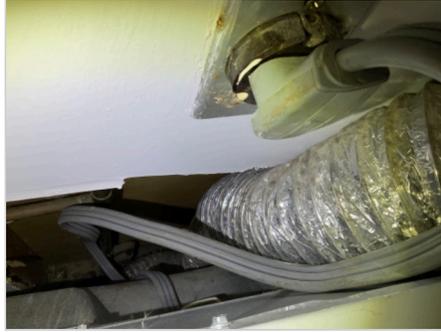
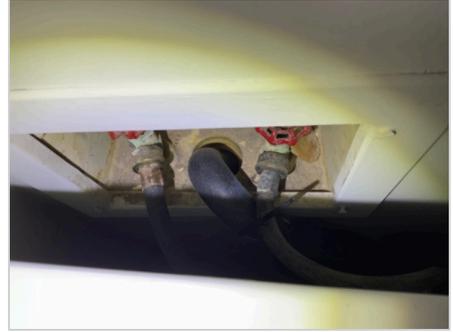
A drain for a washing machine was present.

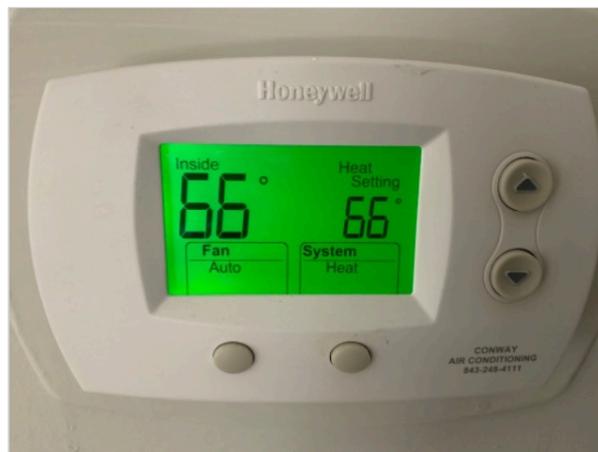
Photo 109

The control for the heating and air conditioning system was a 24 volt digital thermostat located on the hallway wall of the home. The thermostat was manufactured by Honeywell and found to be in working order.

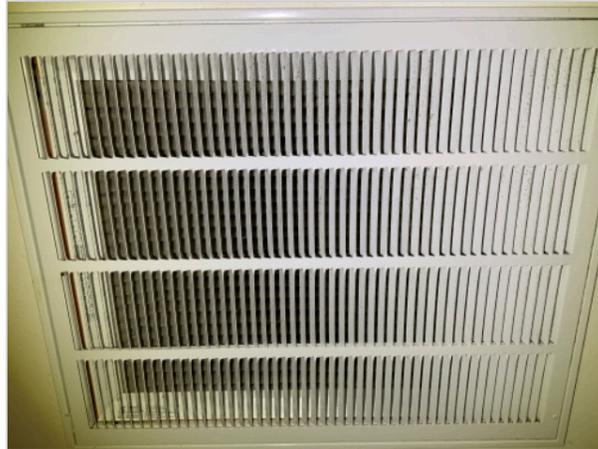
Photo 110

The disposable/washable filter should be replaced/cleaned on a regular basis to maintain the efficiency of the system. The efficiency rating is not within the scope of this inspection. A disposable filter(s) was installed in a hallway filter grille.
