# HomeTeam<sup>®</sup>

### HOME INSPECTION REPORT

The HomeTeam Inspection Service made a visual inspection of 123 Main Street, Anytown, USA 55555. Enclosed please find a written, narrative report of our findings in accordance with the terms of our Inspection Agreement.

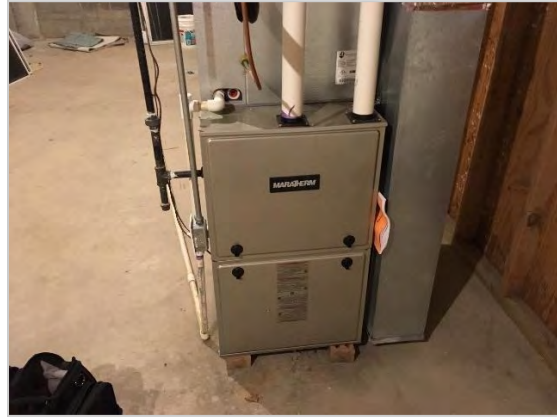
Photo 15

**A condensate leak was noted on the air handler drain line.** Repairs should be made by a qualified contractor.

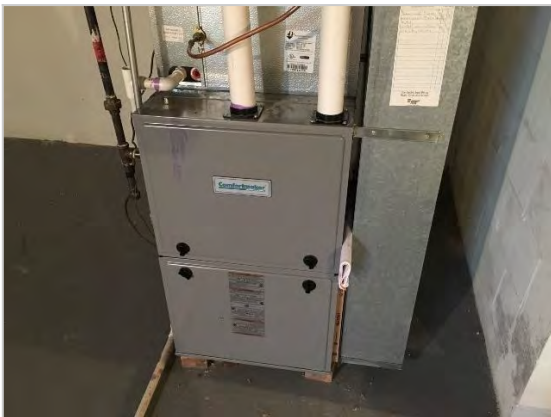
Photo 17

The unit was located in the basement of the structure.

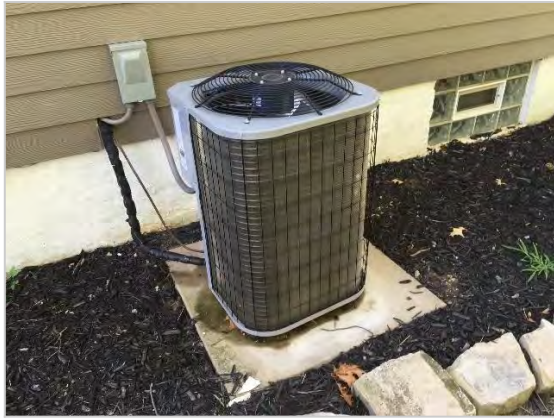
Photo 19

Serial Number X15330728. The unit is located on the left side of the structure. This unit is approximately 1 years old. Periodic preventive maintenance is recommended to keep this unit in good working condition, and HomeTeam strongly recommends partnering with a reputable HVAC company for routine maintenance for the heating and cooling systems in the fall and spring. The air conditioning system was tested and found to be functional. As a reminder, this is functionality test and visual inspection only; we do not check suction pressures, contactor amps, or refrigerant levels. If a more detailed inspection is required, please consult with an HVAC company.

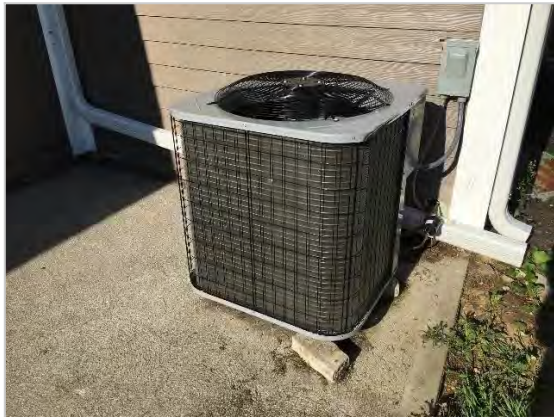
Photo 21

The second electric outdoor air conditioner condensing unit was a Comfortmaker, Model Number R4A348AKN100 and Serial Number X152462739. The unit is located in the back of the structure. This unit is approximately 1 years old. Periodic preventive maintenance is recommended to keep this unit in good working condition. The air conditioning system was tested and found to be functional.
