HomeTeam[®]

INSPECTION SERVICE

HOME INSPECTION REPORT

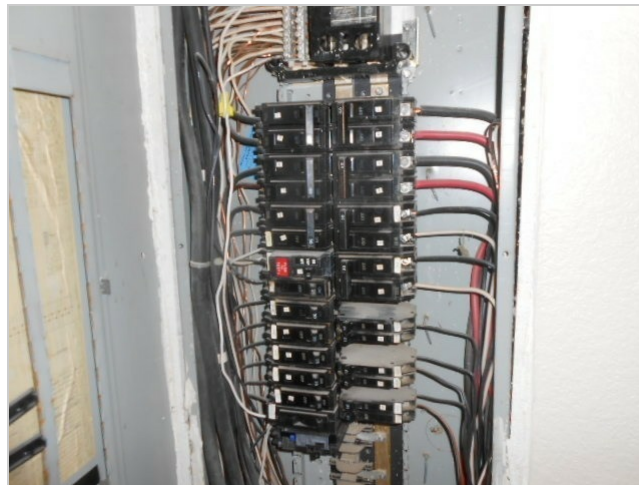
The branch circuits within the panel were constructed of copper wiring. These branch circuits and the circuit breaker to which they were attached appeared to be appropriately matched. The visible house wiring consisted primarily of the Romex type and appeared to be in overall good condition.

The electrical panel cover was removed for inspection of the house wiring, circuits and breakers.
