PROPERTY INSPECTION REPORT

Prepared For:	Bill Sample		
	(Name of Client)		
Concerning:	123 Sample Drive Anytown, TX 55555		
	(Address or Other Identification of Inspected Property)		
By:	Chuck Chenoweth (# TREC #20801)	Joel Mower (# TREC #21621)	Marc Poulain (# 23085)
	(Name and License Number of Inspector)		9-21-2018
			(Date)
	(Name, License Number of Sponsoring Inspector)

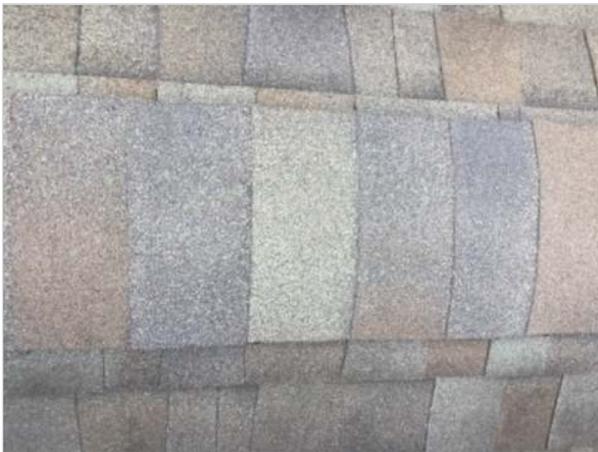
The shingles were sealed. The nailing pattern wasn't determined from this inspection. Flashing details were not visible. The remaining life of the shingles wasn't determined by this inspection; moderate wear and granule loss were observed. There was approximately 1/8-inch shingle granule accumulation contained with gutters. The visual inspection of the roof surface is not intended as a warranty or an estimate of the remaining life of the roof. Roof leaks may only become evident during periods of heavy rain and/or winds from specific directions.

Representative shingle condition

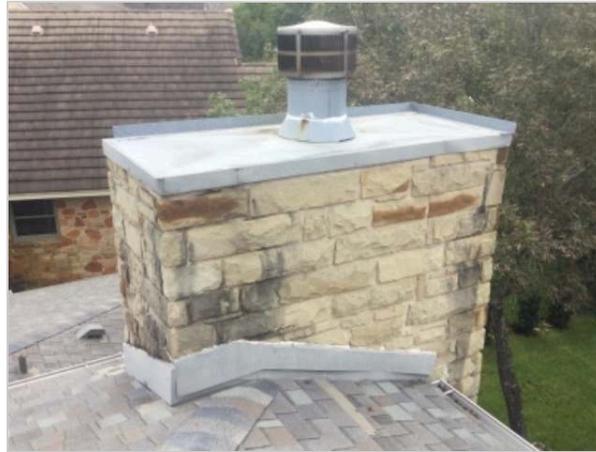
Upper chimney structure

A damper stop was not installed; this is required when a gas log insert is present.

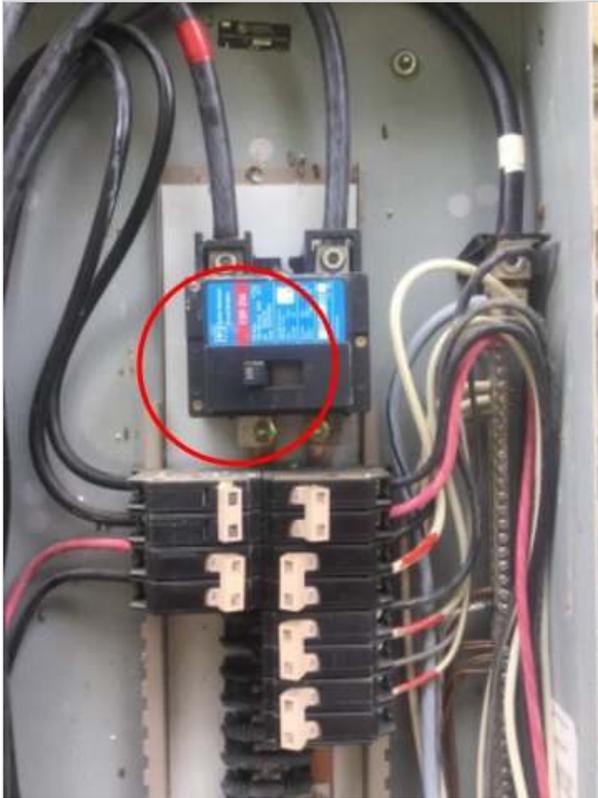
Gas lines were not determined to be properly bonded; bonding wire not visibly located. The earth grounding rod was not fully driven; approximately 9-10-inches was exposed above ground. Outer entrance panel cover hinges missing. Inner entrance panel cover securing screws were pointed.

225 amp principle service disconnect

Note: Many items listed as deficient in this report may not have been deficient at the time of initial construction as mechanical standards change over the years. It is recommended that all deficiencies be evaluated by a licensed electrical contractor prior to closing and repairs addressed as needed. The condition of the electrical wiring is not able to be determined in inaccessible locations including, but not limited to inside walls and insulated areas of the attic. An attempt was made to check all receptacles and light fixtures throughout interior and exterior locations; some switches and receptacles may not be accessible in occupied homes.
