HOME INSPECTION REPORT

On Thursday, June 23, 2022 The HomeTeam Inspection Service made a visual inspection of 1234 Sample Dr. Any Town, USA 55555. Enclosed please find a written, narrative report of our findings in accordance with the terms of our Inspection Agreement. Although general maintenance items may have been addressed verbally at the time of the inspection, they may not be included in the enclosed report.

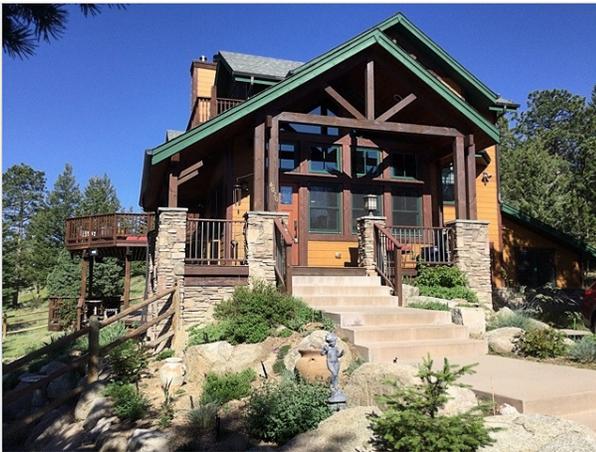
Photo 1

The structure was situated on a moderately sloped lot. The general grade around the structure appeared to be inadequate on the right side to direct rain water away from the foundation, assuming normal drainage and downspout, gutter, and other systems are functioning properly.

HomeTeam recommends having the soil regraded on the right side of the structure and further assessed at the time of regrading.

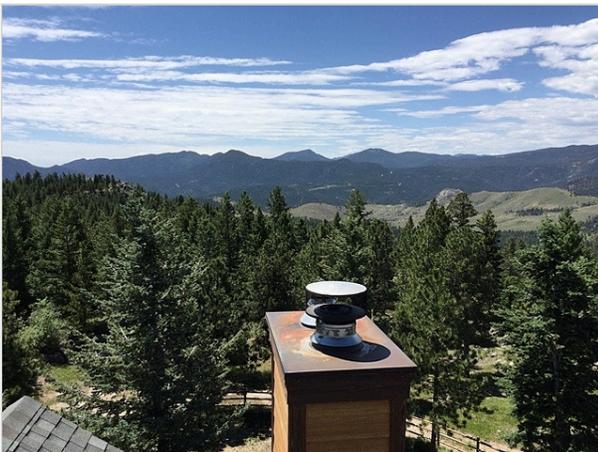
Photo 14

The structure had one chimney. Observation of the chimney was made from the roof. The flashing around the roof penetration point appeared to be adequate.

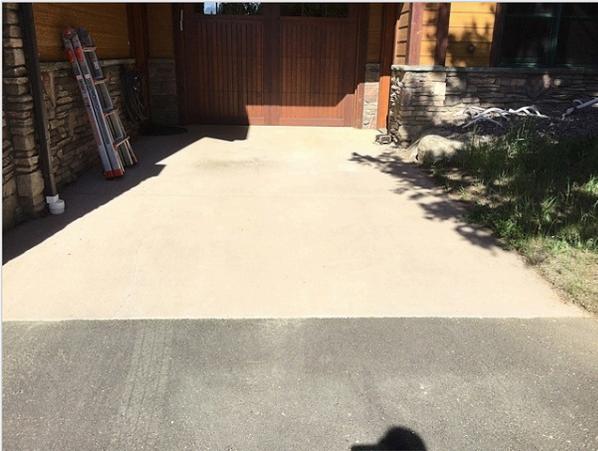
Photo 18

An asphalt driveway is present in the front of the structure. Cracks and spalling were not observed on the driveway. Surface defects in driveways develop and progress with age and are considered normal as long as they do not create a safety hazard. Sealing defects may help slow the rate of deterioration.

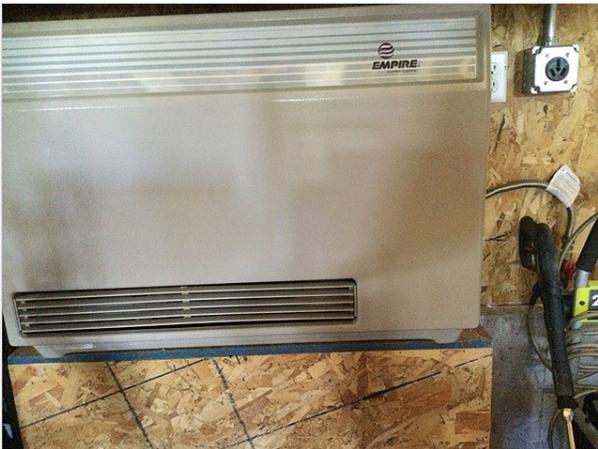
Photo 24

The garage was heated by a propane forced air furnace. The control for this heating system was located in the unit. The thermostat was found to be in working order. The garage heating system was functional.

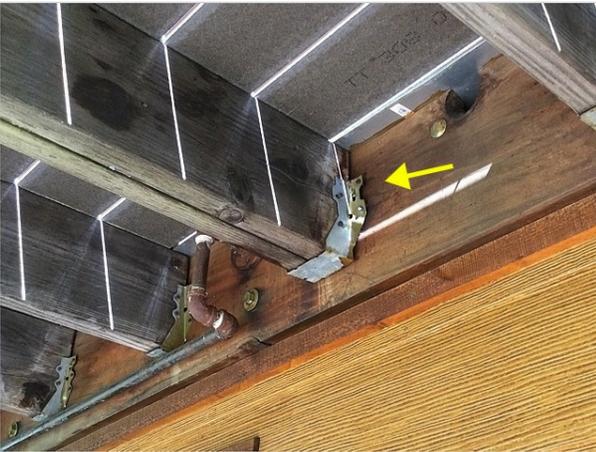
Photo 38

A few of the joist hangers on the middle deck appear to be coming loose. Recommend repairs by a qualified contractor.

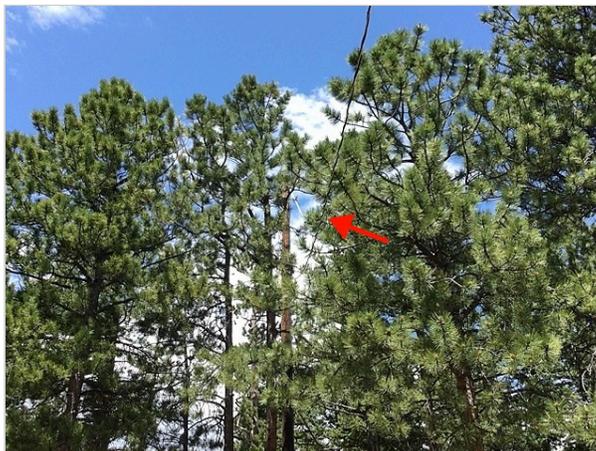
Photo 44

The main electrical service wire feeding this structure was in contact with tree branches. For safety, the local power company should be contacted to trim away the branches from the power line.

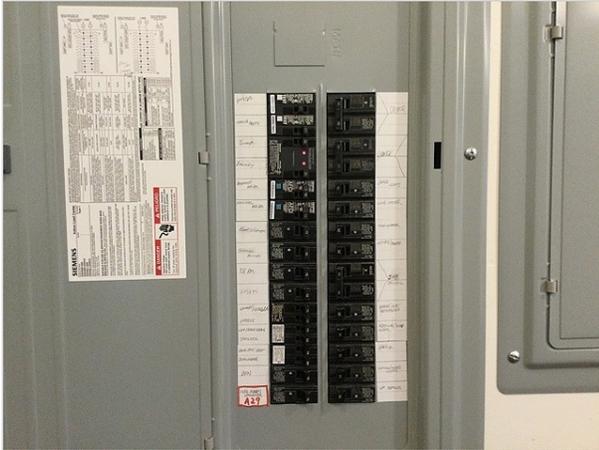
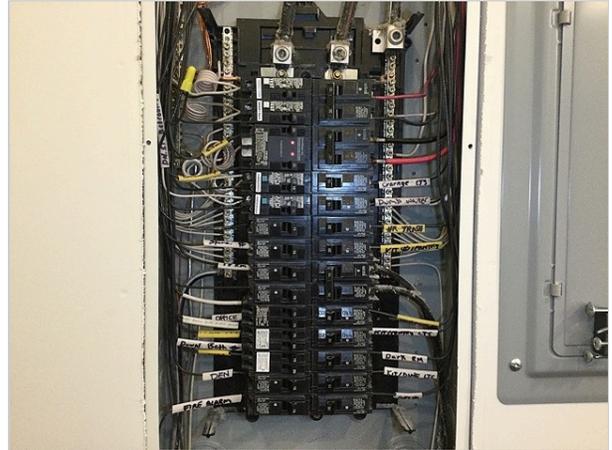
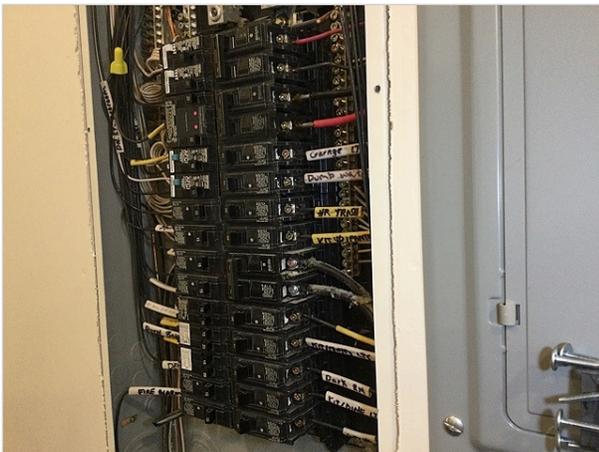
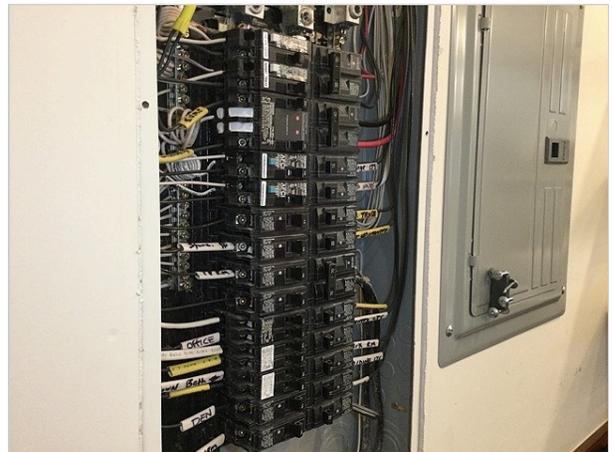
The service wire appeared to be 120/240 volt and 200 amp and entered a Siemens service panel, located on the rear

utility room wall. The main service disconnect was 200-amp rated and was located adjacent to the service cable entry point. The branch circuits within the panel were copper. These branch circuits and the circuit breaker to which they were attached appeared to be appropriately matched. The internal components of the service panel, i.e. main lugs, bus bars, etc were in good condition.

The electrical service appeared to be adequate. As a reminder, alarms, electronic keypads, remote control devices, landscape lighting, telephone and television wiring are beyond the scope of this inspection.

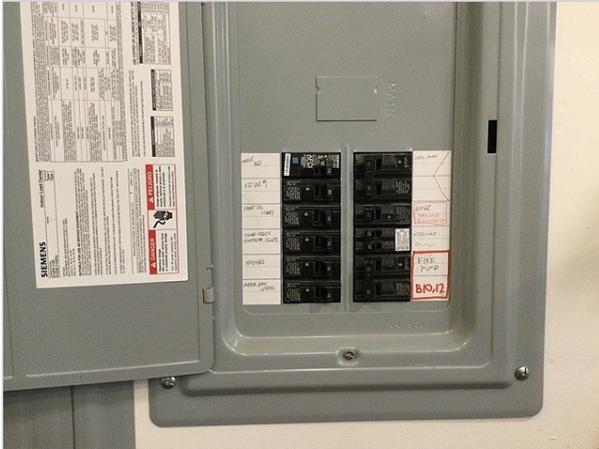
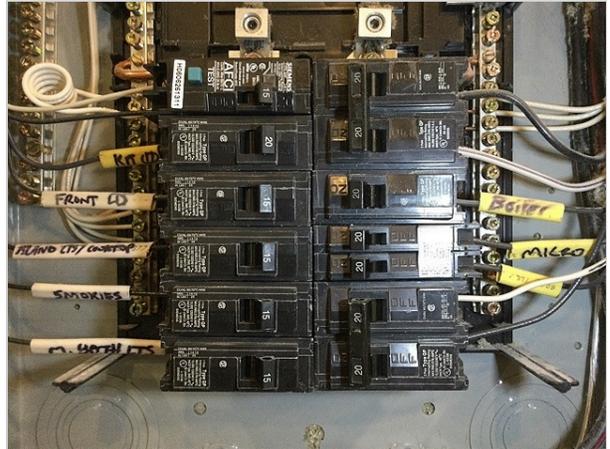
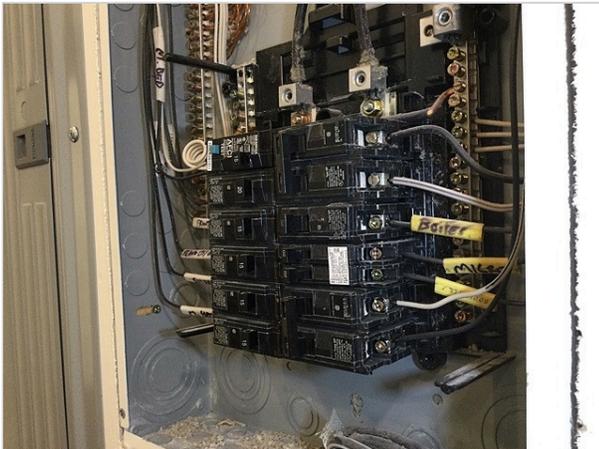
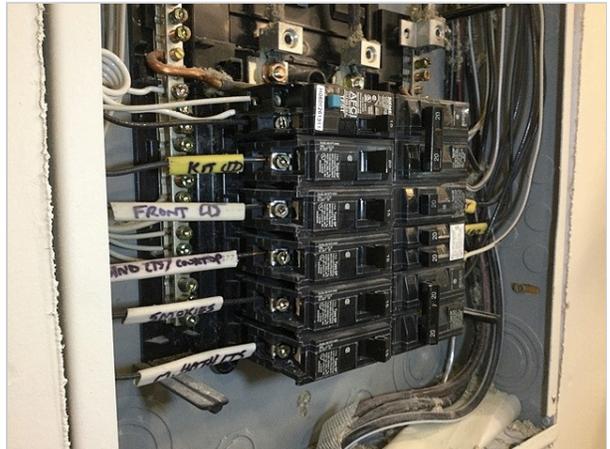
An electric service sub-panel was located on the utility room wall, and was manufactured by Siemens. The service wire appeared to be rated for 70 amps. The disconnect switch for this panel was located in the main panel, and was rated at 70 amps. The branch circuits within the panel were copper. These branch circuits and the circuit breaker to which they were attached appeared to be appropriately matched. The visible wiring consisted primarily of the Romex type and appeared to be in good condition.

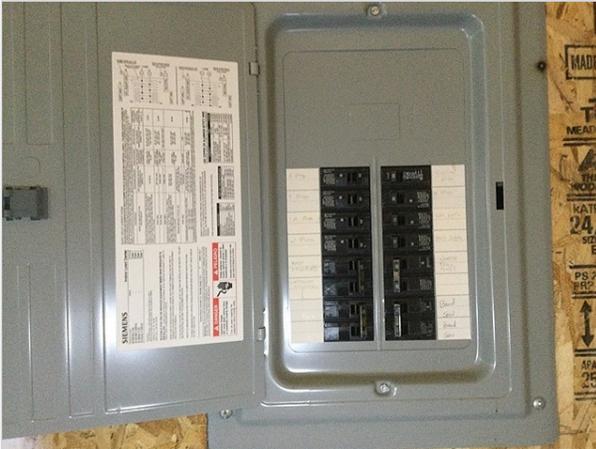
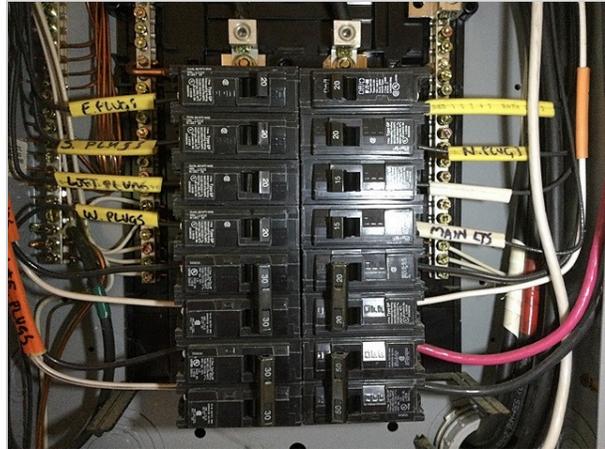
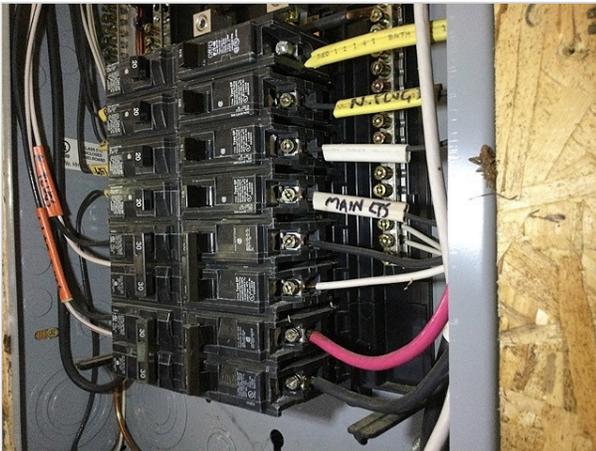
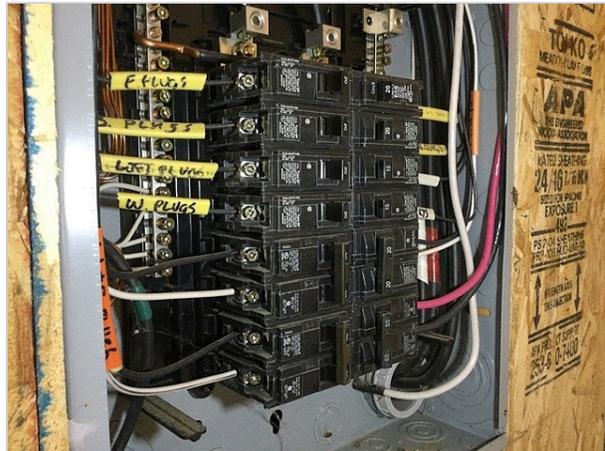
An electric service sub-panel was located in the detached garage, and was manufactured by Siemens. The service wire appeared to be rated for 100 amps. The disconnect switch for this panel was located adjacent to the service entrance, and was rated at 100 amps. The branch circuits within the panel were copper. These branch circuits and the circuit breaker to which they were attached appeared to be appropriately matched. The visible wiring consisted primarily of the Romex type and appeared to be in good condition.

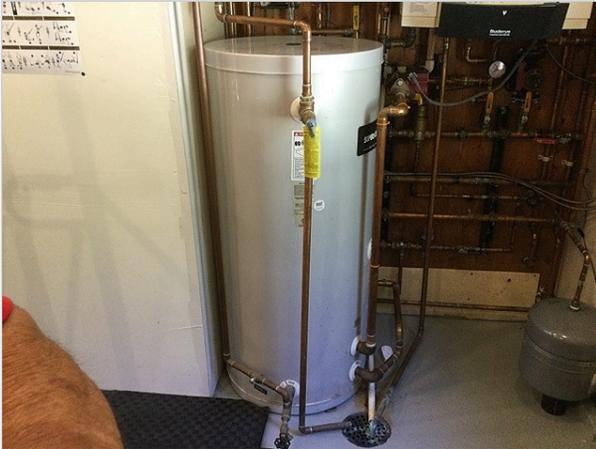
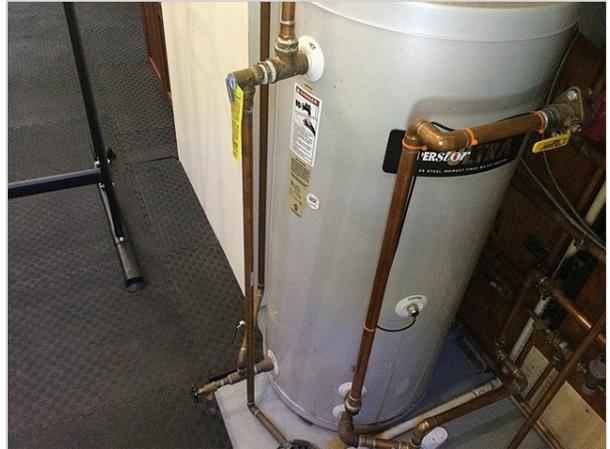
A 60 gallon capacity, water heater was located in the utility room. The water heater was manufactured by SuperStor, model number SSU-60 and serial number J13L26111. Information on the water heater indicated that it was manufactured 17 years ago.

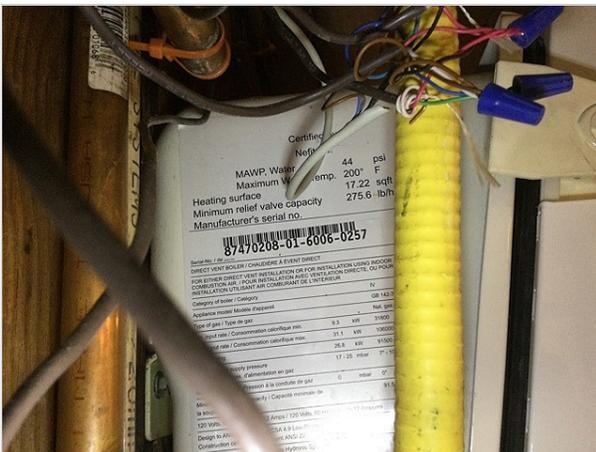
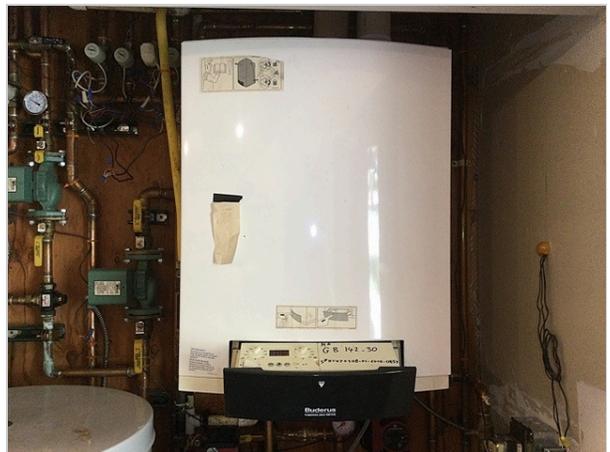
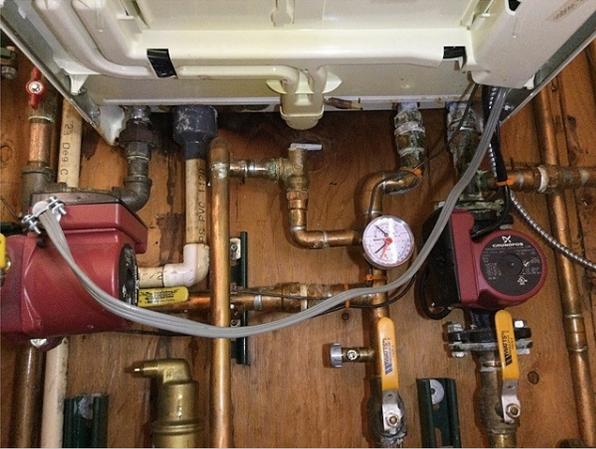
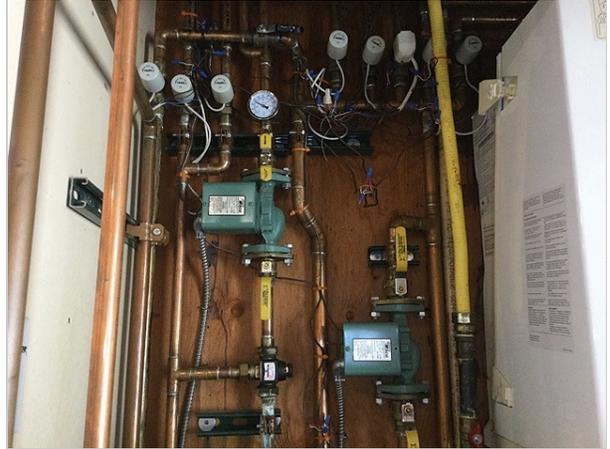
There was a propane tankless water heater located in the utility room. The water heater was manufactured by Buderus. Information on the water heater indicated that it was manufactured approximately sixteen years ago. A temperature and pressure relief valve (T & P) was present. Because of the lime build-up typical of T & P valves, we do not test them. An overflow leg was present. It did terminate close to the floor. Your safety depends on the presence of a T & P valve and an overflow leg terminating close to the floor.

The tankless water heater was functional.

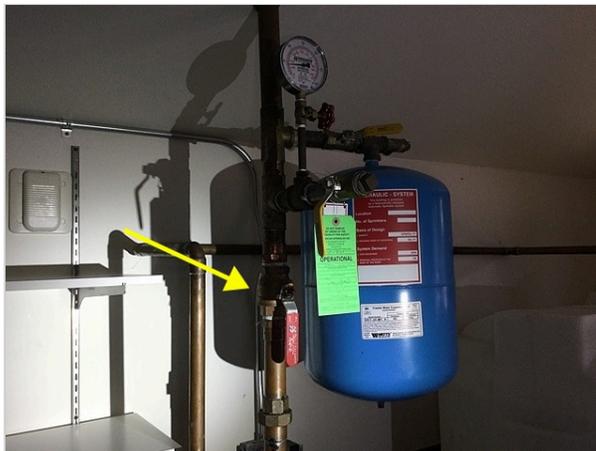
Photo 91

main water shut off

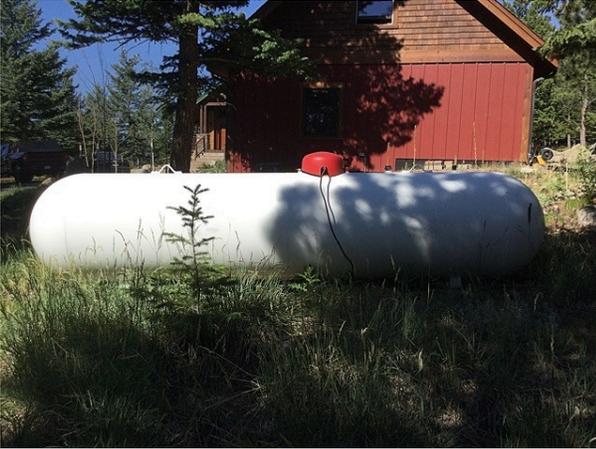
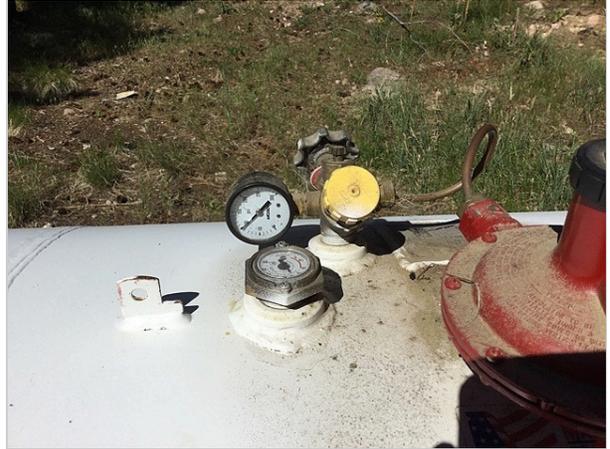
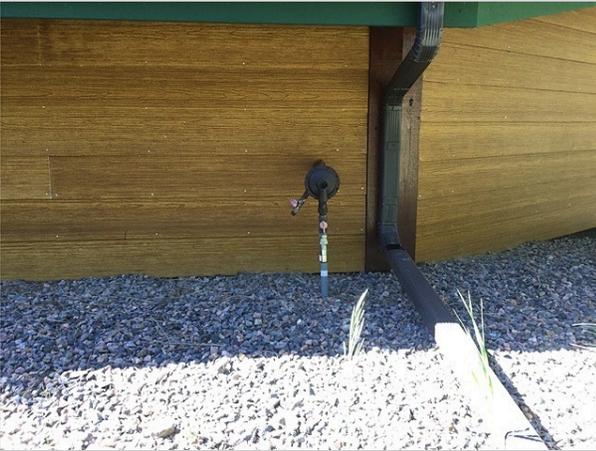
A bonding or grounding device is recommended to be verified and/or installed on the CSST (Corrugated Stainless Steel Tubing) natural gas system in order to reduce the chances of a natural gas leak or fire. Bonding is provided primarily to prevent a possible electric shock to people who come in contact with the gas piping and other metal objects connected to the CSST system. Nearby lightning strikes can also result in an electrical surge and can potentially puncture a hole in the CSST. Additional information regarding this type of condition can be found at: <http://csstsafety.com/>

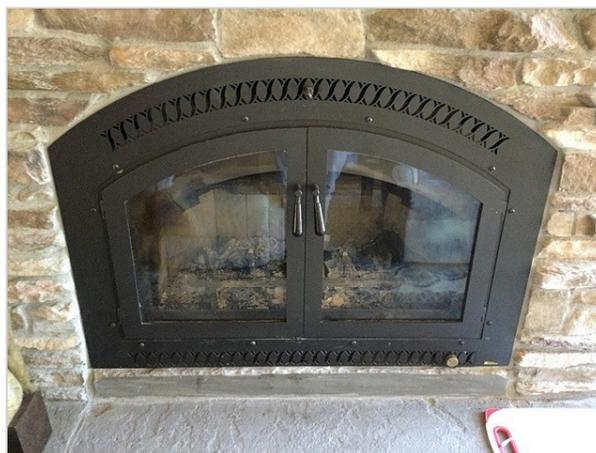
Photo 96

A wood-burning fireplace was located in the basement family room. There was no visual evidence of creosote buildup in the firebox and/or chimney. There were no cracks observed in the firebox or visible portions of the chimney. The fireplace was not tested for operation.

Note: a home inspection of the fireplace and chimney/flue exhaust is limited to the readily visible portions only. The inner reaches of a flue are mainly inaccessible. Our view was not adequate to discover possible deficiencies or damage, even with a strong light. For safe and efficient operation we recommend annual inspections by a qualified fireplace professional. A qualified chimney sweep will clean the interior if necessary, using specialized tools, testing procedures, mirrors and video cameras as needed to evaluate the fireplace system. If the fireplace has not been cleaned and inspected by a qualified fireplace professional within the past year, we recommend this be done prior to use.

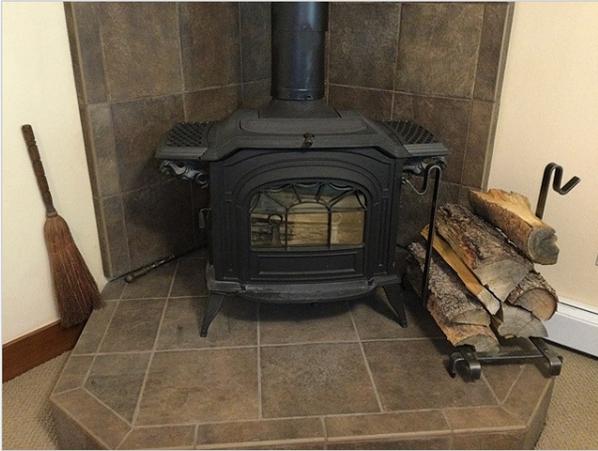
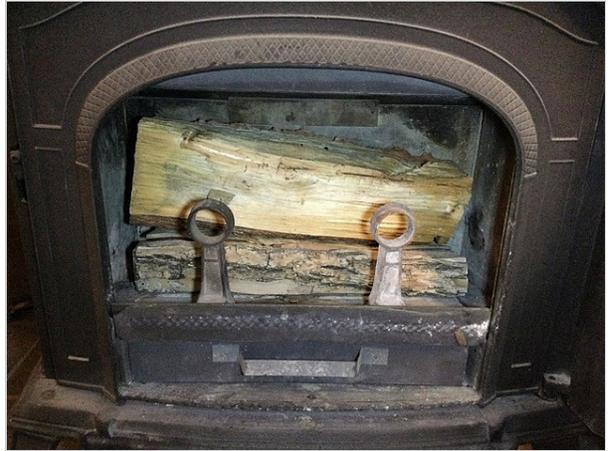
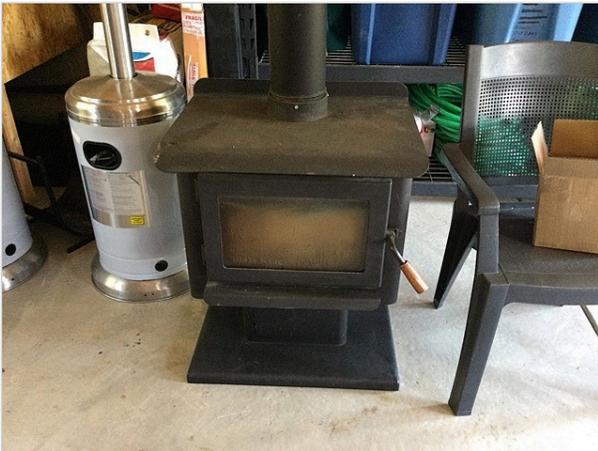
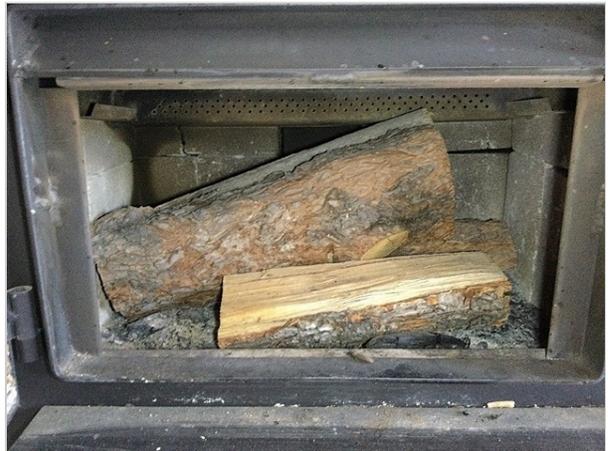
There were two wood-burning stoves located in the lower level family room and garage. For safety reasons, recommend that the wood-burning stove and the chimney or pipe to which it is vented be cleaned and re-inspected before using as there may be hidden defects not fully visible at the time of the inspection. Although not actually tested, the stove appeared to be functional. The stove appeared to have adequate clearances from combustible materials.

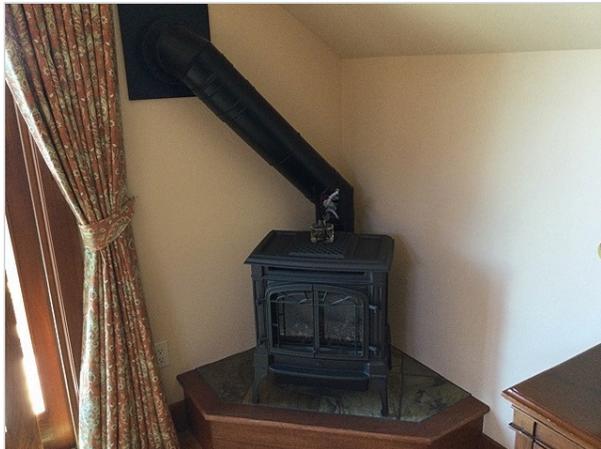
Photo 101

There was a propane-burning stove located in the primary bedroom. For safety reasons, recommend that the gas-burning stove and the chimney or pipe to which it is vented be cleaned and re-inspected before using as there may be hidden defects not fully visible at the time of the inspection. The stove was non-functional at the time of inspection. The stove appeared to have adequate clearances from combustible materials.

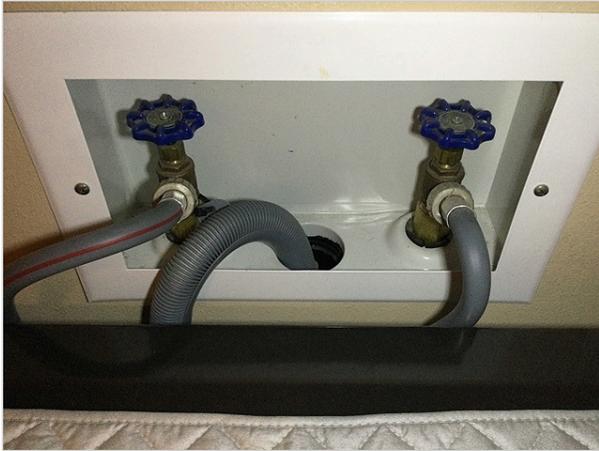
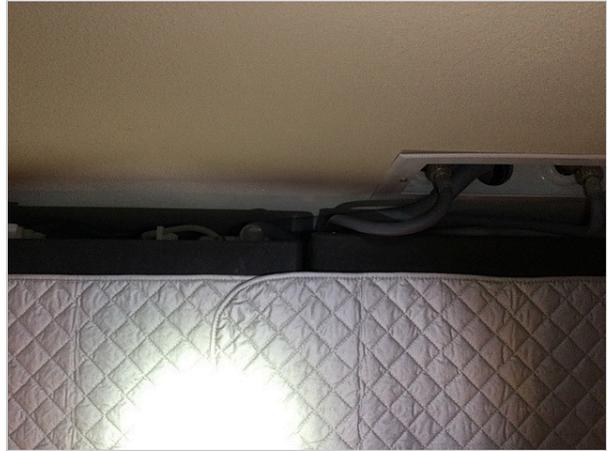
The Kenmore washer and dryer were operated. Laundry room drains are not tested. It is recommended that all washing machines have a drip pan installed under the unit and that stainless steel flex hoses be installed on the washing machine cold and hot water supply hose bibs. Please note that the washer and dryer was run without clothing and, therefore, some defects may appear when run full of clothing which may not have been evident at the time of the inspection. The cleaning efficiency is not within the scope of this inspection. There are no warranties or guarantees of the normal operating conditions of the units. This note is supplied for informational purposes only, as many clients want to know the type of dryer connections available to them. A 240 volt style outlet for an electric clothes dryer was installed in the laundry area. Consult with a qualified contractor if the desired type of connection is not available.

Note: it is recommended that the dryer vent be cleaned periodically, for safety.

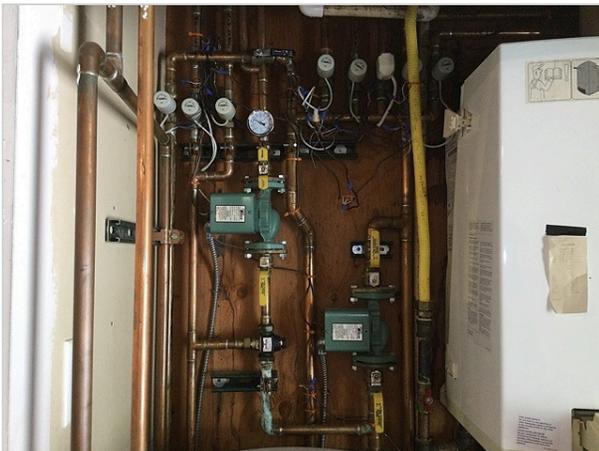
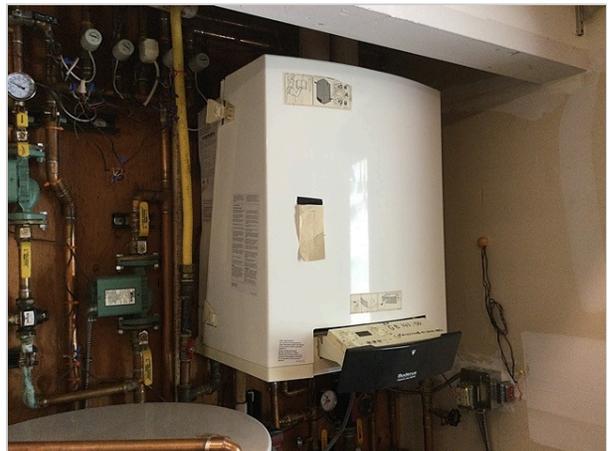
The structure was heated by a Buderus propane tankless water heater, which is 16 years old. The unit was located in the utility room of the structure. The heating system was found to be functional.

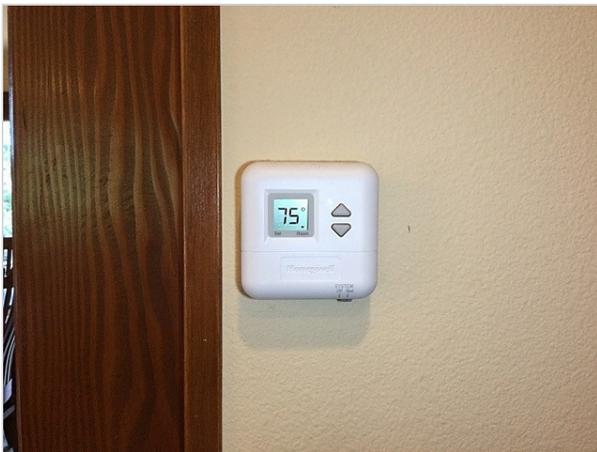
kitchen

The controls for the heating system were 24 volt digital thermostats located on various walls of the home. The thermostats were manufactured by Honeywell and were found to be in working order.
