HOME INSPECTION REPORT

The HomeTeam Inspection Service made a visual inspection of 123 Main Street, Anytown, USA 55555. Enclosed please find a written, narrative report of our findings in accordance with the terms of our Inspection Agreement.

File Number: **1132 - 083016**

Address of Inspection: **123 Main Street**

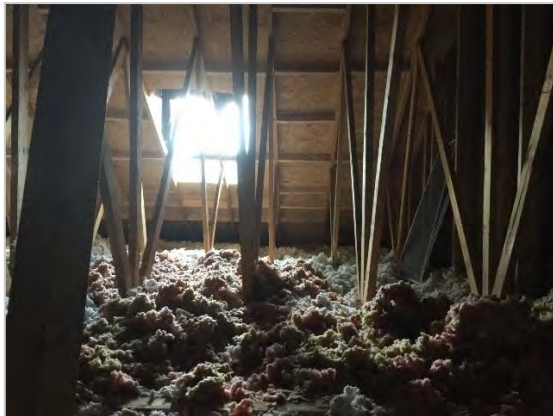
Photo 7

As with all aspects of the home inspection, attic and roof inspections are limited in scope to the visible and readily accessible areas. Due to configuration, parts of the attic were not accessible. Many areas of the roof are not visible from the attic especially near the base, where the largest volume of water drains. The presence or active status of roof leaks cannot be determined unless the conditions which allow leaks to occur are present at the time of the inspection, ie, heavy rain combined with high winds. Please be aware that rain alone is not always a condition that causes a leak to reveal itself. The conditions that cause leaks to occur can often involve wind direction, the length of time it rains, etc.
