HOME INSPECTION REPORT

On November 19, 2016 The HomeTeam Inspection Service made a visual inspection of 123 Sample Road Anywhere, GA 55555. Enclosed please find a written, narrative report of our findings in accordance with the terms of our Inspection Agreement.

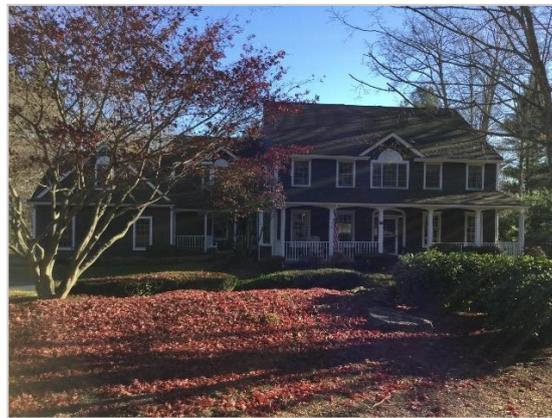
Photo 1

The structure was situated on a moderately sloped lot. The general grade around the structure appeared to be adequate to direct rain water away from the foundation, assuming normal drainage and downspout, gutter, and other systems are functioning properly.

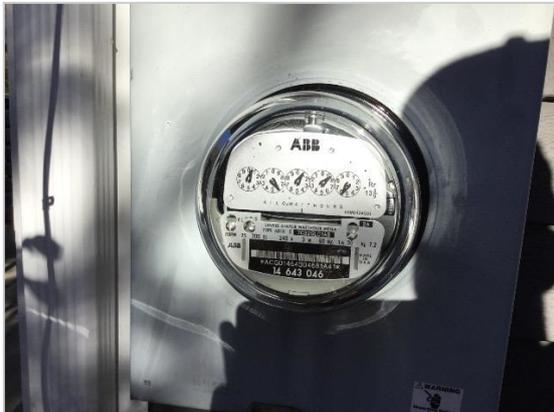
Photo 15

The underground electric service wire entered the structure on the right wall. The electric meter was located on the exterior wall.

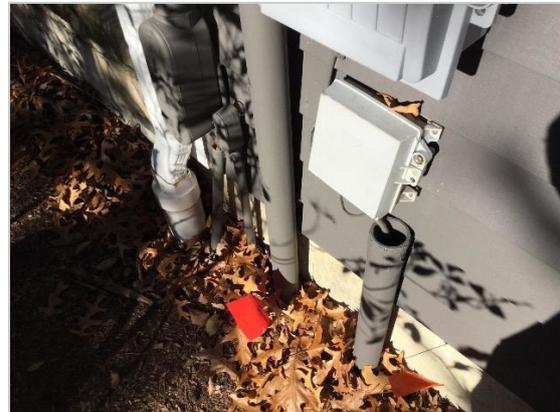
Photo 16

The service wire appeared to be 120/240 volt and 200 amp and entered a Square D service panel, located on the right basement wall. The main service disconnect was 200-amp rated and was located in the main panel. The branch circuits within the panel were copper and aluminum. These branch circuits and the circuit breaker to which they were attached appeared to be appropriately matched. The internal components of the service panel, i.e. main lugs, bus bars, etc were in good condition.

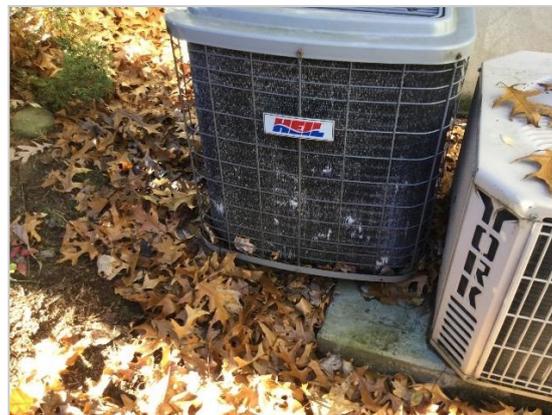
Photo 24

The fins on the outdoor compressor unit are bent. Combing or straightening the fins may improve the efficiency of the unit by aiding heat transfer.
