HOME INSPECTION REPORT

On Tuesday, March 26, 2024 The HomeTeam Inspection Service made a visual inspection of 123 Anywhere Street, Anytown, USA 11111. Enclosed please find a written, narrative report of our findings in accordance with the terms of our Inspection Agreement.

Alan Benavides
HomeTeam Inspection Service
Florida Home Inspector HI16910

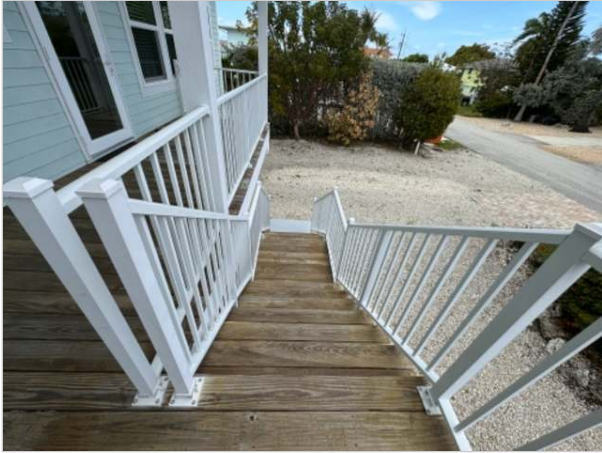
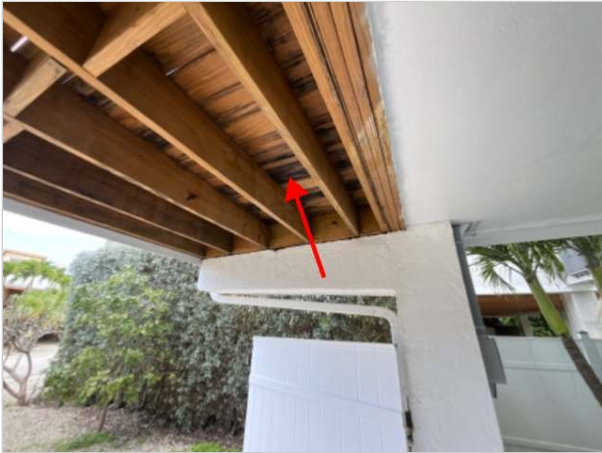
Extensive plant and/or tree overgrowth was observed against the structure. HomeTeam recommends trimming or removing this growth to prevent possible damage including insect infestation, moisture buildup, and impact damage to the roof and structure.

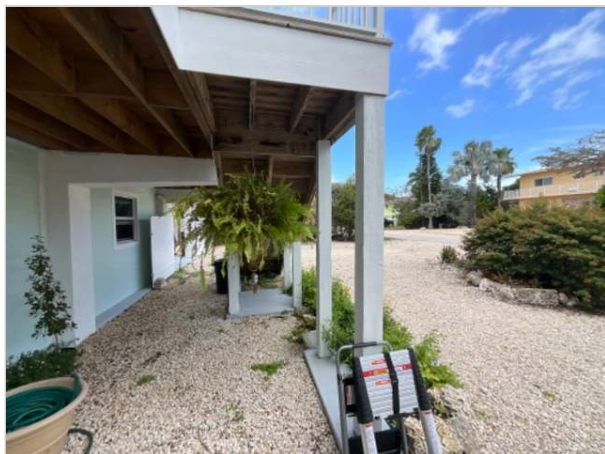
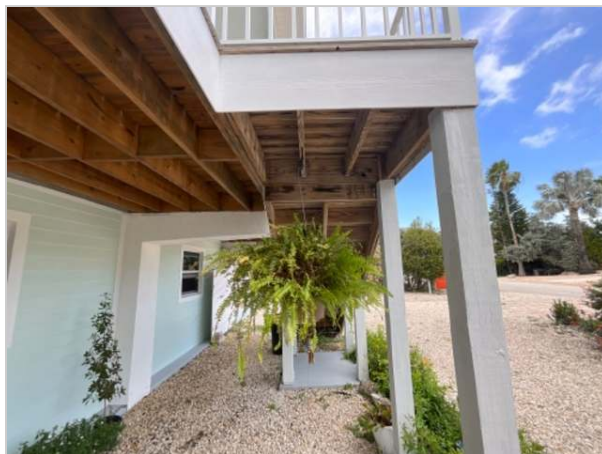
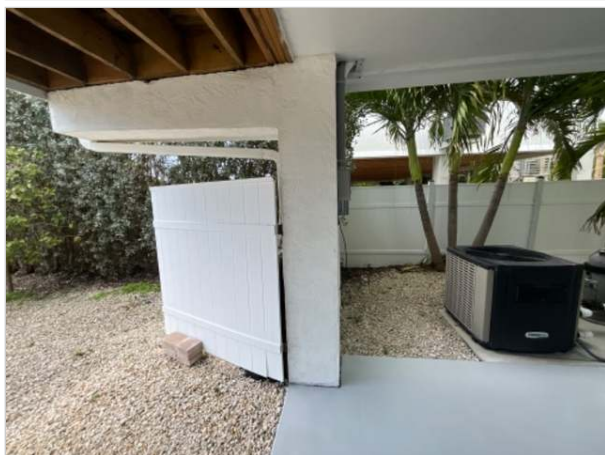
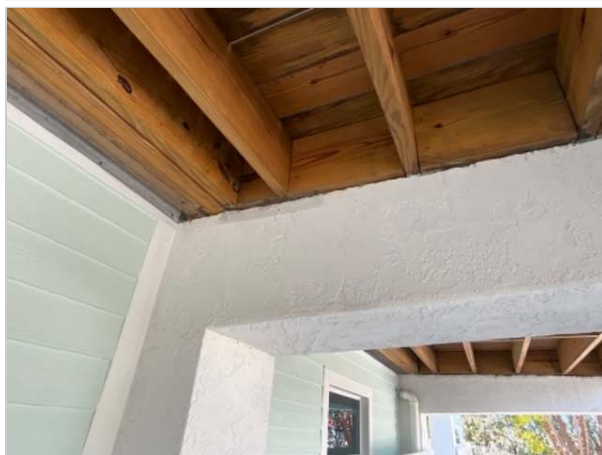
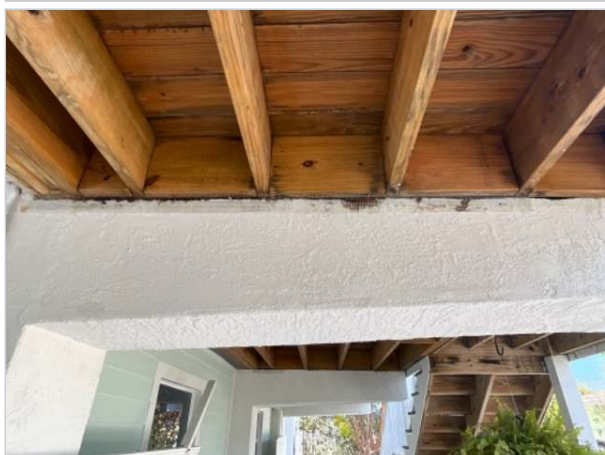
The foundation was constructed of Concrete filled steel columns A single inspection cannot determine whether movement of a foundation or wall structure has ceased. Any exterior cracks should be patched and monitored regularly

for movement. There were no material defects observed in the visible portions of the foundation.

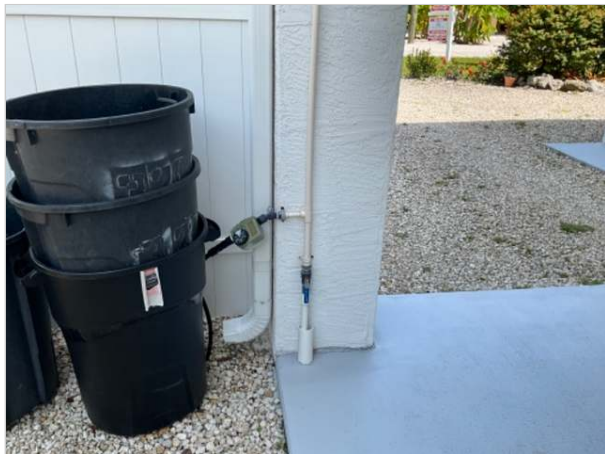
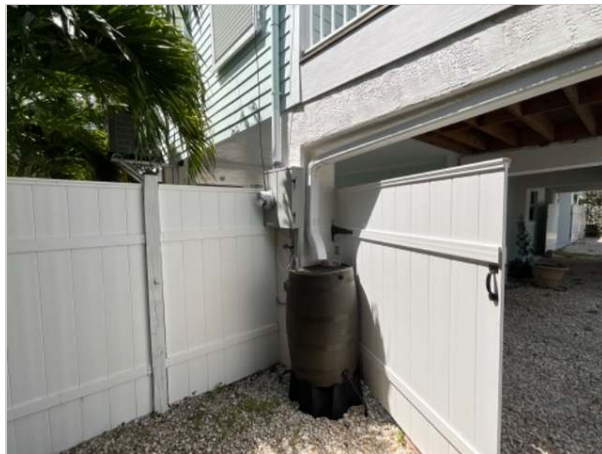
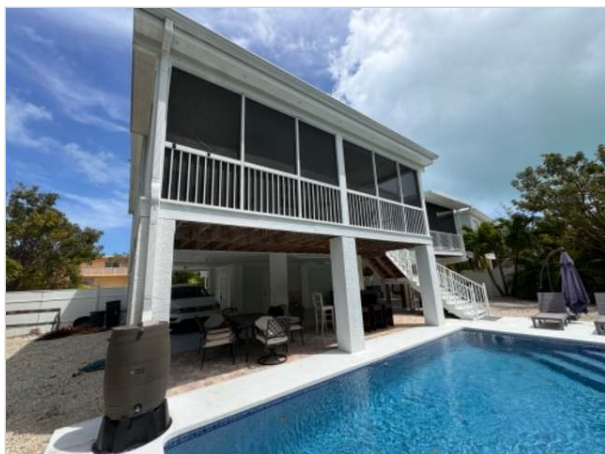
The roof drainage system was in the front and the back of the home and consisted of metal (aluminum, galvanized, cooper, or any other metal product) gutters and downspouts which appeared to be functional at the time of the inspection. The gutters Appeared to be pushing water away from the foundation There were no material defects observed in the visible portions of the gutters and downspouts.

Gutters and downspouts should receive routine maintenance to prevent premature failure and drainage problems that may lead to water intrusion. **Observation of fascia behind the gutters is obscured by the gutters.** Keeping the gutters clean will help reduce the likelihood of overflows and resulting damage to fascia or roof decking. Homeowners should be aware that gutters that have been dirty or clogged for an extended time may have led to unobservable damage to fascia or roofing components i.e roof deck.

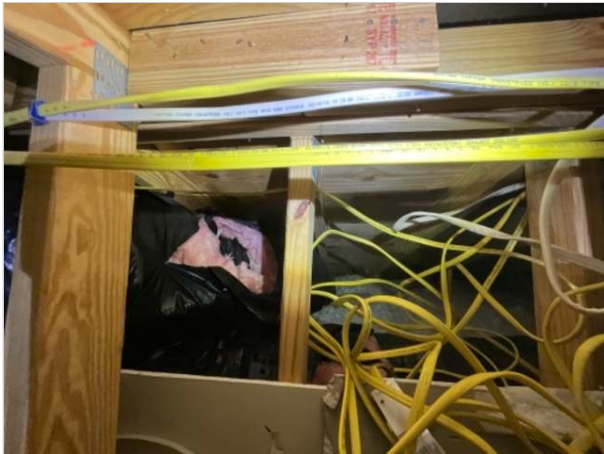
Because of the configuration of the trusses, ductwork, and insulation, which limited access, it was not possible to inspect all areas of the attic.

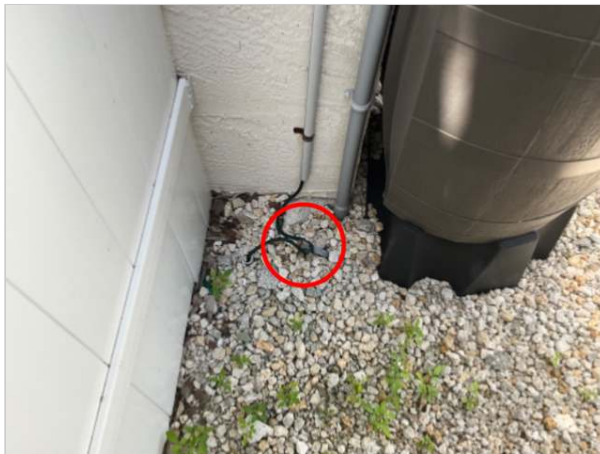
Ground rod is sticking up out of the ground. It is recommended that this condition be further evaluated by a licensed electrical contractor for repair.

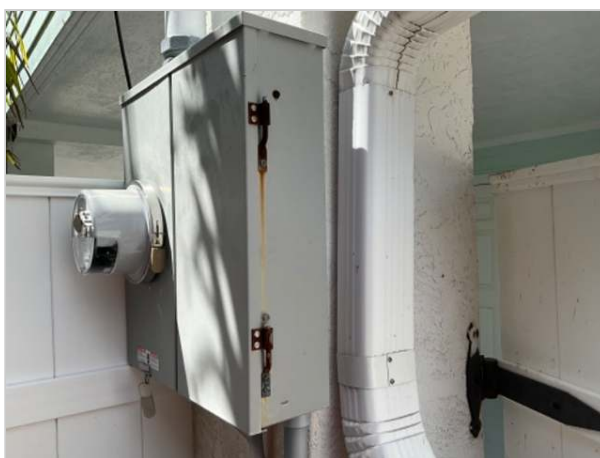
There was corrosion on the electrical service entrance box. Maintenance would be recommended in order to access the main breaker with ease whenever needed.

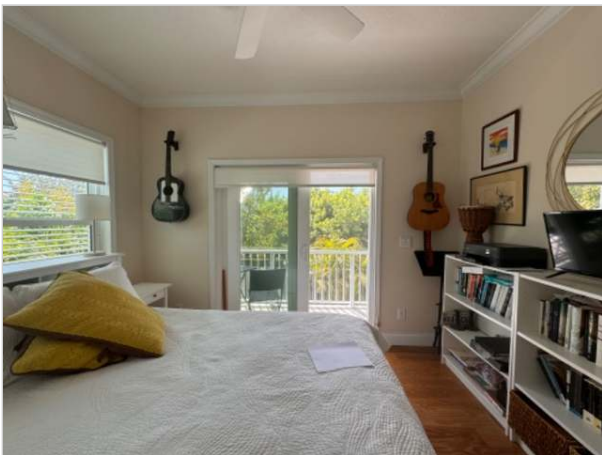
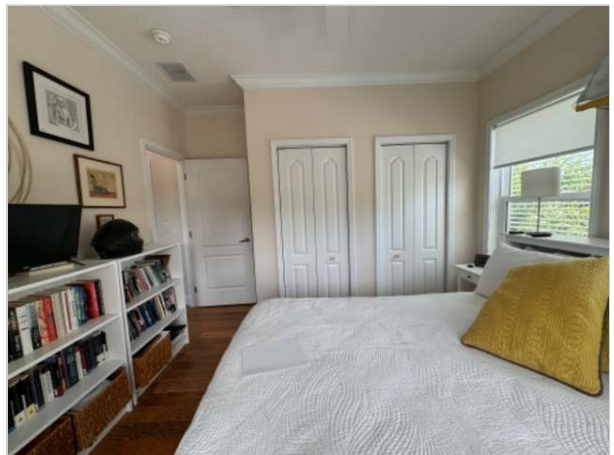
A stain was present on the ceiling of the structure. The stain appeared to be dry at the time of the inspection and should be monitored for any future moisture.

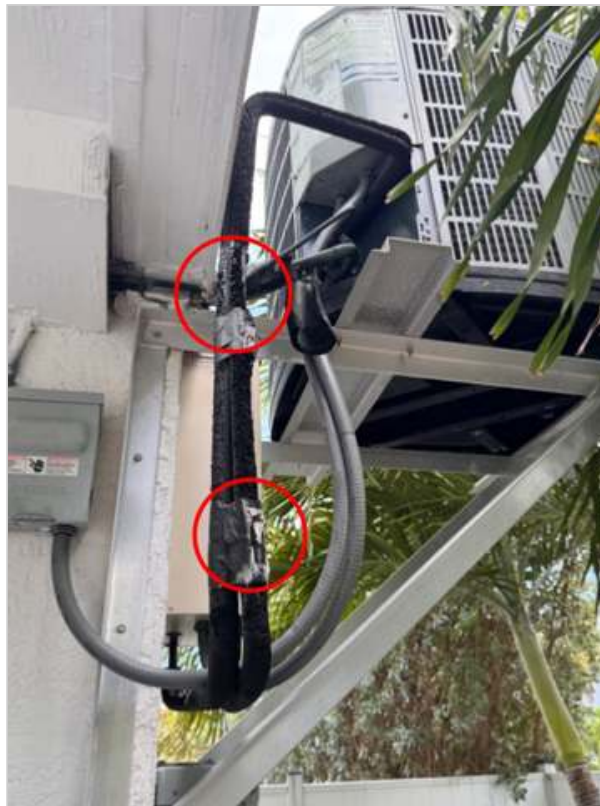
The insulation on the exterior air conditioning line set is damaged. This could affect the efficiency of the system and should be replaced.

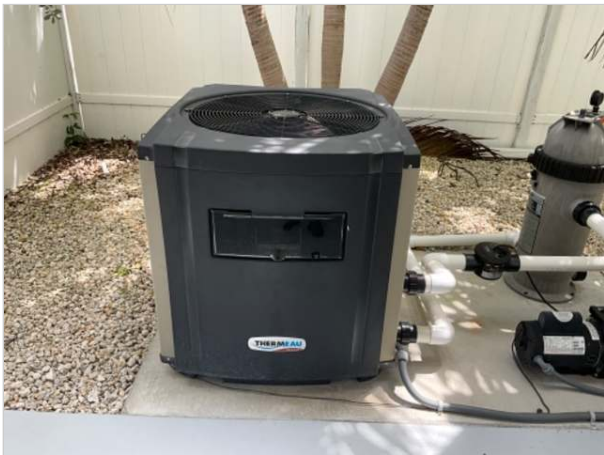
The Thermeau pool electric heater was NOT ABLE TO BE ACTIVATED at the time of the inspection. No panels were opened on the unit. A complete inspection and service by a qualified technician is recommended before closing and use. No panels are opened. Performance testing of such equipment is not within the scope of the home inspection.

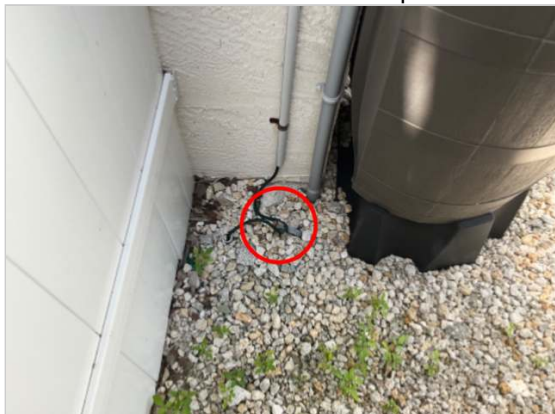
- Ground rod is sticking up out of the ground. It is recommended that this condition be further evaluated by a licensed electrical contractor for repair.

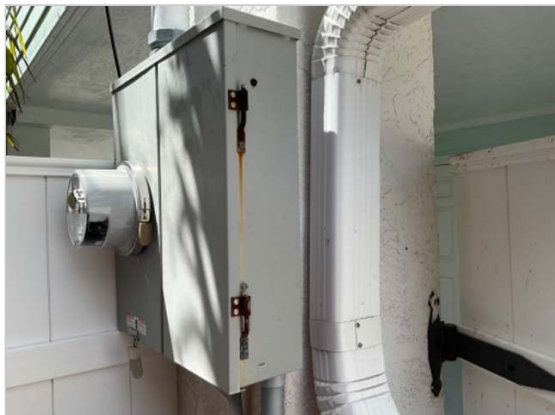
- There was corrosion on the electrical service entrance box. Maintenance would be recommended in order to access the main breaker with ease whenever needed.

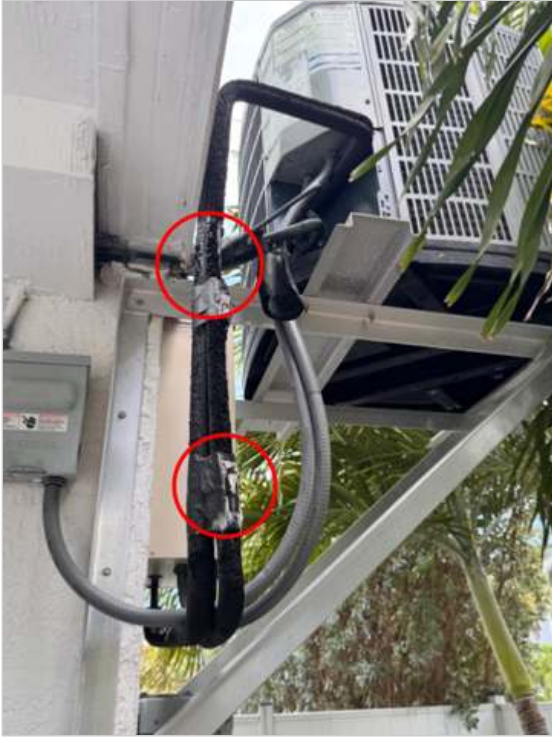
- The insulation on the exterior air conditioning line set is damaged.

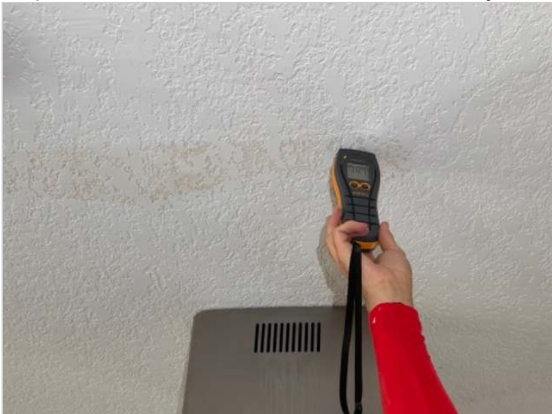
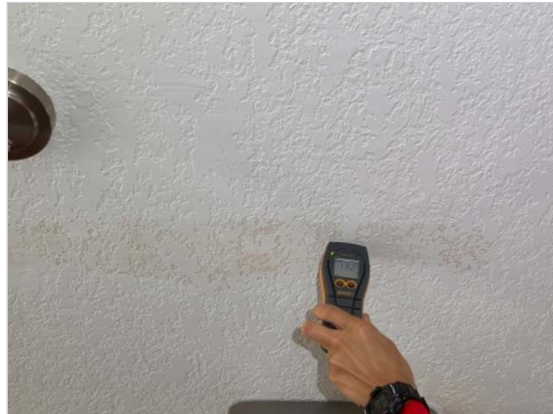
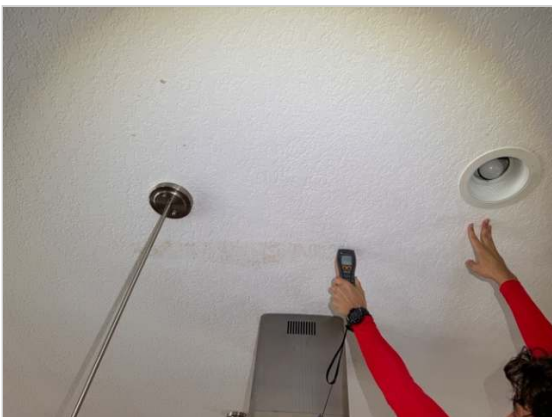
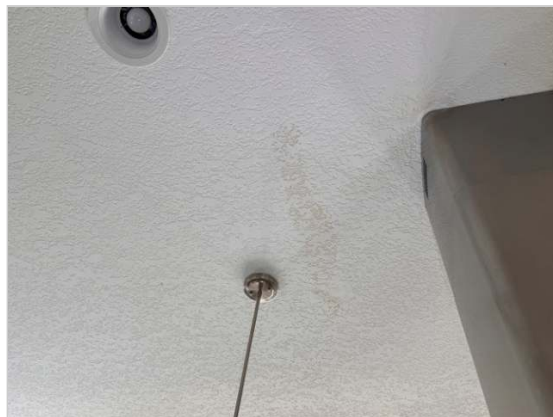
- **A stain was present on the ceiling of the structure.** The stain appeared to be dry at the time of the inspection and should be monitored for any future moisture.
