### *HOME INSPECTION REPORT*

The HomeTeam Inspection Service made a visual inspection of 123 Main Street, Anytown, USA 55555. Enclosed please find a written, narrative report of our findings in accordance with the terms of our Inspection Agreement.

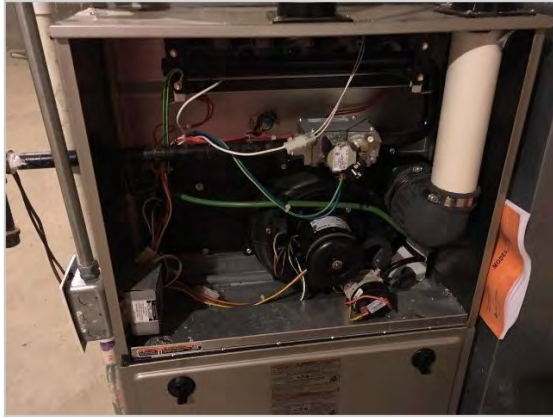
Photo 14

NOTE: Codes change for proper furnace installation. As a reminder, this is a visual and functional check of the system only. Whenever a furnace is replaced by a licensed HVAC technician it is necessary for him to bring the setup up to the then-current code. This may include altering the current configuration of the system. This is a functional test only; if a complete and exhaustive checkout of all of the components of the HVAC system is desired, or if your warranty company requires a specific inspection from their approved HVAC vendor list, contact a reputable and licensed HVAC company prior to closing.

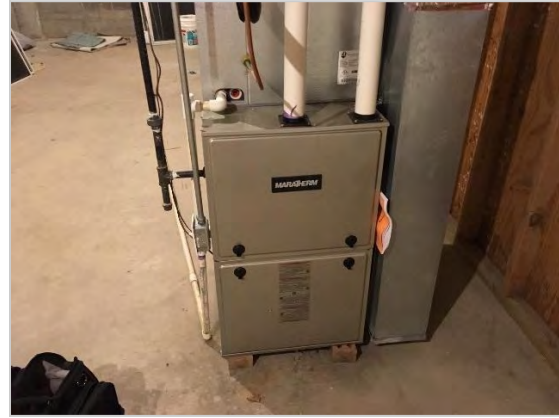
Photo 15

**A condensate leak was noted on the air handler drain line.** Repairs should be made by a qualified contractor.

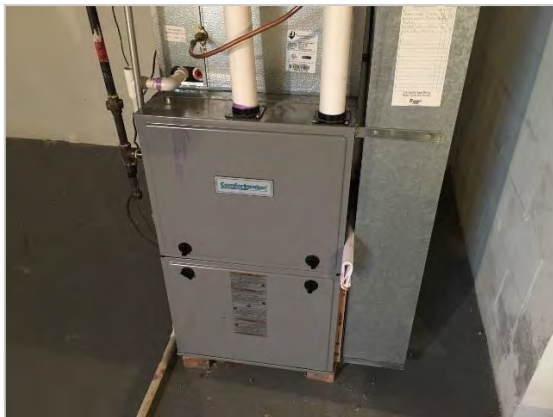
Photo 17

The unit was located in the basement of the structure.

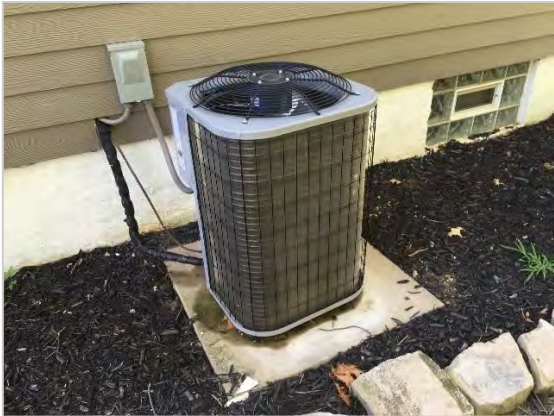
Photo 19

The electric outdoor air conditioner condensing unit was a Comfortmaker, Model Number R4A336AKN100 and

Serial Number X15330728. The unit is located on the left side of the structure. This unit is approximately 1 years old. Periodic preventive maintenance is recommended to keep this unit in good working condition, and HomeTeam strongly recommends partnering with a reputable HVAC company for routine maintenance for the heating and cooling systems in the fall and spring. The air conditioning system was tested and found to be functional. As a reminder, this is functionality test and visual inspection only; we do not check suction pressures, contactor amps, or refrigerant levels. If a more detailed inspection is required, please consult with an HVAC company.

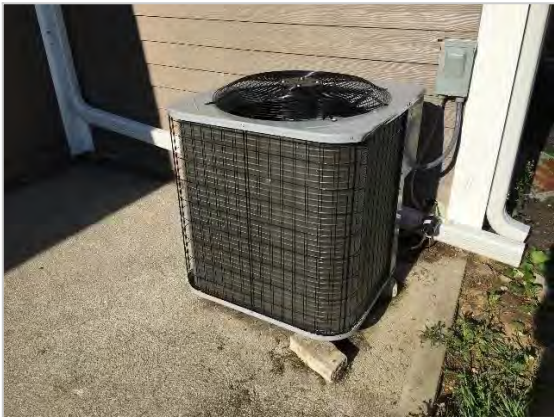
Photo 21

The second electric outdoor air conditioner condensing unit was a Comfortmaker, Model Number R4A348AKN100 and Serial Number X152462739. The unit is located in the back of the structure. This unit is approximately 1 years old. Periodic preventive maintenance is recommended to keep this unit in good working condition. The air conditioning system was tested and found to be functional.
