HOME INSPECTION REPORT

**123 Sample Drive
Anytown, TX 55555**

PROPERTY INSPECTION REPORT

Prepared For:	Bill Sample (Name of Client)	
Concerning:	123 Sample Drive, Anytown, TX, 55555 (Address or Other Identification of Inspected Property)	
By:	John Rigamonti (TREC License # 25912)	5-1-2023 (Date)
(Name, License Number of Sponsoring Inspector)

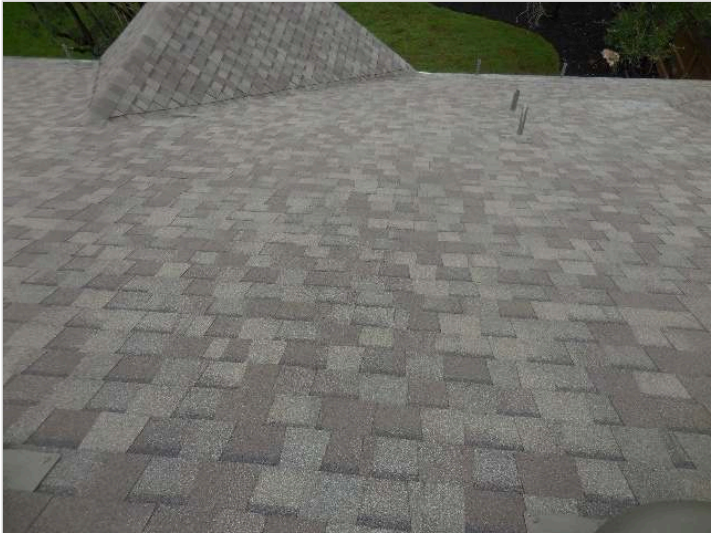
View of roof covering (back).

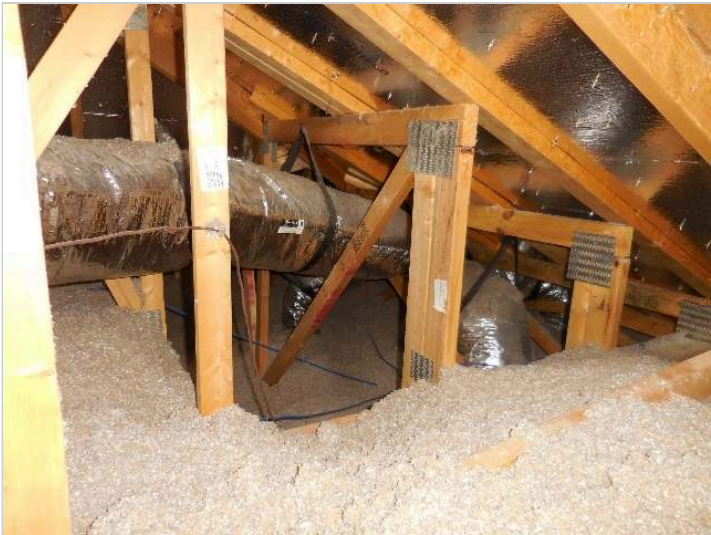
(none) No major visual deficiencies were observed on the roof structures and attics at the time of the inspection.

View of upper attic space (over common room).

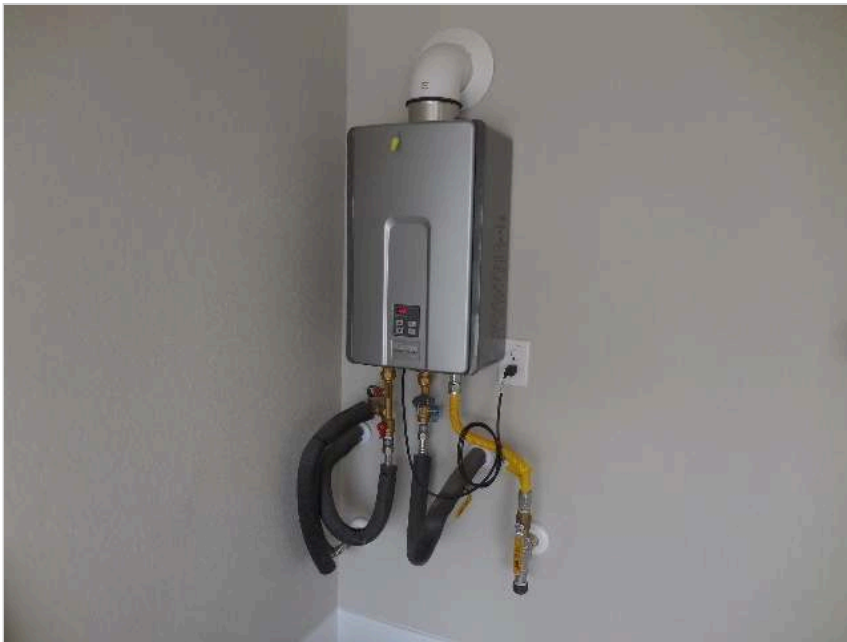
(none) There were no visible deficiencies noted on the water heater(s) at the time of inspection.

View of tankless water heater in garage.
