# HomeTeam<sup>®</sup>

### HOME INSPECTION REPORT

On Saturday, August 4, 2018 The HomeTeam Inspection Service made a visual inspection of 123 Sample Dr, Anytown, AZ 55555. Enclosed please find a written, narrative report of our findings in accordance with the terms of our Inspection Agreement.

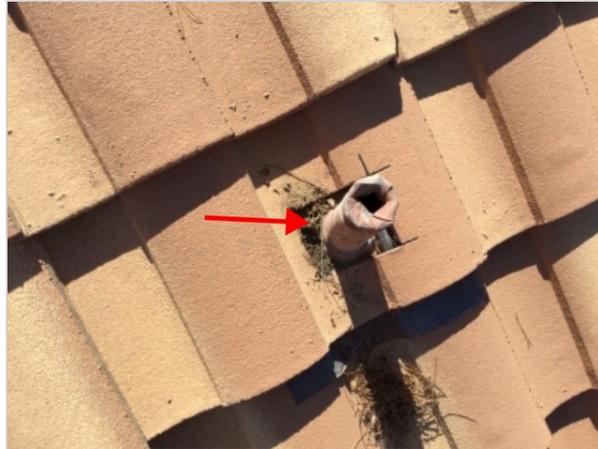
**Photo 16**

> Excessive leaves and other debris were observed on roof. This debris can trap moisture on roof and cause deterioration of the roofing material.

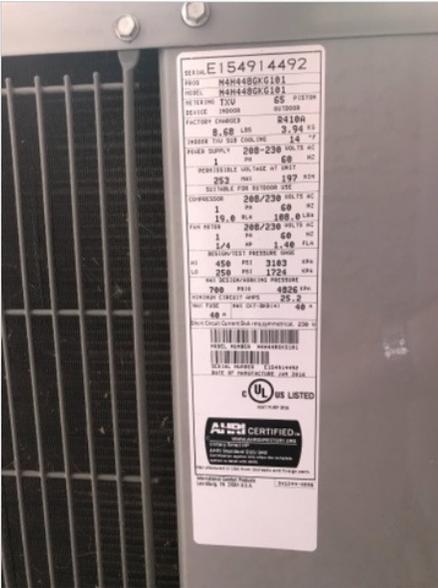
Photo 23

> HVAC unit does not have the correct fusing or breakers based on the information on the HVAC label. Suggest repair by a qualified HVAC technician or qualified electrician.

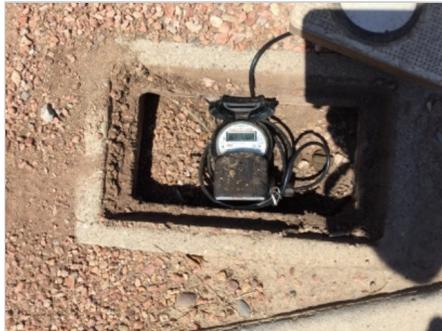
**Photo 36**

Water Meter

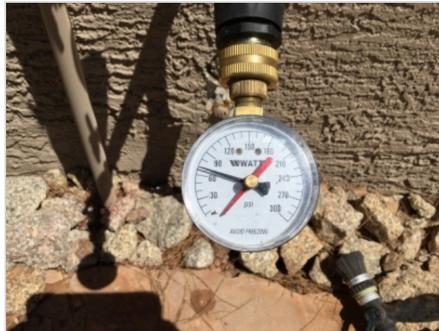
**Photo 37**

Water Pressure- 72 PSI

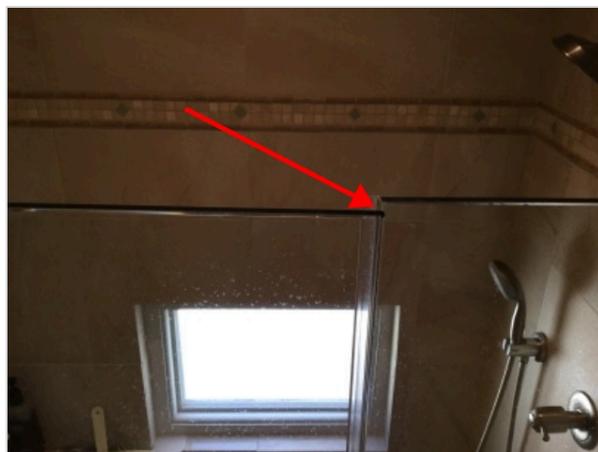
**Photo 43**

> **Shower door requires adjustment to ensure that the door closes properly.** Without adjustment, either the shower door or the stationary glass panel will eventually get chipped. Suggest repair by a qualified party such as the company that installed the shower door.

Master Bath

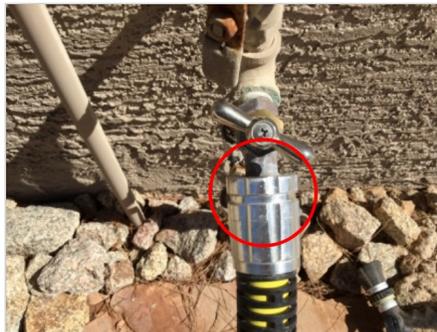
Photo 47

No Vacuum Breaker

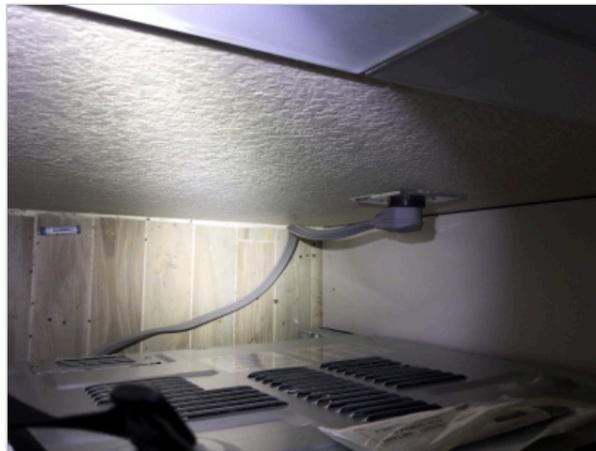
**Photo 49**

> **Oven and range combination does not have an anti-tilt bracket installed** to keep the unit from tipping forward. An anti-tilt bracket should be installed by a qualified party.

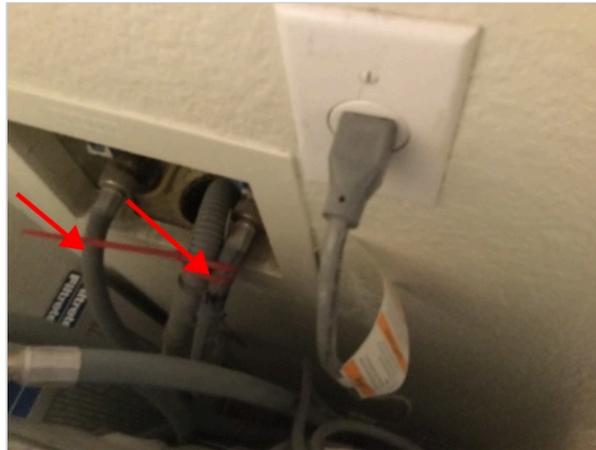
**Photo 50**

> **Rubber hose(s) under constant water pressure found in home.** HomeTeam recommends replacement of any rubber hose that under constant pressure (water heater, washing machine, toilet, sinks) with a stainless steel braided reinforced hose. The stainless steel braided hose will last much longer in the dry Arizona air than a typical rubber hose although the stainless steel hose will need to be replaced per the manufacturer's suggested interval.

Washer Supply Hoses

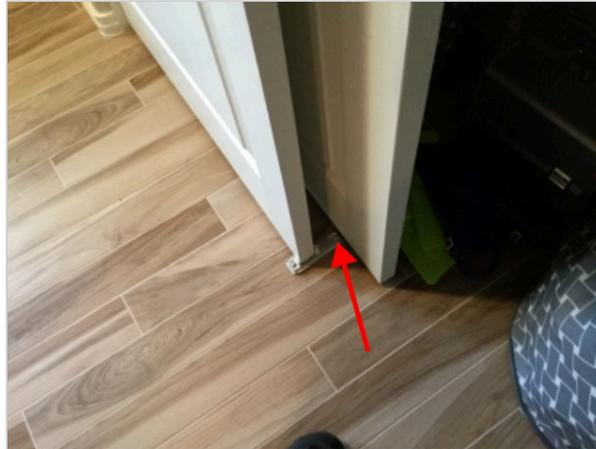
**Photo 51**

> **Closet door hardware missing or in need of repair.** Suggest repair or installation by a qualified party.

Left Front Bedroom Closet

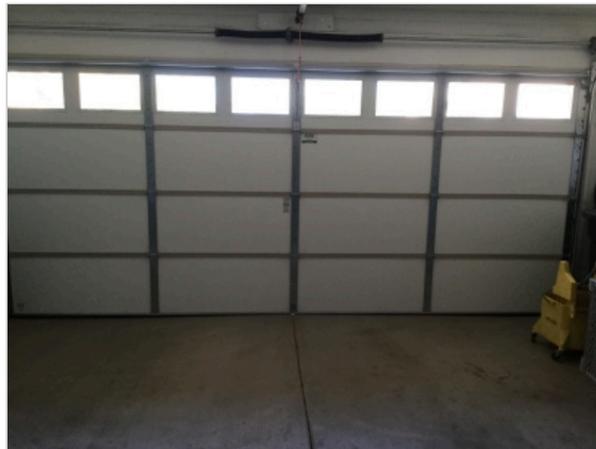
Photo 52

> **The garage door safety pressure reverse system is not operable.** This means that the door does not stop and reverse when resistance is placed at the base of the door. The opener should be adjusted or repaired.

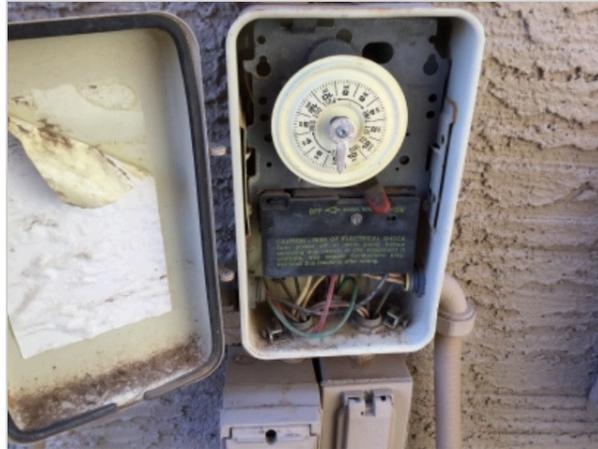
**Photo 66**

**> Terminal shield in timer box is damaged or missing.** Suggest replacement to ensure that electrical connections are not accidentally contacted while actuating timer.
