HOME INSPECTION REPORT

On Wednesday, March 20, 2019 The HomeTeam Inspection Service made a visual inspection of 123 Sample Dr, Anytown, MI 44444. Enclosed please find a written, narrative report of our findings in accordance with the terms of our Inspection Agreement.

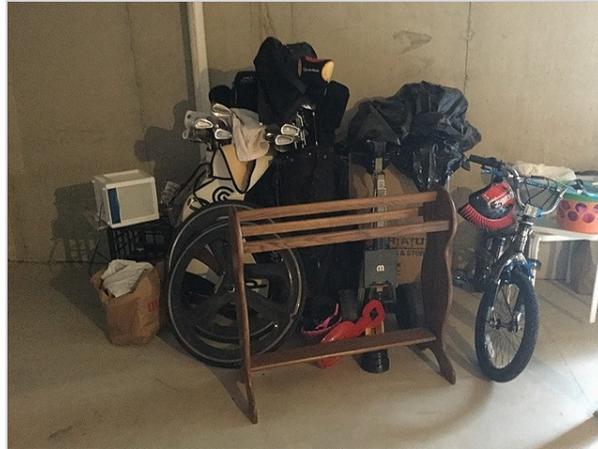
Photo 25

The basement was cluttered with many stored items and/or shelves at the time of inspection. The obstructed areas were not able to be visually inspected.

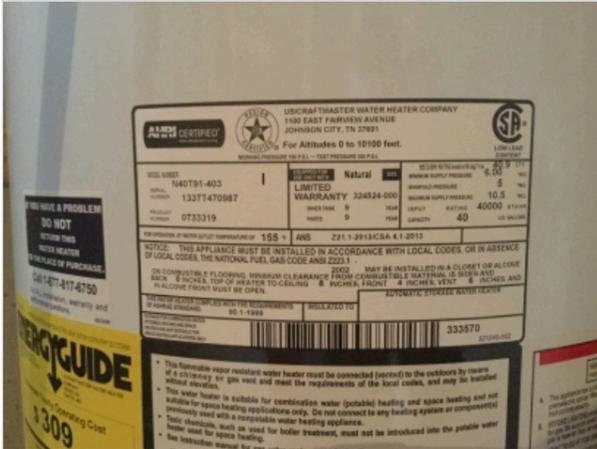
Photo 28

A 40 gallon capacity, natural gas water heater was located in the basement. The water heater was manufactured by Whirlpool, model number N40t91403 and serial number 1337t470987. Information on the water heater indicated that it was manufactured 6 years ago.

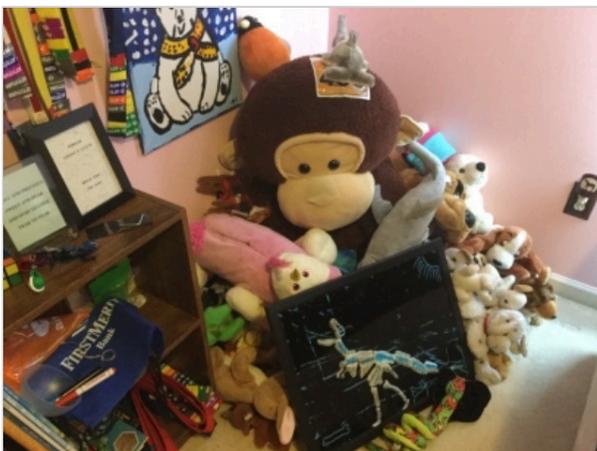
Photo 30

The interior living area was cluttered with many stored items and/or shelves at the time of inspection. The obstructed areas were not able to be visually inspected.

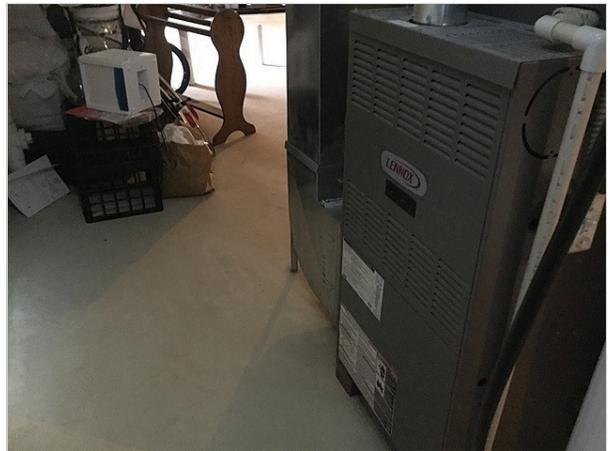
Photo 37

Evidence of water was noted inside the furnace compartment. The condition is most likely caused by a condensate leak in the furnace and/or air conditioning condensate drain lines. The water can also be caused by a leaking humidifier if one is installed. Water inside the furnace compartment can damage the furnace cabinet or other operational components and should be repaired. The furnace compartment was dry at the time of the inspection. Consult with a qualified heating contractor to determine the source of the water and correct the issue.

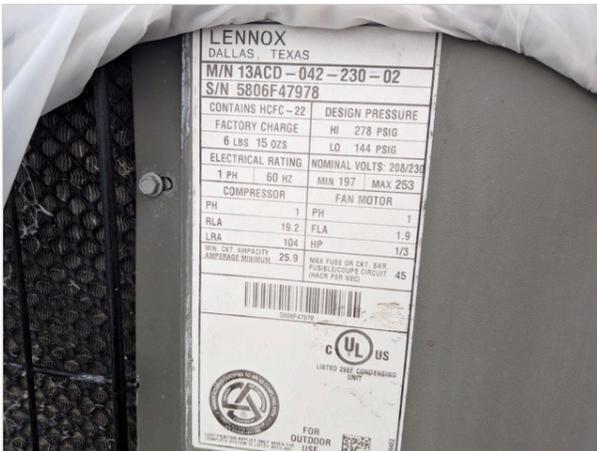
Photo 40

The electric outdoor air conditioner condensing unit was a Lennox, Model Number 13ACD-042-230-02 and Serial Number 5806F47978. The unit is located in the back of the structure. This unit is approximately 13 years old. Periodic preventive maintenance is recommended to keep this unit in good working condition. The cooling system was not tested due to cold exterior temperatures.

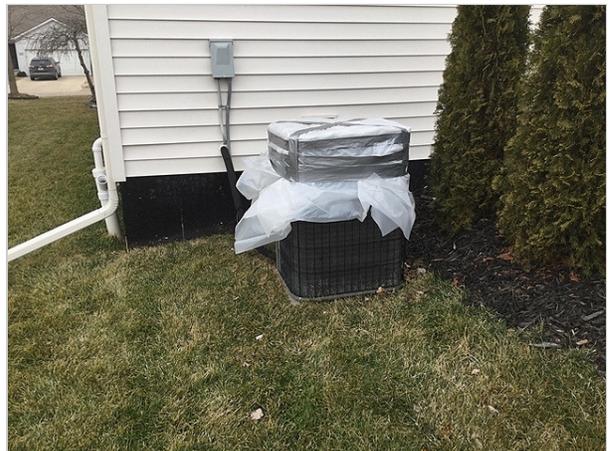
Photo 41

The insulation on the exterior air conditioning line set is damaged. This could affect the efficiency of the system and should be replaced.

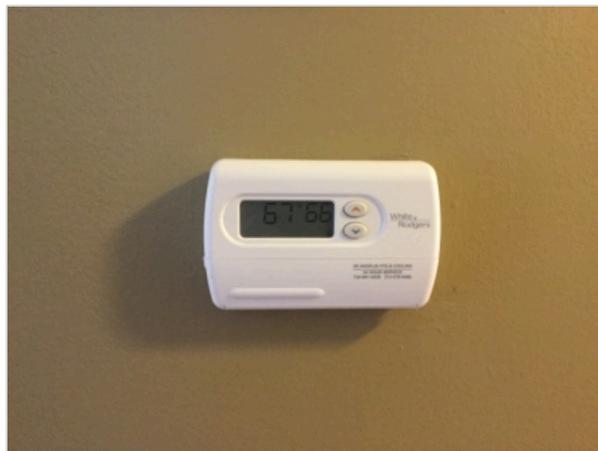
Photo 43

The control for the heating and air conditioning system was a 24 volt digital programmable thermostat located on the entry way wall of the home. The thermostat was manufactured by White Rodgers and was found to be in working order.
