### *HOME INSPECTION REPORT*

SUMMARY: The purpose of this summary is to provide a "quick view" of the results of the home inspection. Please be sure to read the full body of the inspection report, as it contains much more detail about this home. **Any recommendations for additional evaluation must be performed prior to the conclusion of the inspection contingency period.** A home inspection is not designed to eliminate all risk and cannot and should not be relied upon to discover all defects that are not disclosed by the sellers. The following is a summary of the inspection performed at 123 Sample Drive, Castle Rock, CO 80104:

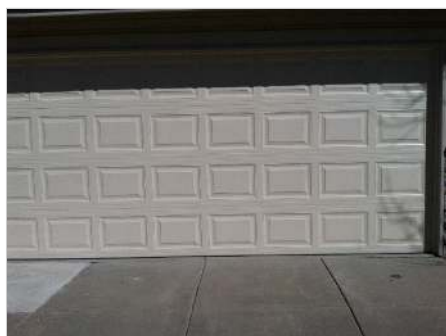
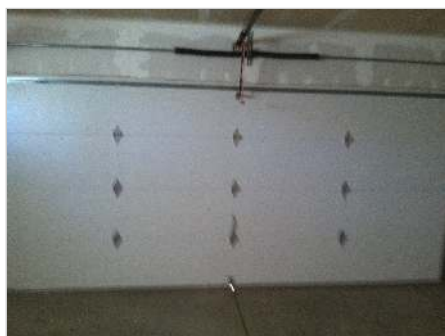
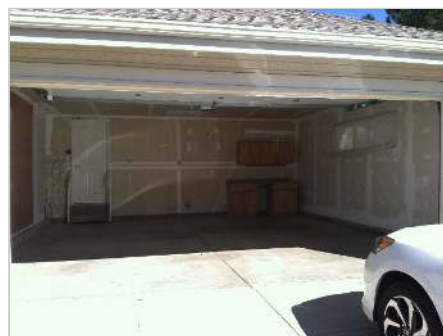
The attached garage was designed for two cars with access provided by one overhead-style door. The Lift Master brand electric garage door opener was tested and found to be functional. The beam automatic safety reverse on the garage door was tested and found to be functional. The visible areas of the concrete garage floor were in serviceable condition.

Note: settlement of the garage concrete floor was observed. The garage floor was serviceable at the time of the inspection. If the serviceability is in question, then it is recommended that the garage floor be further evaluated by a

qualified contractor.

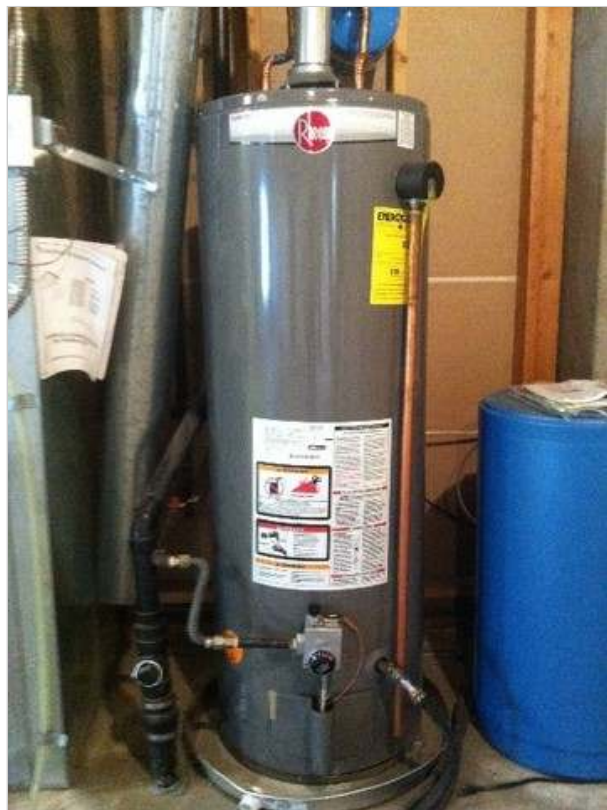
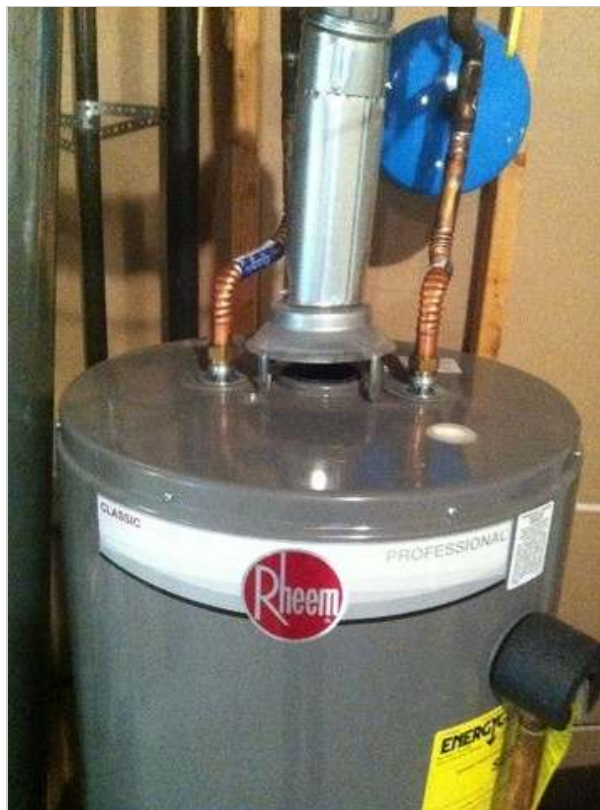
There was a 50 gallon capacity, natural gas water heater located in the basement. The water heater was manufactured by Rheem, model number PROG50-38N RH58 with serial number M101525732. Information on the water heater indicated that it was manufactured approximately three years ago. A temperature and pressure relief valve (T & P) was present. Because of the lime build-up typical of T & P valves, we do not test them. An overflow leg was present. It did terminate close to the floor. Your safety depends on the presence of a T & P valve and an overflow leg terminating close to the floor. The water heater was functional.

- Note: the water heater fired when called to do so from the thermostat. The flame was observed to be normal and there was no combustible gas leaks present. A normal life expectancy of a gas fired water heater is 10-15 years meaning that any water heater we inspect that is in or past this age should be considered a deferred cost item. We recommend draining 5-10 gallons of water from the tank 2-3 times per year to expel rust and sediment and extend water heater life.

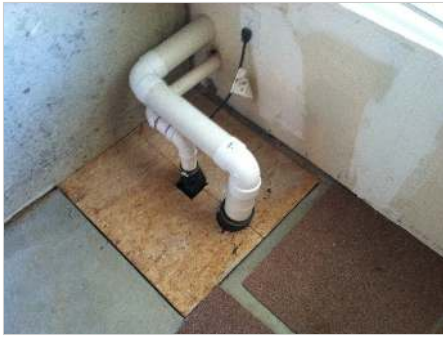
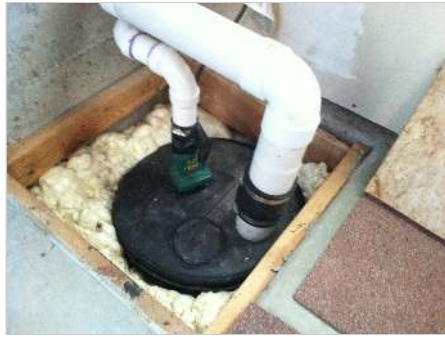
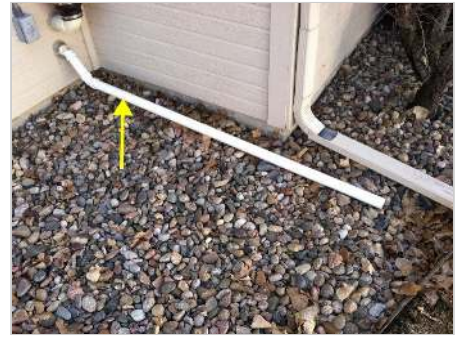
Sump pump discharge pipe

There was a sump pump located in the basement. The sump pump was inspected and functional.

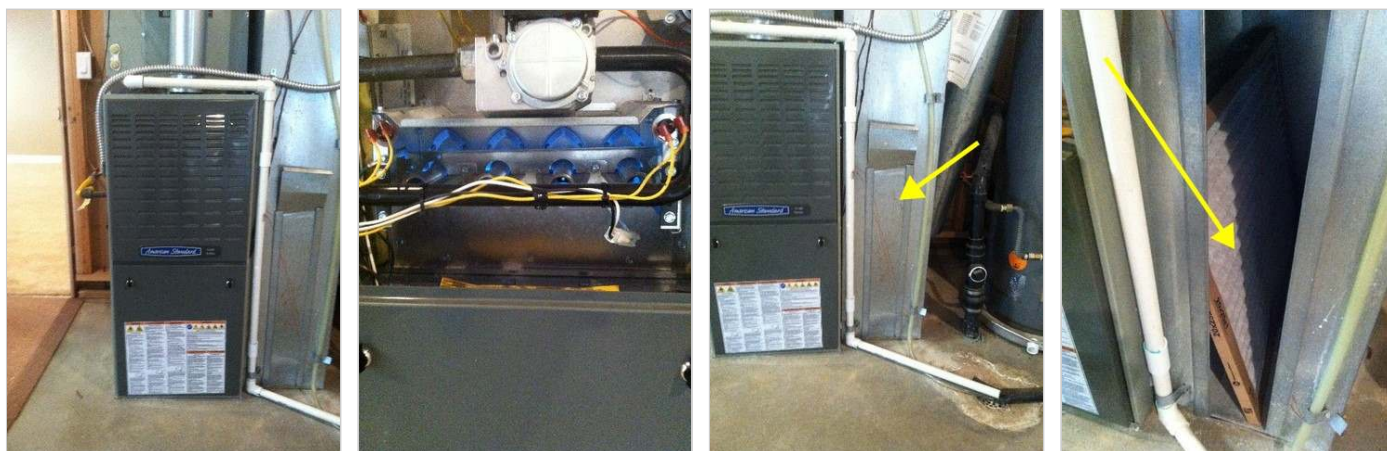
Replace filter here

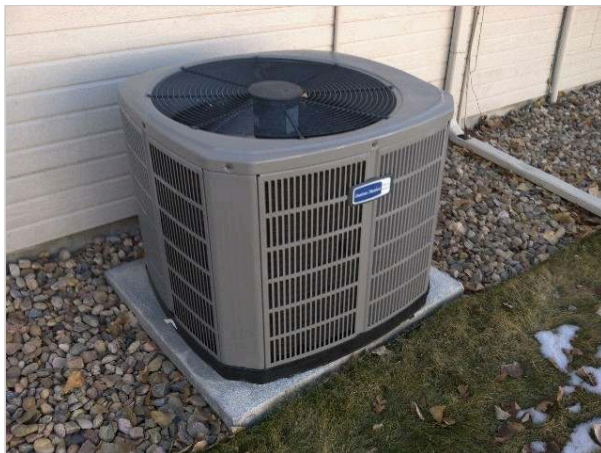
The electric outdoor air conditioner condensing unit was an American Standard, model number 4A7A3042D1000NA

with serial number 15043ND73F. The unit is located in the rear of the home. Information on the air conditioner indicated it is approximately three years old.

Note: the cooling system was visually inspected but was not operated due to cool or cold exterior temperatures. When outdoor temperatures have been below 60 degrees Fahrenheit within the past 24 hours, extended operation of the cooling system could damage the compressor. Recommend that the compressor be further evaluated by a licensed heating, ventilation and air conditioning technician.

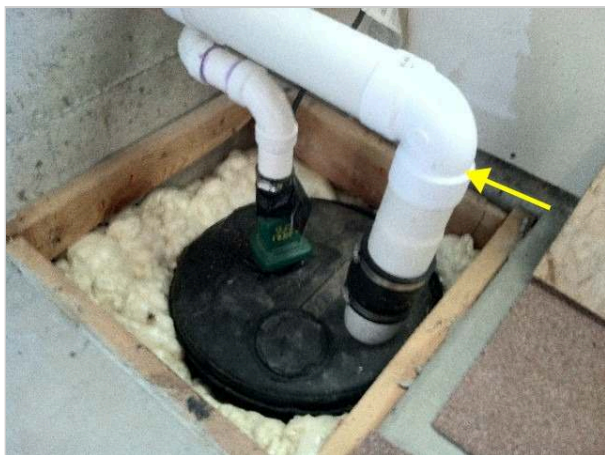
There was a radon mitigation system installed in the basement to the exterior of the home. Information on the identification tag indicated the system was installed in 2014 . The mitigation system appeared to be functional at the time of the inspection. No radon testing was performed. For additional information, visit [www.epa.gov/radon](http://www.epa.gov/radon).

Radon mitigation pipe installed in basement sump
