Thursday, March 28, 2019

RE: 123 Sample Drive
Anytown, IN 46112
Inspection #: XXXX

HOME INSPECTION REPORT

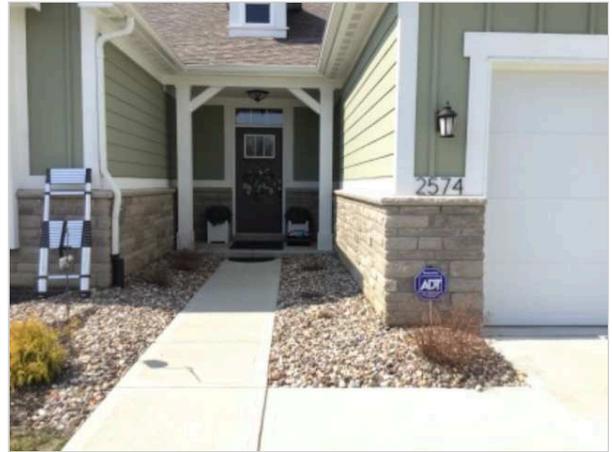
Photo 2

LANDSCAPING MULCH ON SIDING: There are areas where the landscaping mulch is too high and in contact with the siding. Even with exterior brick, mulch that is in contact with the siding can retain moisture and cause damage or insect infestation. Recommend removal of the mulch to an acceptable level.

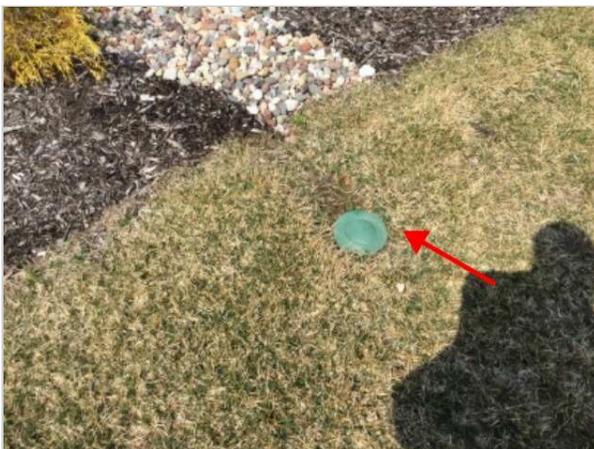
Photo 4

There were termite bait stations located around the perimeter of the house. Termite bait stations are sometimes installed as a preventative measure and sometimes used as a treatment method. Termite bait stations require regular servicing. It is recommended that you consult with the current home owner to determine if the bait stations are being regularly serviced by a pest control company.

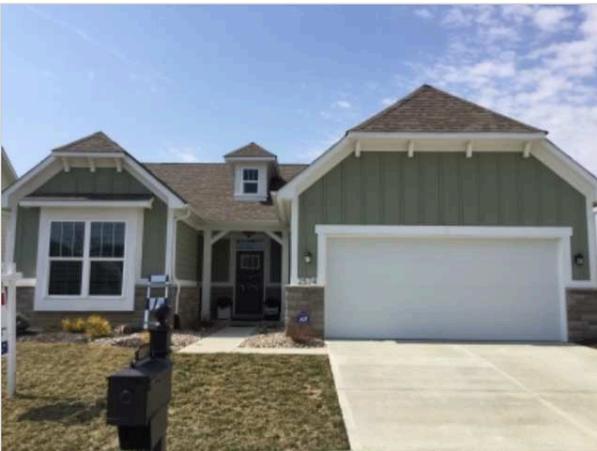
Photo 18

Front

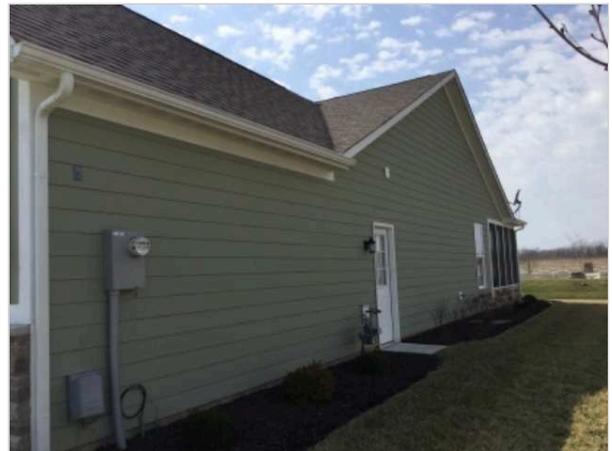
Photo 19

Right side

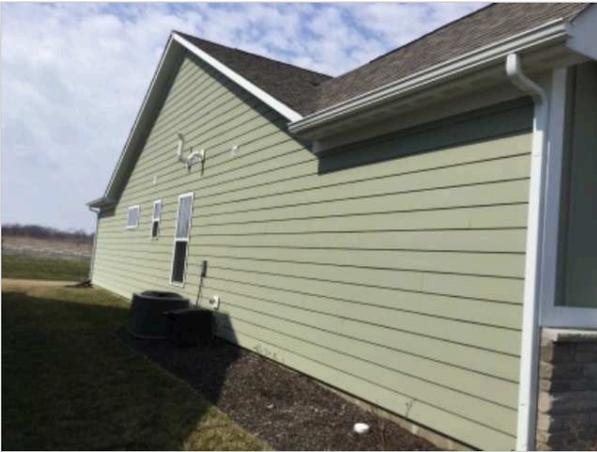
Photo 20

Left side

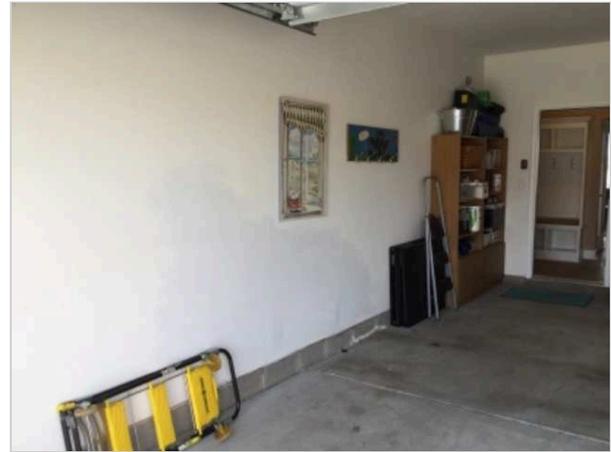
Photo 36

GARAGE SLAB: The slab in the garage shows signs of settlement and is cracked. The slab is not of structural concern to the home, and is serviceable, however repair of the concrete slab would likely fall into the major defect category.

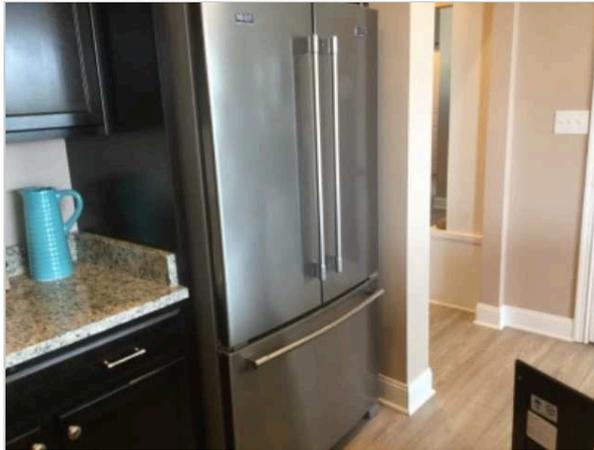
Photo 49

The Maytag refrigerator was inspected and did appear to be functional. The temperatures in the refrigerator and freezer section were 38 degrees F and 0 degrees F respectively. The temperature setting, water dispenser and ice maker, if present, are not within the scope of the inspection.

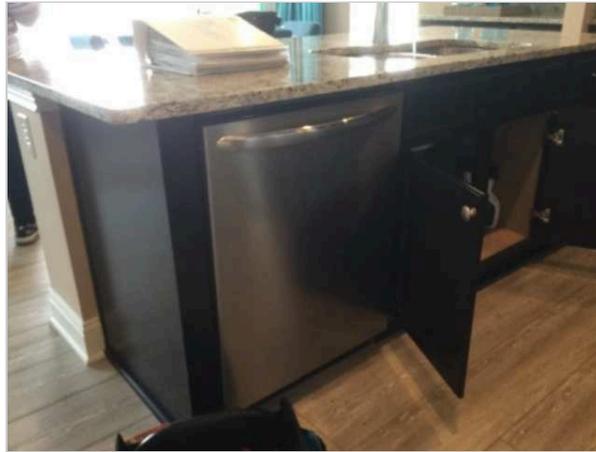
Photo 50

The Frigidaire dishwasher was tested and did appear to be functional. Dishwashers are observed through a complete cycle and are only checked to see that they fill and drain. The efficiency of the wash cycle is not within the scope of this inspection.

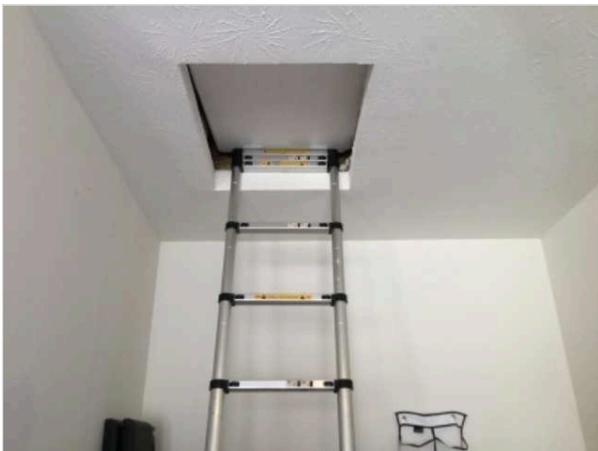
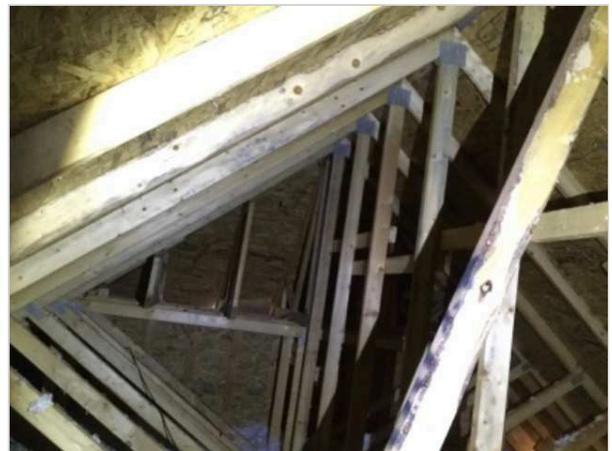
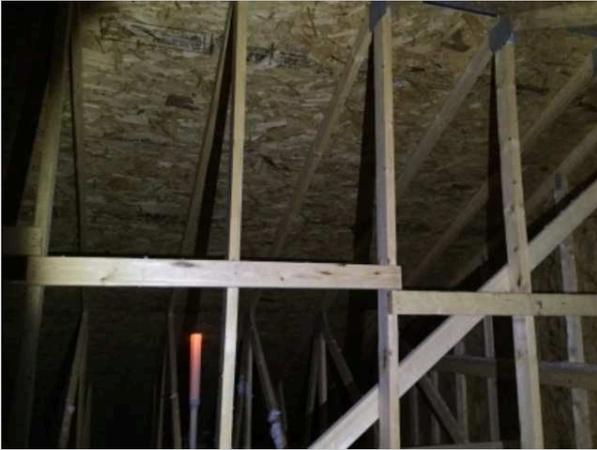
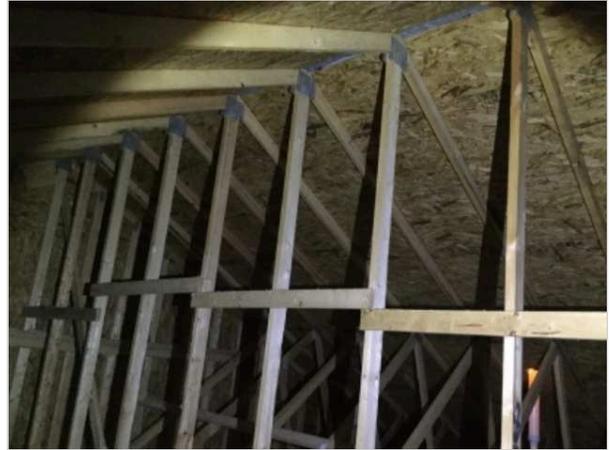
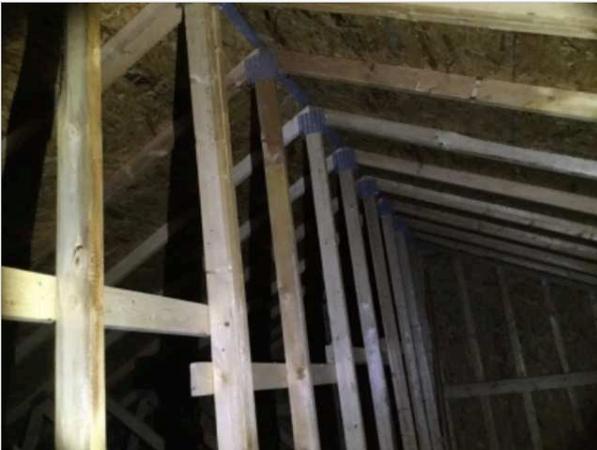
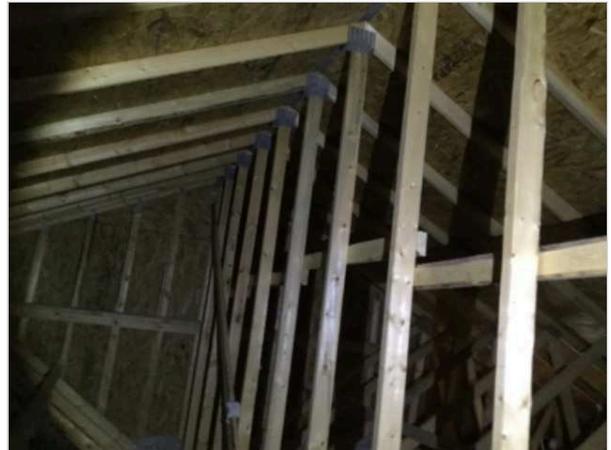
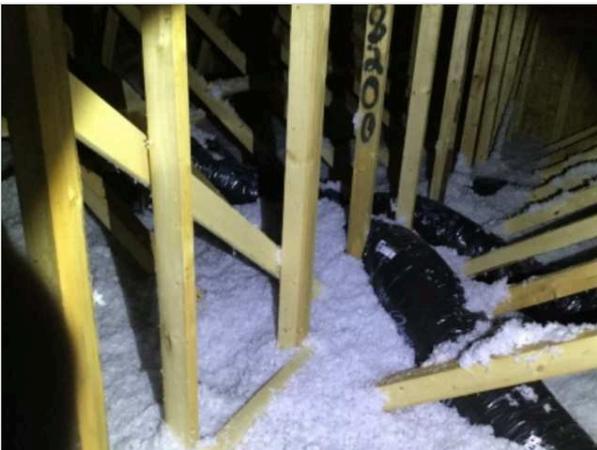
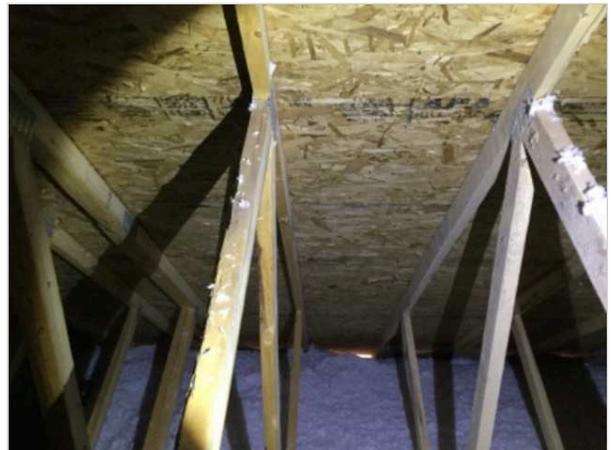
The attic was accessed through a scuttle in the garage . The attic above the living space was insulated with loose-fill insulation, approximately 14-inches in depth. Ventilation throughout the attic was provided by soffit and ridge vents. The roof structure consisted of two-inch by four -inch wood trusses spaced 24 inches on center and OSB (waferboard) sheathing.

Because of the configuration of the trusses and the ductwork, and depth of the insulation, which limited access, it was not possible to inspect all areas of the attic. There was no moisture visible in the attic space. The absence of visible indications of moisture is not necessarily conclusive evidence that the roof is free from leaks. The only way to be sure a roof does not leak is to inspect the underside of the roof during a heavy rain. There were no major visual defects observed in the attic or roof structure.

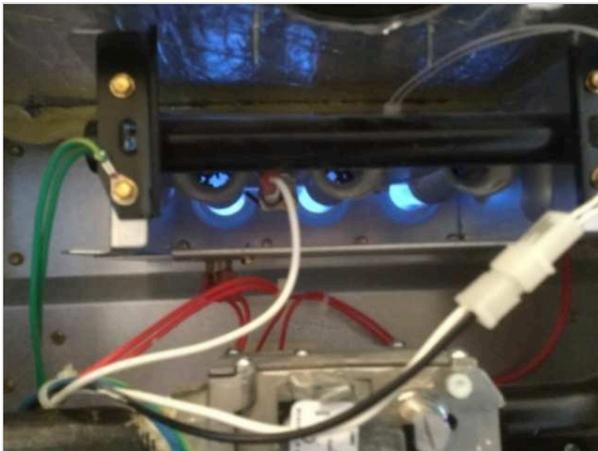
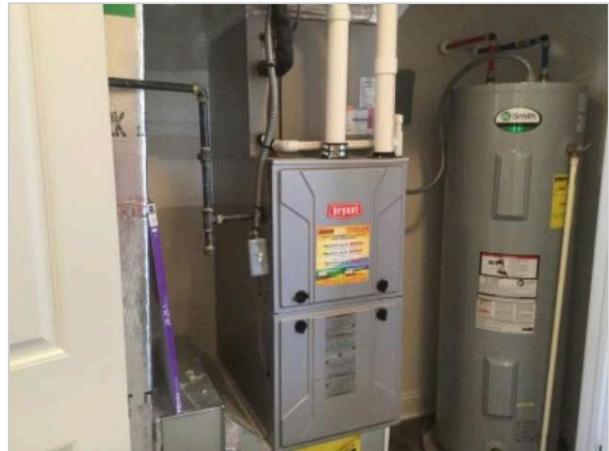
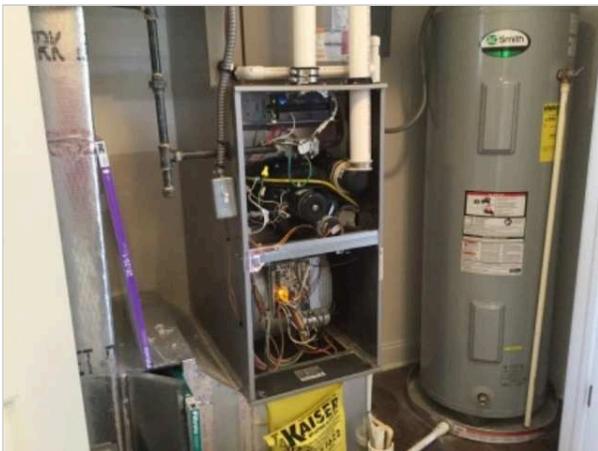
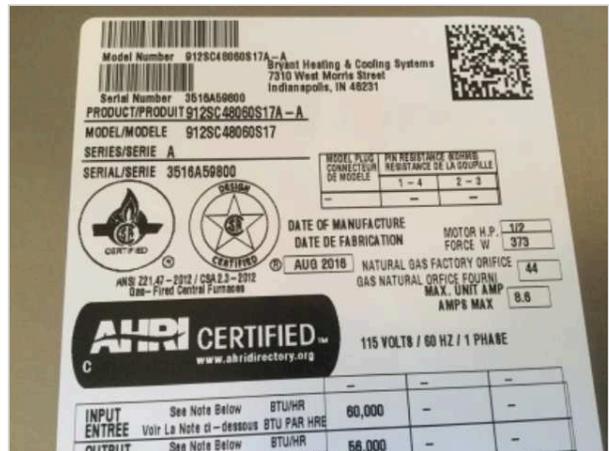
The heating system was functional.

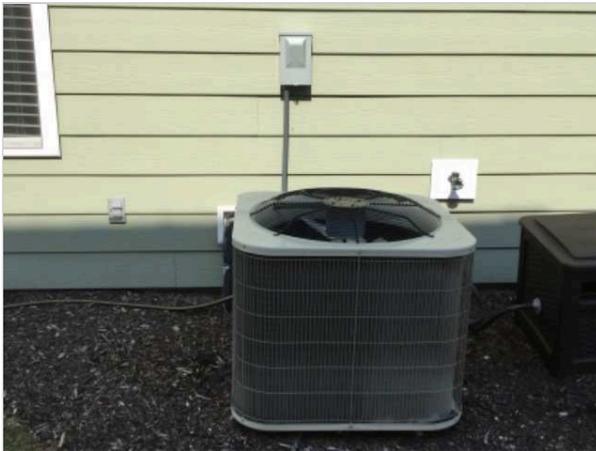
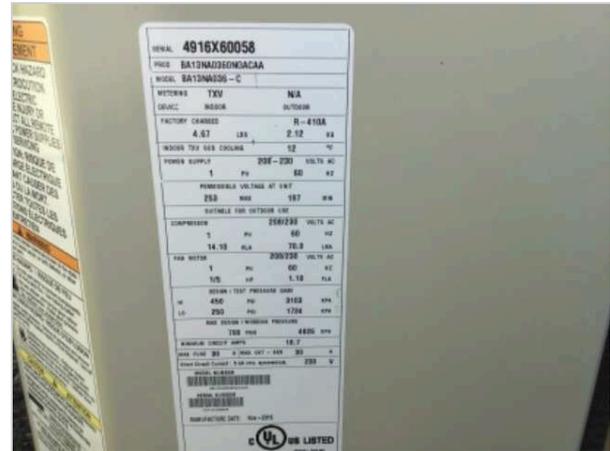
The electric outdoor air conditioner condensing unit was a Bryant, Model Number BA13NA036-C and Serial Number 4916X60058. The unit is located on the left side of the home. This unit is approximately 3 year(s) old. Periodic preventive maintenance is recommended to keep this unit in good working condition.

The cooling system was not tested.

AIR CONDITIONING NOT TESTED: The cooling system was visually inspected but was not operated due to cold outdoor temperatures. When outdoor temperatures have been below 60 degrees Fahrenheit within the past 24 hours, operation of the cooling system could damage the compressor. It is recommended that the system be cleaned and serviced in the spring.
