HomeTeam[®]

HOME INSPECTION REPORT

This summary provides a quick overview of the results of the inspection performed on 8/3/2015 at 123 Sample Drive, Homosassa, FL 34446:.

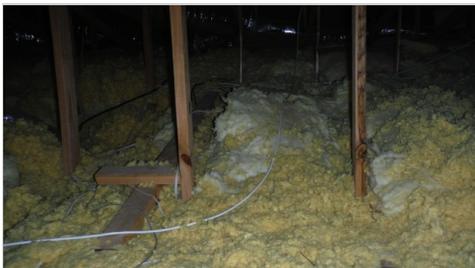
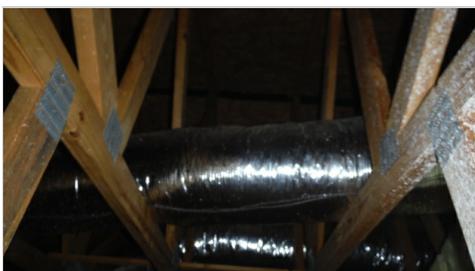
The attic was accessed through a pull down ladder in the garage. The attic above the living space was insulated with blown insulation, approximately 12-inches in depth. Ventilation throughout the attic was provided by soffit and ridge vents. The roof structure consisted of two-inch by four-inch wood trusses spaced 24 inches on center and strandboard sheathing. There was no moisture visible in the attic space . There were no material defects observed in the visible portions of the attic and roof structure .

Because of the configuration of the trusses and the ductwork, which limited access, it was not possible to inspect all areas of the attic.

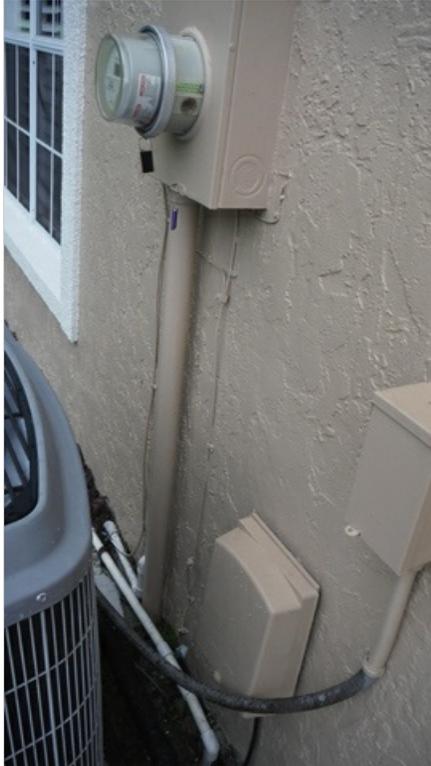
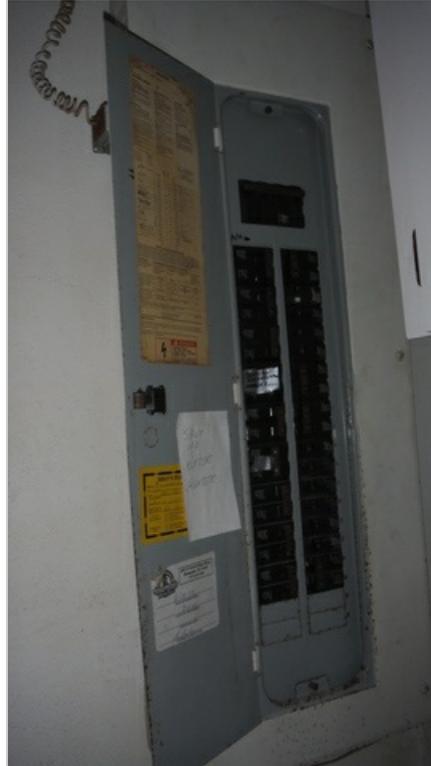
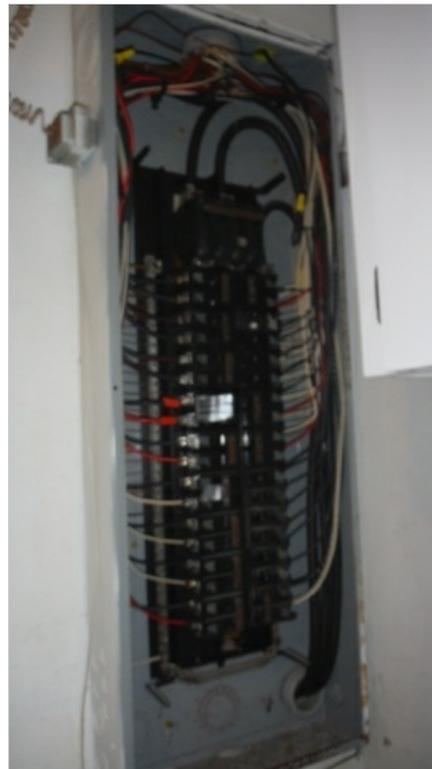
The underground electric service wire entered the home on the left side wall. The electric meter was located on the exterior wall.. The system was properly grounded to a footer The service wire entered a Siemens service panel, located on the garage wall with a 200 amp and 120/240 volt rated capacity. The branch circuits within the panel were copper. These branch circuits and the circuit breakers to which they were attached did appear to be appropriately matched. The main shut off was located at the service panel. The visible wiring consisted primarily of the Romex type and appeared to be in good condition.

The electric panel is surrounded by cabinets and is not immediately accessible. This could create an unsafe condition in the event of an emergency.

- The electric panel is surrounded by cabinets and is not immediately accessible. This could create an unsafe condition in the event of an emergency.
- A home inspection of the fireplace and chimney is limited to the readily visible portions only and the fireplace was not operated. The inner reaches of a flue is mainly inaccessible. Our view was not adequate to discover possible deficiencies or damage, even with a strong light. For safe and efficient operation we recommend annual inspections by a qualified fireplace professional. A qualified chimney sweep will clean the interior if necessary, using specialized tools, testing procedures, mirrors and video cameras as needed to evaluate the fireplace system. If the fireplace has not been cleaned and inspected by a qualified fireplace professional within the past year we recommend this be done prior to use.

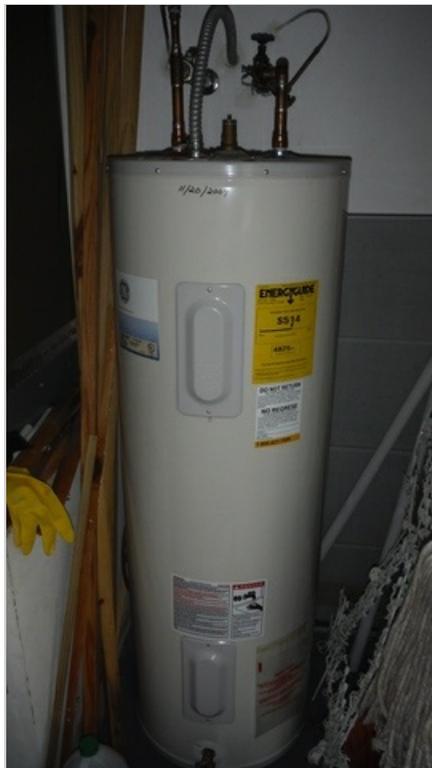
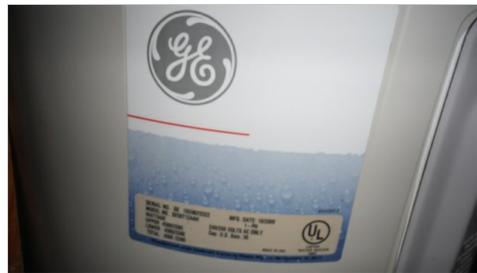
There was a 50 gallon capacity, electric water heater located in the garage. The water heater was manufactured by General Electric, serial number 1009B25522 information on the water heater indicated that it was manufactured 6 years ago. The water heater was functional.

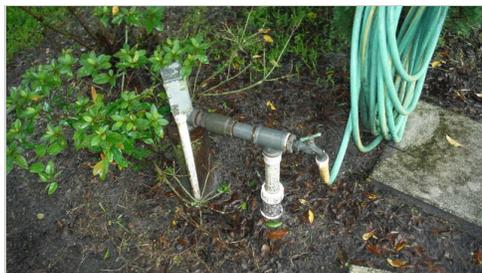
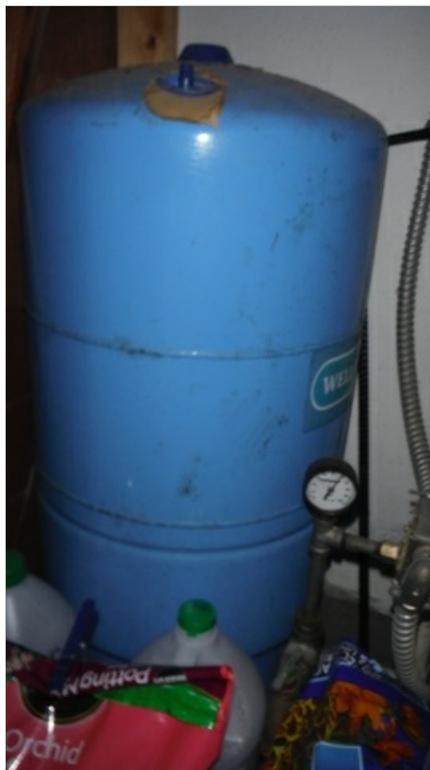
There was an electric pump located in the left yard and a pressure tank located in the garage. The pump was for lawn irrigation and functioned properly.

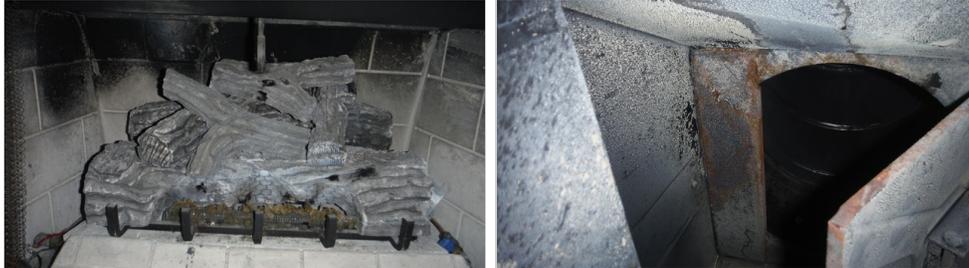
A gas fireplace was located in the family room. There were no cracks observed in the firebox or visible portions of the chimney. For safety reasons, a fireplace and the chimney or pipe to which it is vented should be cleaned and re-inspected as there may be hidden defects, not fully visible at the time of the inspection. The fireplace was not tested for operation or function.

A home inspection of the fireplace and chimney is limited to the readily visible portions only and the fireplace was not operated. The inner reaches of a flue is mainly inaccessible. Our view was not adequate to discover possible deficiencies or damage, even with a strong light. For safe and efficient operation we recommend annual inspections by a qualified fireplace professional. A qualified chimney sweep will clean the interior if necessary, using specialized tools, testing procedures, mirrors and video cameras as needed to evaluate the fireplace system. If the fireplace has not been cleaned and inspected by a qualified fireplace professional within the past year we recommend this be done prior to use.

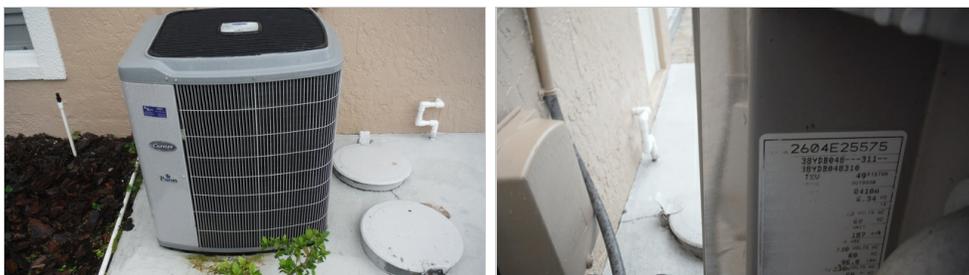
The electric outdoor heat pump condensing unit was a Carrier, Serial Number 2604E25575. The unit is located on the left side of the home. This unit is approximately eleven years old. There was a disconnect present. The refrigerant line was insulated.

The air handler was a Carrier, Serial Number 2904A73202. The unit is located in the garage. This unit is approximately eleven years old. The condensate lines appeared to be properly installed. Temperature differentials (TD) were determined by calculating the difference in the temperature at the warm air return against each cold air supply vents. The TDs were: 14* to 19* F. The ideal range is from 13* to 19* F. Periodic preventive maintenance is recommended to keep this unit in good working condition. The cooling system was found to be functional.

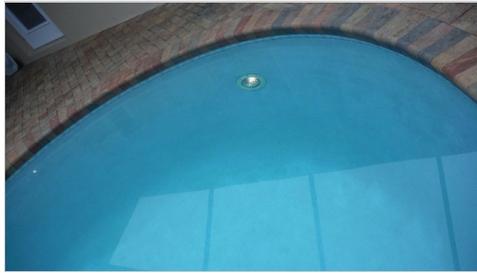
Pool light illuminated

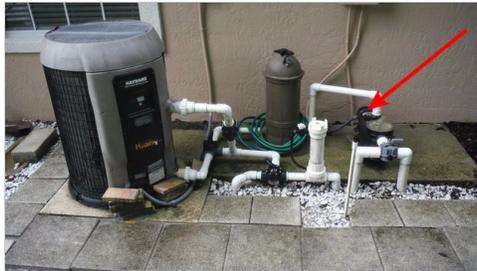
Pump

The Marathon pool circulating pump was operational at the time of the inspection.

The pool pump was louder than normal. This could indicate failing bearings.

- The pool pump was louder than normal. This could indicate failing bearings.
- The pool heater control panel activated when the fuse was inserted in the on position. The heater did not activate.
- The front office window had a sprung spring on the left side.
The two left side bedroom doors would not latch when closed. Recommend adjusting the catch latch.
- There was a small water mark in the living room above the sliding glass door. It appears to be possibly coming from the vent pipe directly above. Recommend sealing the vent pipe and if the mark appears to get bigger contact a qualified licensed roofing contractor to further evaluate.
- The cold water knob on the laundry room sink leaks when turned on. Recommend replacing seals and tightening.
