HomeTeam[®]

HOME INSPECTION REPORT

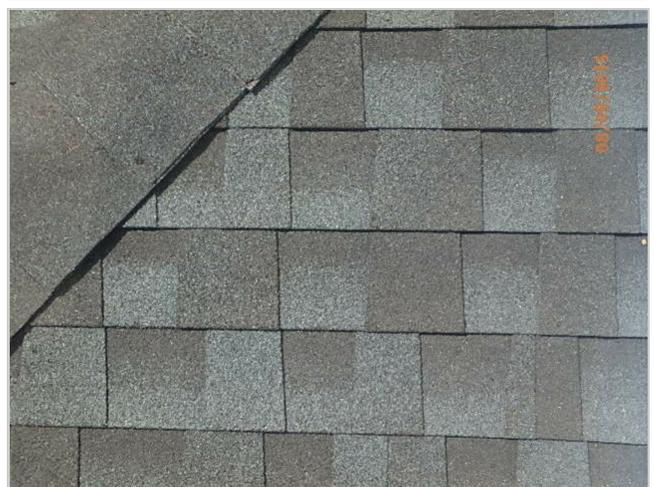
Photo 7

The roof requires routine maintenance to prolong its life (nail pops on front of roof).

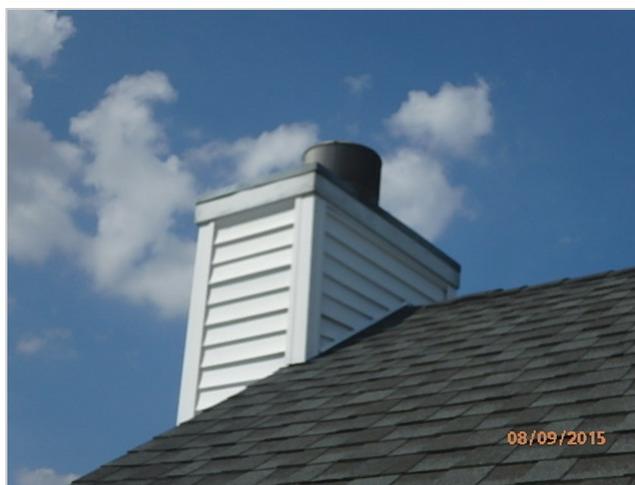
Photo 10

The home had one flue chase. Observation of the flue chase was made from the ground with the aid of binoculars. The flashing around the roof penetration point appeared to be adequate.

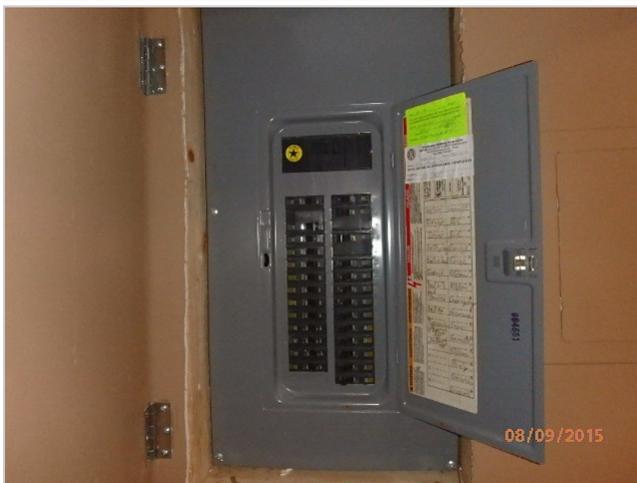
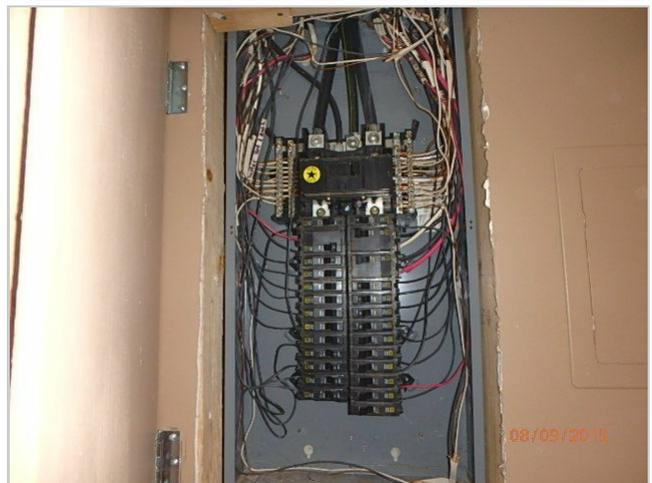
The electrical service appeared to be adequate. As a reminder, alarms, electronic keypads, remote control devices, landscape lighting, telephone and television wiring are beyond the scope of this inspection.

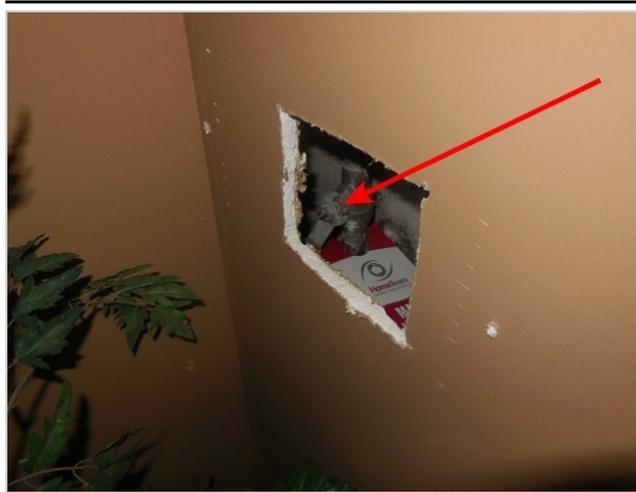
Photo 18

The main water shutoff valve for the home was located adjacent to the water service entry point on the left wall in the basement. Water shutoff valves are visually inspected only. No attempt is made to operate the main or any other water supply shutoff valves during the inspection. These valves are infrequently used and could leak after being operated.

Main water shut off.

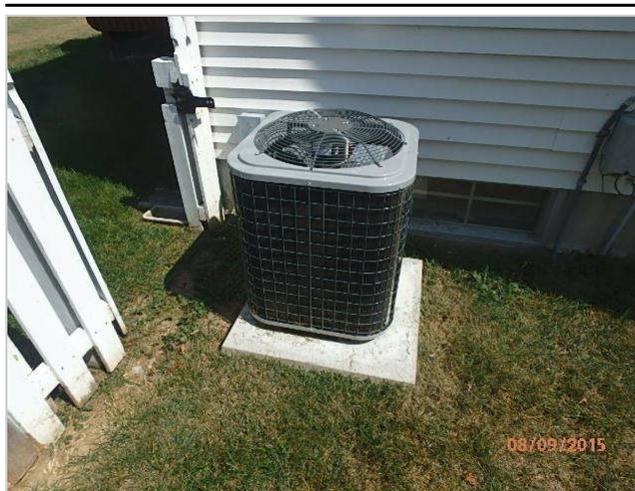
Photo 24

The electric outdoor air conditioner / heat pump condensing unit was an Arcoaire, Model Number N4A336AKB300 and Serial Number E143723407. The unit is located on the left side of the home. This unit is approximately 1 year old. Periodic preventive maintenance is recommended to keep this unit in good working condition, and HomeTeam strongly recommends partnering with a reputable HVAC company for routine maintenance for the heating and cooling systems in the fall and spring. The air conditioning system was tested and found to be functional. As a reminder, this is functionality test and visual inspection only; we do not check suction pressures, contactor amps, or refrigerant levels. If a more detailed inspection is required, please consult with an HVAC company.
