# HomeTeam<sup>®</sup>

### HOME INSPECTION REPORT

On Tuesday, April 17, 2018 The HomeTeam Inspection Service made a visual inspection of 123 Main Street, Columbus, OH 43054. Enclosed please find a written, narrative report of our findings in accordance with the terms of our Inspection Agreement.

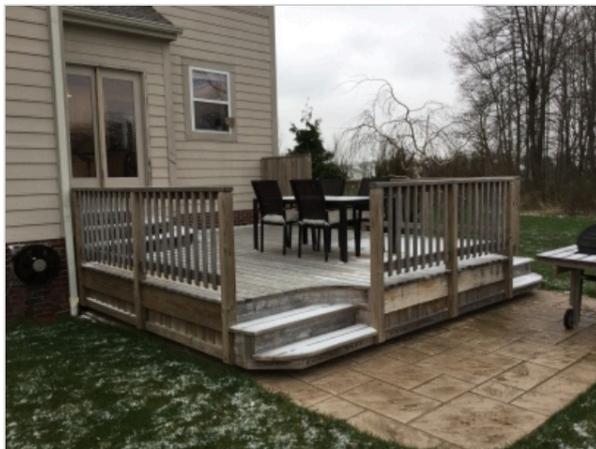
Photo 7

A wood deck was located in the back of the structure. There did not appear to be significant deterioration of the deck surface. The handrails on the deck appeared to be secure. A wood deck should be cleaned and sealed regularly to prevent deterioration.

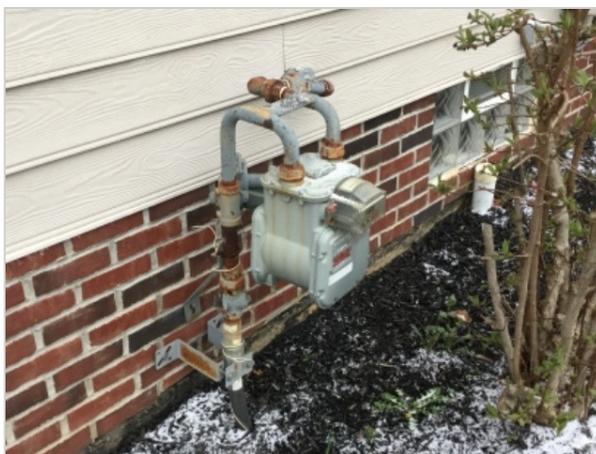
Photo 8

The gas meter and main shutoff were located on the left exterior wall. There was no noticeable odor of gas detected at the time of the inspection.

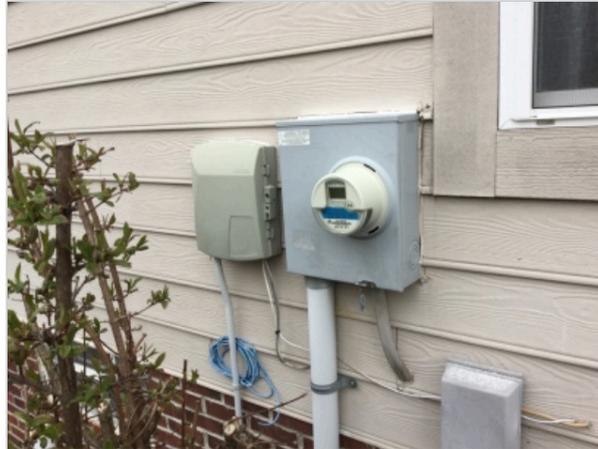
Photo 20

The underground electric service wire entered the structure on the left wall. The electric meter was located on the exterior wall.

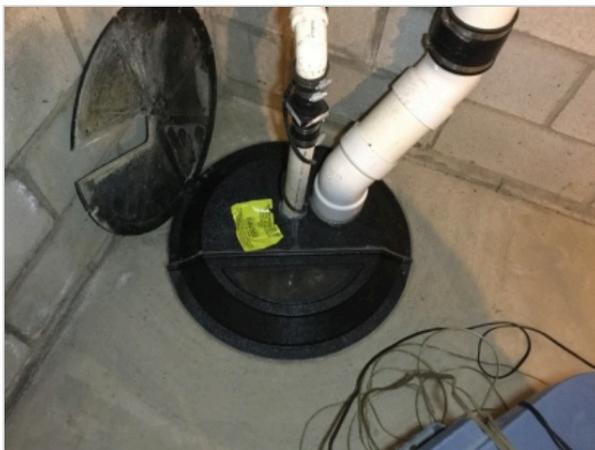
Photo 27

There was a sump pump located in the basement. The sump pump was not tested because the pump has an internal activation system that is not accessible.. HomeTeam recommends all sump pumps be tested regularly. Backup pumps (battery and hydro) provide an added measure of protection and should be considered as an upgrade.

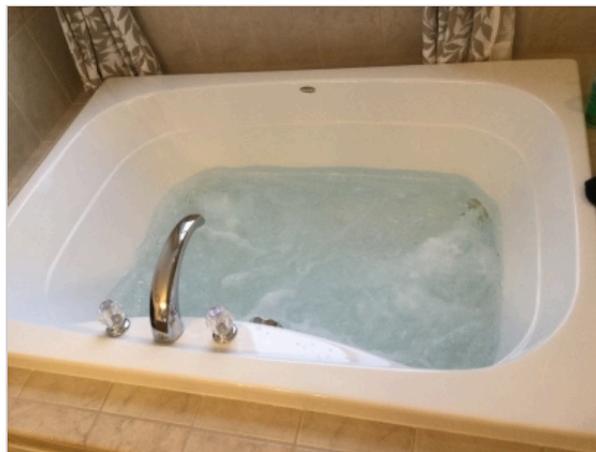
**Photo 29**

The GFCI for the jetted tub was located in the water closet.

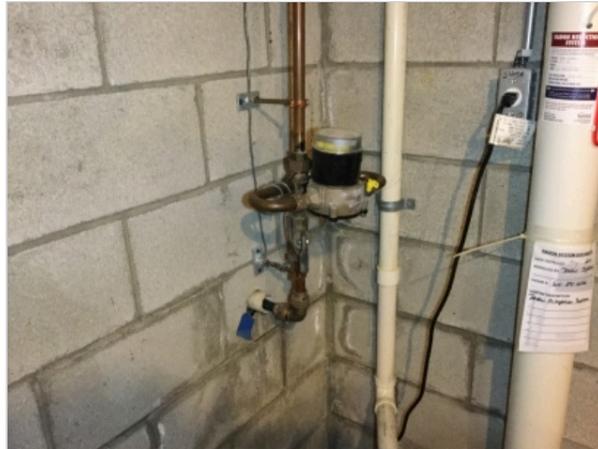
Photo 30

The main water shutoff valve for the structure was located adjacent to the water service entry point on the front wall in the basement. Water shutoff valves are visually inspected only. No attempt is made to operate the main or any other

water supply shutoff valves during the inspection. These valves are infrequently used and could leak after being operated.

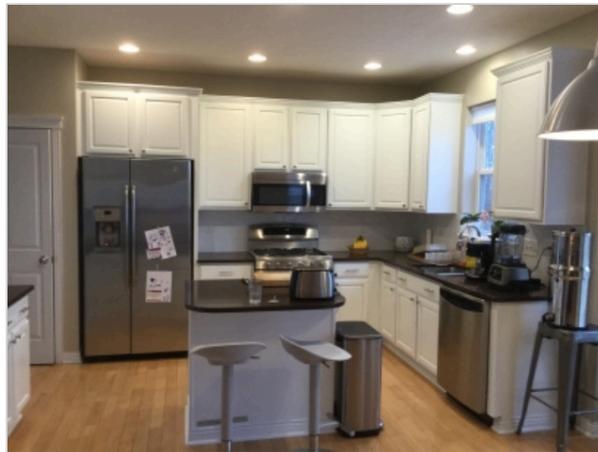
**Photo 34**

The visible portions of the kitchen cabinets and counter tops were in good condition. The appliances were operated to check basic operational function only. No consideration is given regarding the age or components that may be worn or otherwise affected by wear and tear or use. The kitchen contained the following appliances:

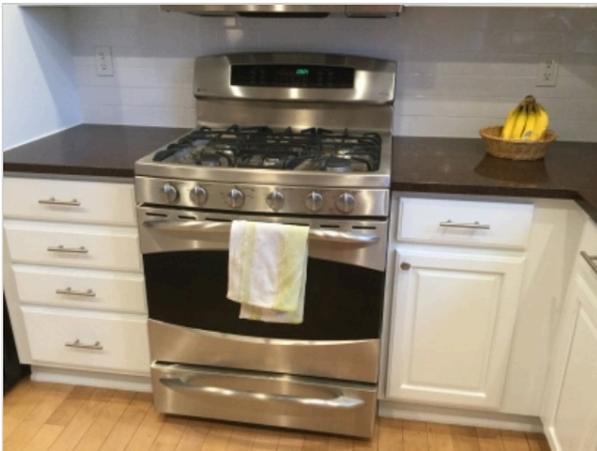
Photo 36

The natural gas oven and range combo was inspected and did appear to be functional. The accuracy of the clock, timers and settings on ovens are not within the scope of this inspection.

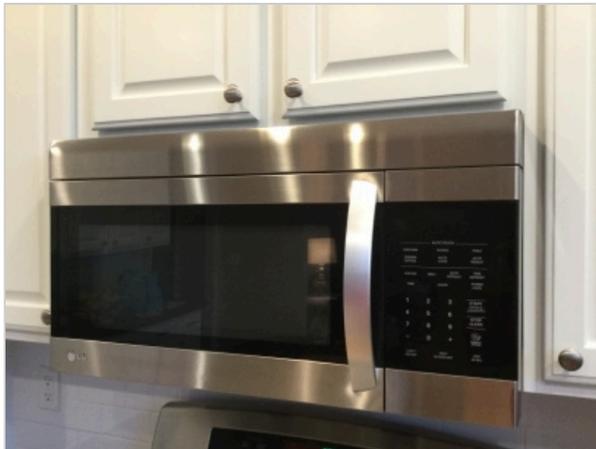
**Photo 39**

The range hood and microwave combination was inspected and did appear to be functional. The exhaust capacity is not within the scope of this inspection. Cleaning the fan and filter may increase the exhaust capability.

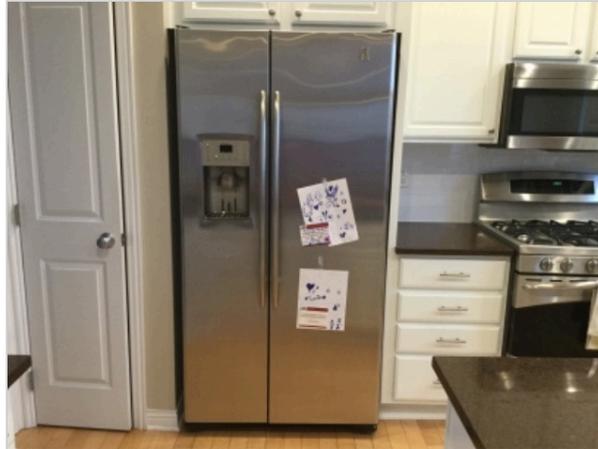
**Photo 40**

The refrigerator was inspected and did appear to be functional. The ice maker operation and hookups, if present, are not within the scope of the inspection.

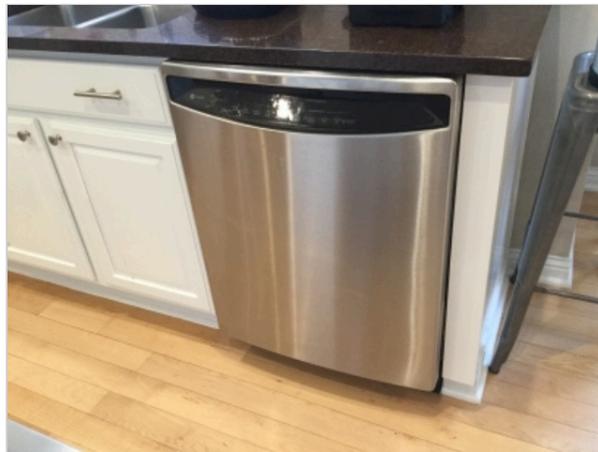
**Photo 41**

The dishwasher was tested and did appear to be functional.

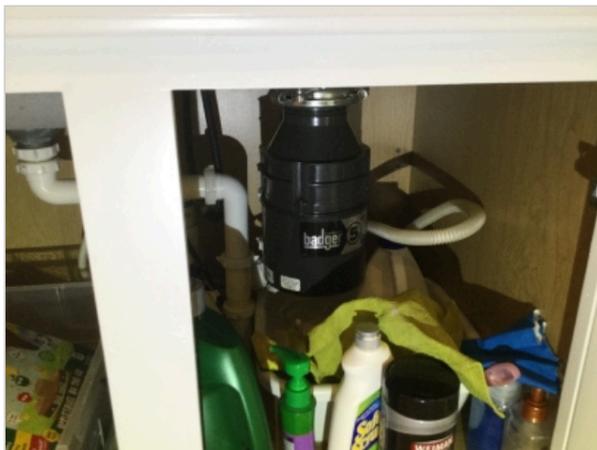
Photo 42

The disposal was inspected and did appear to be functional. The efficiency rating and chopping / grinding ability of the unit is not within the scope of the inspection.

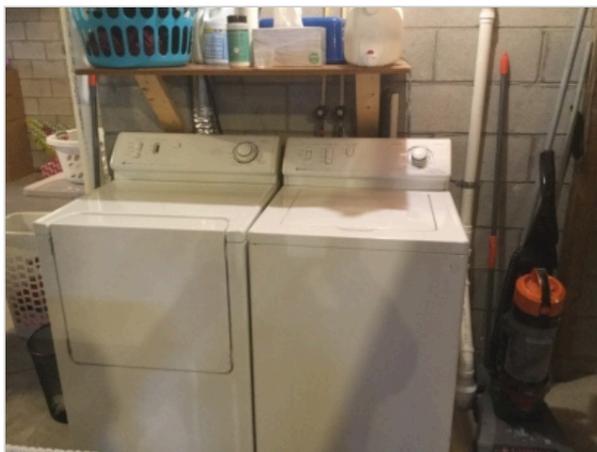
Photo 43

A drain for a washing machine was present.

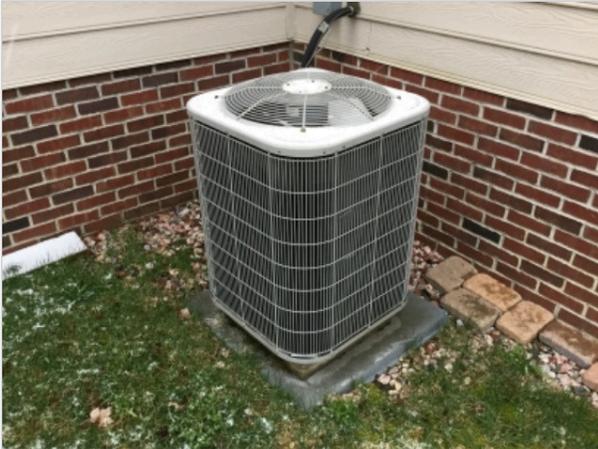
Photo 48

The electric outdoor air conditioner condensing unit was a Bryant, Model Number 113ANA036-B and Serial Number 2507E34703. The unit is located in the back of the structure. This unit is approximately 11 years old. Periodic preventive maintenance is recommended to keep this unit in good working condition, and HomeTeam strongly recommends partnering with a reputable HVAC company for routine maintenance for the heating and cooling systems in the fall and spring. The air conditioning system was not tested because the outside temperature was below sixty degrees within the last twenty four hours. As a reminder, this is functionality test and visual inspection only; we do not check suction pressures, contactor amps, or refrigerant levels. If a more detailed inspection is required, please consult with an HVAC company.
