1234 Sample Report Lane Dallas, TX 75228

I. STRUCTURAL SYSTEMS

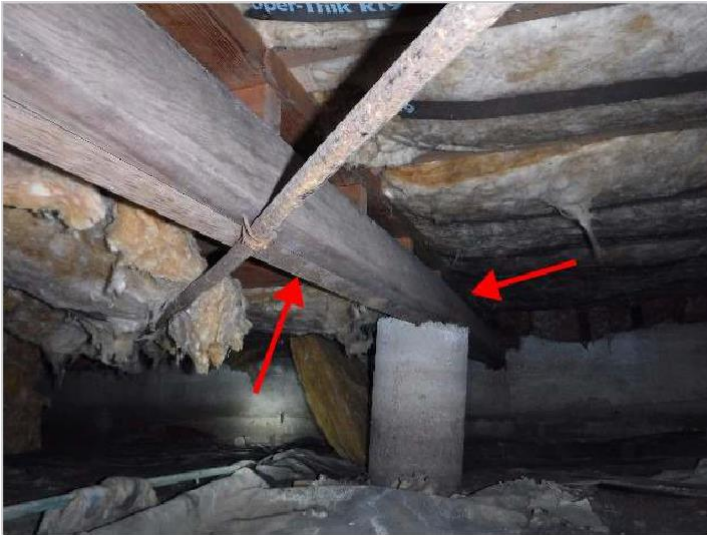
A

The second main beam from the right (PIC A,B) and the second main beam from the left (PIC C,D) in the rear crawl space were unlevel and twisted out of position along the entire lengths. The floor structure appeared to be compromised. Recommend further evaluation by an independent foundation repair specialist.

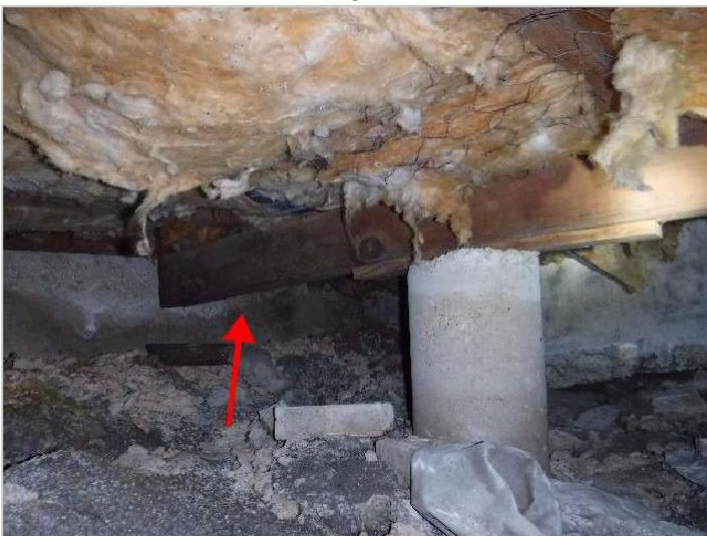
E

Main beam(s) were unlevel in the rear crawl space along the entire front (PIC B,D,E). The floor structure appeared to be compromised. Recommend evaluation by an independent foundation repair specialist.

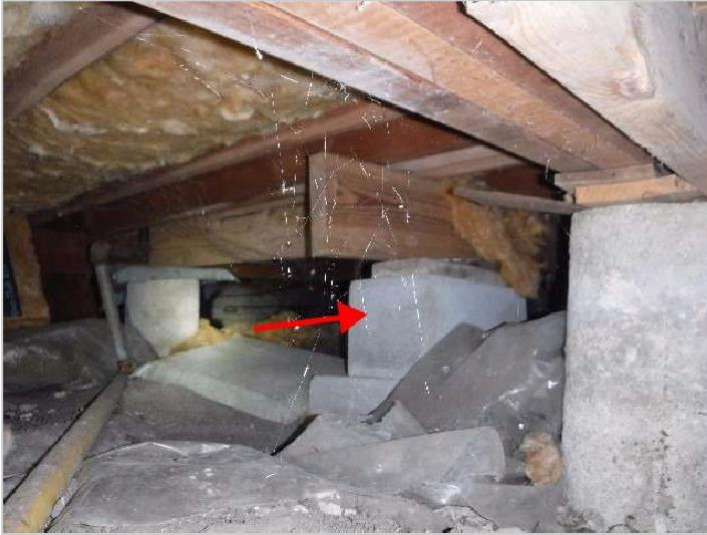
G

The middle main beam in the front crawl space under the kitchen area was twisted out of position (PIC F) and attempts at additional support did not appear to be adequate (PIC F,G). Recommend evaluation and repair as needed by an independent foundation repair specialist.

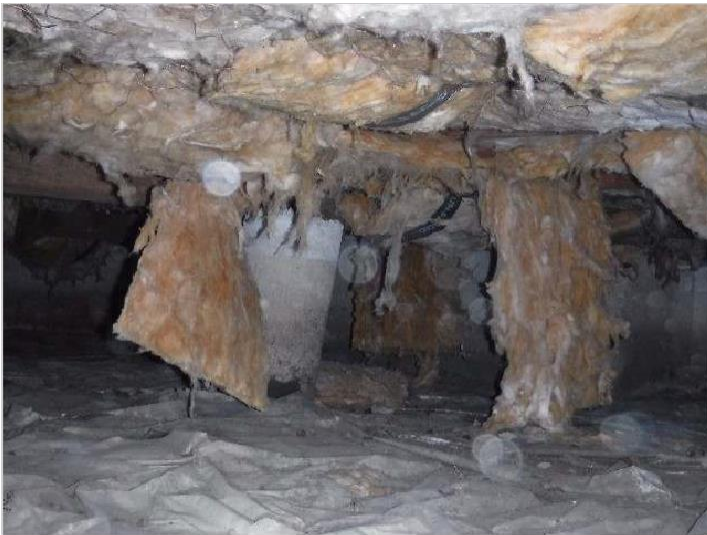
I

The front main beam in the front crawl space was shifted completely off the pier at the left side (PIC H). Attempts at additional support did not appear to be adequate. Recommend evaluation and repair as needed by an independent foundation repair specialist. Insulation under the floor was loose and resting on the ground throughout the front and rear crawl spaces (PIC I,J,K,L).

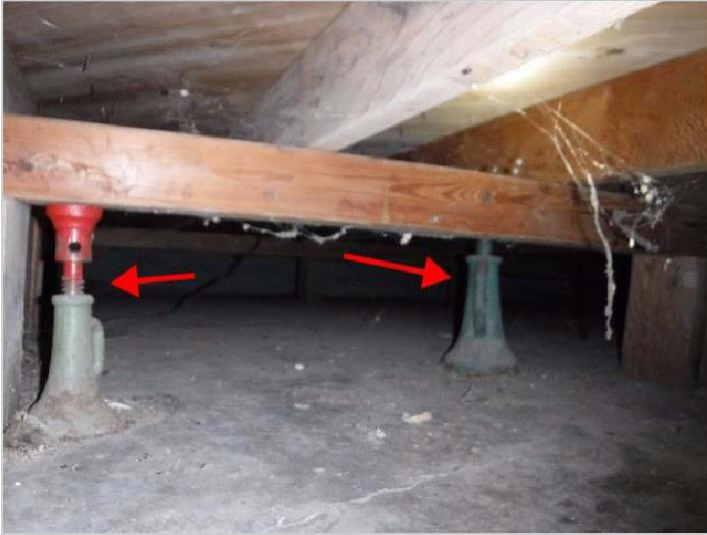
M

Several hydraulic jacks were used for permanent framing support under the front living room area (PIC M).

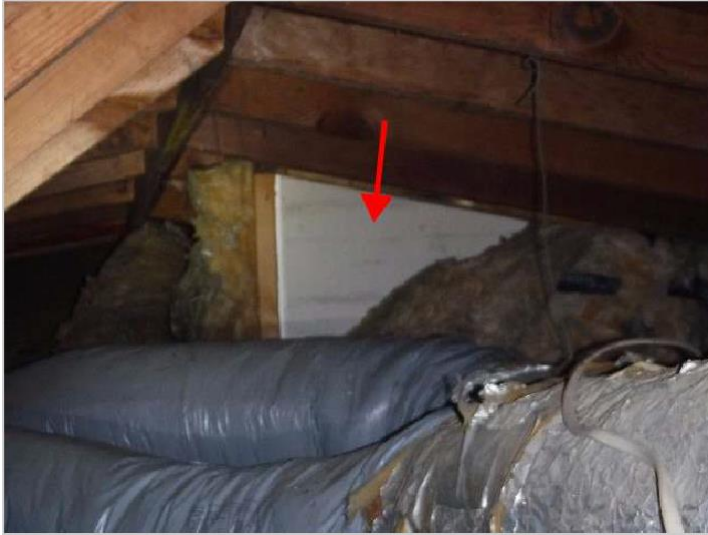
A

The existing insulation throughout the attic areas was not adequate for current efficiency standards, recommend additional insulation for attic space.
 Insulation was missing/loose on the vertical wall(s) at the rear of the rear skylight (PIC A), viewed from the rear attic.
 Indication of vermin infestation was observed throughout the attic areas; recommend evaluation by a licensed pest control contractor.
 WDI damage was observed on a truss chord at the rear middle (PIC B); structural integrity of the truss may be compromised.
 Several damaged and/or separated truss chords were observed at the front middle (PIC C) and the rear middle (PIC D). Structural integrity of the trusses may be compromised.

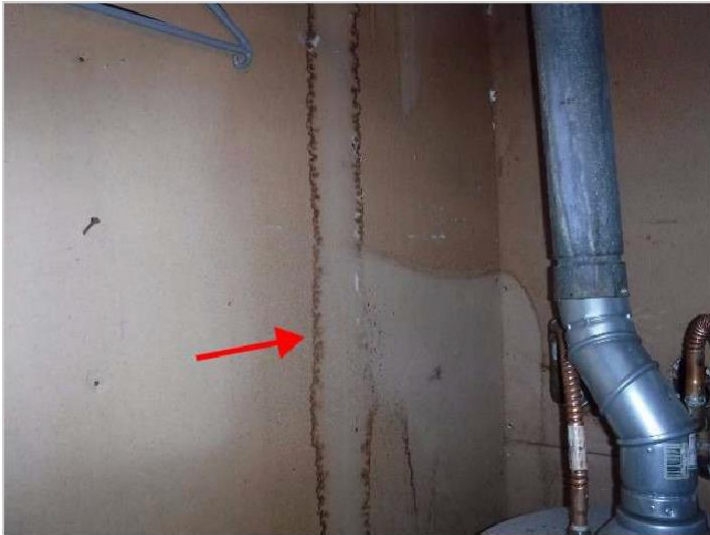
1A

Water stain(s) were observed at left side in garage water heater closet (PIC 1A) and at multiple locations in front entry closet (PIC 1B).
 Baseboards were missing in front entry closet at left side (PIC 1C).
 Door trim was missing in garage at left side exterior entry (PIC 1D).
 Sheetrock crack(s) were observed in utility room above the right side entry (2) (PIC 1E, 1F) and in utility room above exterior entry.
 WDI damage was observed at rear wall in garage bath (PIC 1G). Refer to independent Wood Destroying Insect report if applicable.
 Caulk/seal was needed at backsplash at counter(s) in kitchen (PIC 1H).
 Damaged panels were observed at left side rear in garage (PIC 1I).
 The rear left kitchen countertop was not properly secured.
 Wood panel was cracked/damaged at right side rear in right hall (PIC 1J).

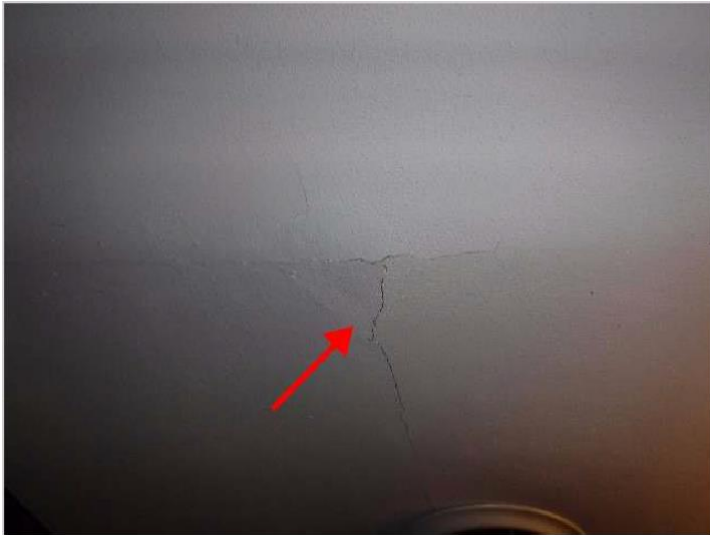
A

Damaged sheetrock was observed at rear middle (PIC A) and front left (PIC B) in front left bedroom.

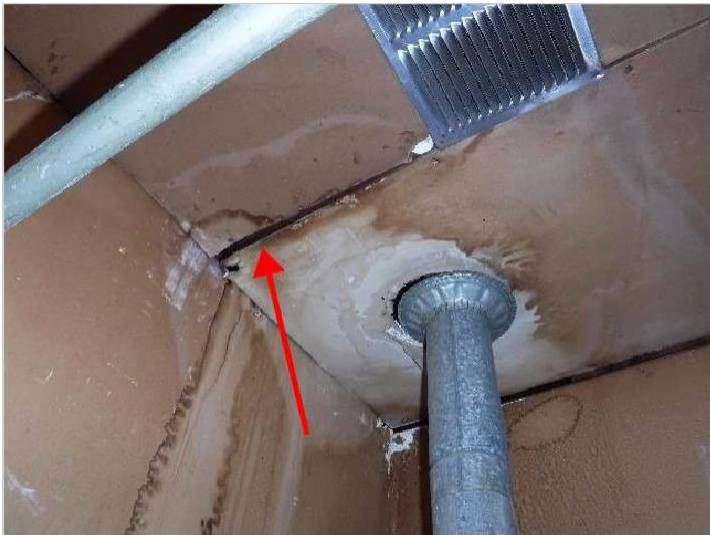
C

Water damage was observed at ceiling above garage water heater (PIC C) and at middle around light/skylight in kitchen (PIC D, E).

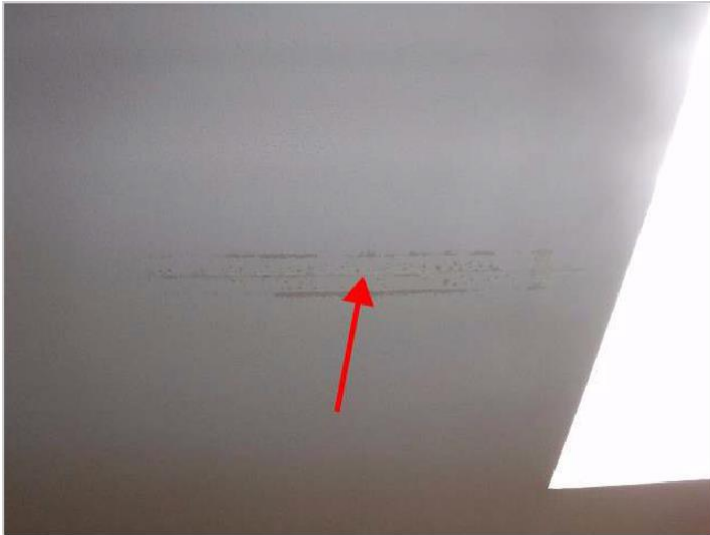
G

Water stain(s) were observed at front right (PIC F) and front left (PIC G) in rear living room, at middle (3) (PIC H, I, J) in rear hall bath and at rear right in front entry closet (PIC K).

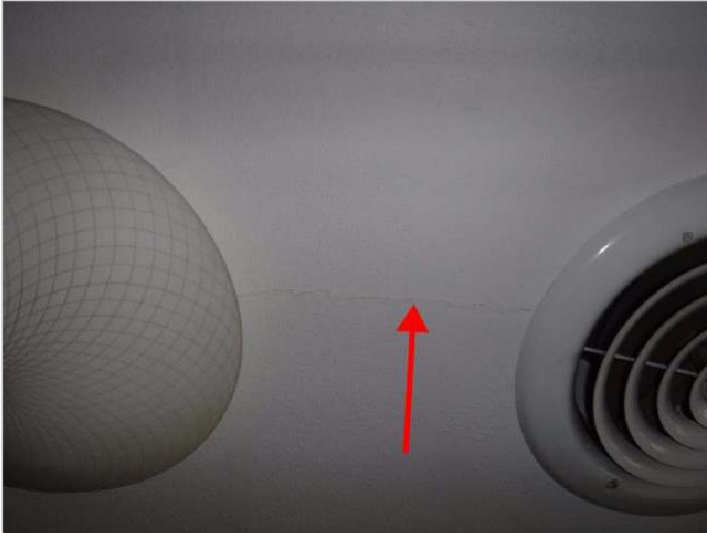
M

Sheetrock crack(s) were observed in front living room at left side hall entry (PIC L) and in rear bedroom at middle (PIC M).

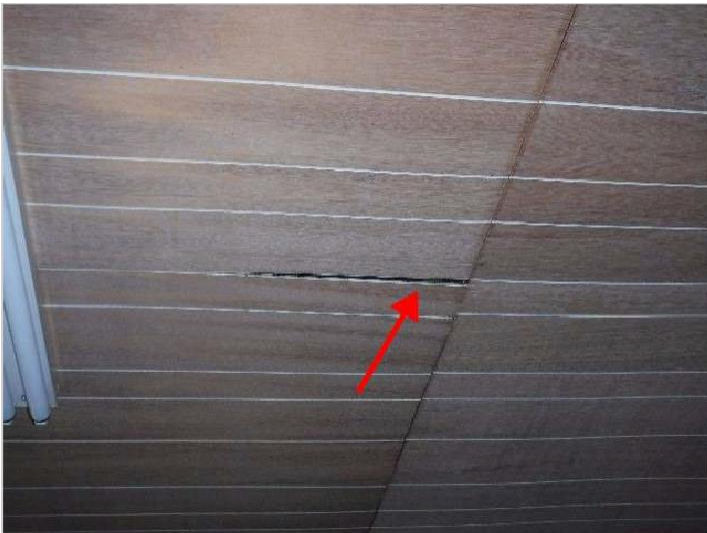
O

Loose/warped panels were observed at multiple locations throughout the garage ceiling (PIC O, P).

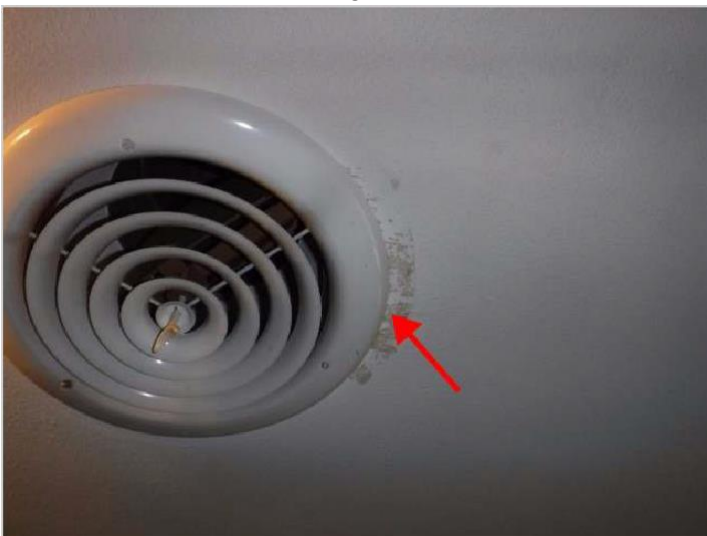
Q

An unidentifiable stain was observed at middle in rear bedroom (PIC Q).

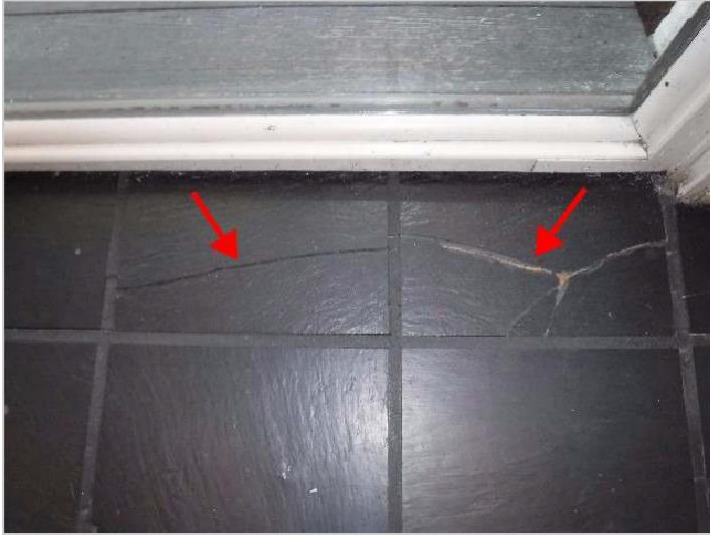
S

Cracked tile(s) were observed in front living room (7) (PIC S, T) and in kitchen (12) (PIC U, V).

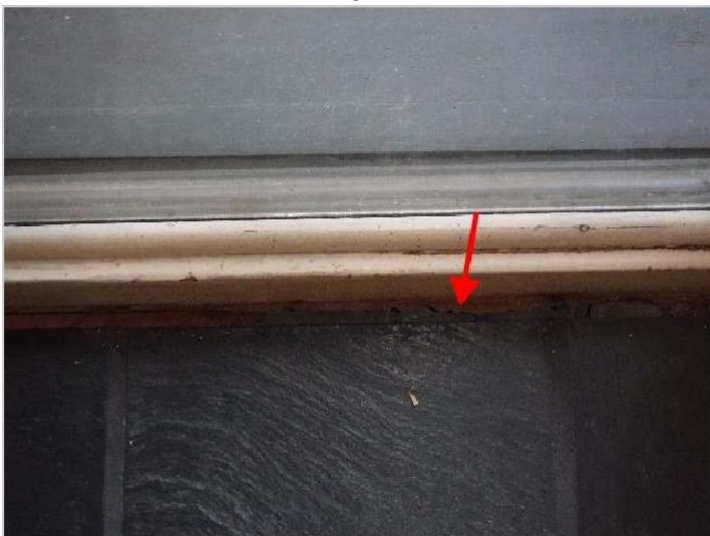
W

Separation between wall and floor was observed at rear in front living room (PIC W) and at front in rear living room (PIC X).

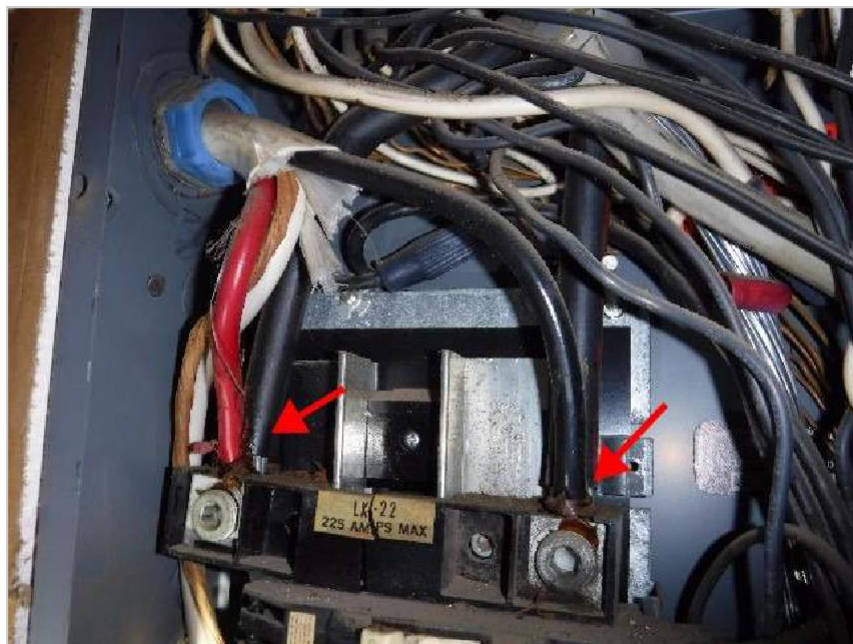
A Federal Pacific sub panel was located in the garage closet.

Recommend replacement of the Federal Pacific sub panel by a licensed electrical contractor due to possible safety concerns.

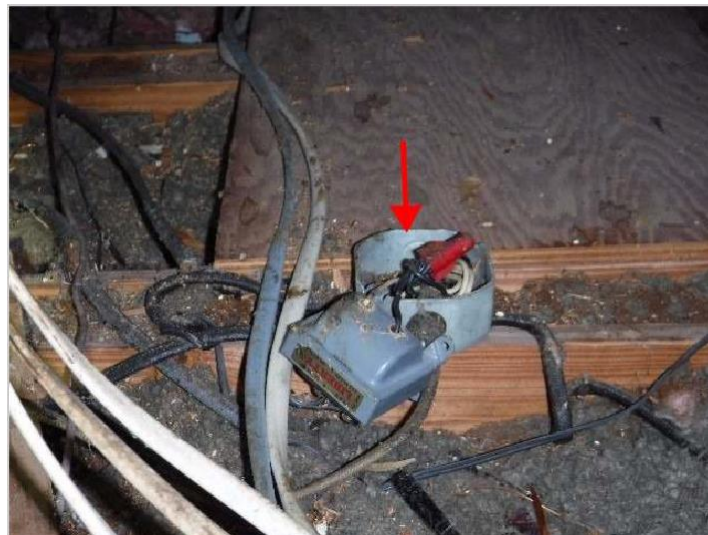
B

Gray vinyl sheathing ducts were observed throughout the attic space (PIC A,B), recommend duct replacement.
