# HomeTeam<sup>®</sup>

### *HOME INSPECTION REPORT*

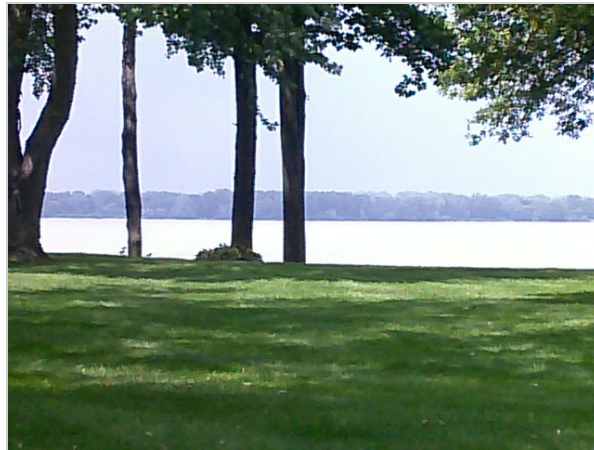
The inspected property consisted of a two story structure with brick siding that was occupied at the time of the inspection. There were no material visual defects on the visible portions of the siding. The age of the property, as reported by the Erie County website was said to be 90 - 100 years old. The approximate temperature at the start time of the inspection was 70 - 80 degrees Fahrenheit, and the weather was overcast with some rain. The utilities were on at the time of the inspection. The seller was present during the inspection.

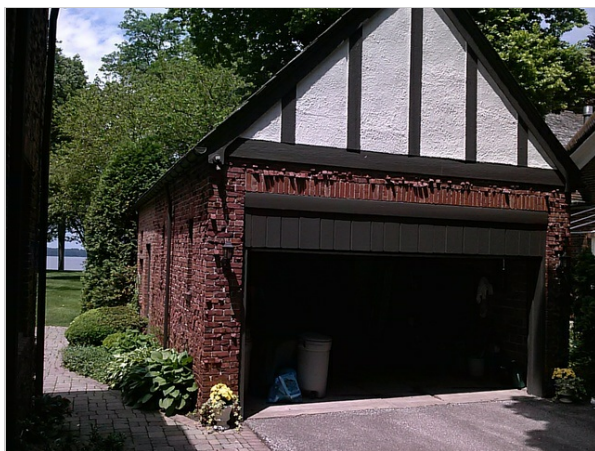
## Garage

The detached garage was designed for one car with access provided by one electric overhead door. The concrete garage floor was in a condition typical for the age of this property. There were no material defects observed at the garage.

***NOTE: The presence of many stored items and/or a cluttered condition in the garage attic area and parking area blocked much of the visual inspection, mostly at floor and along the walls.***

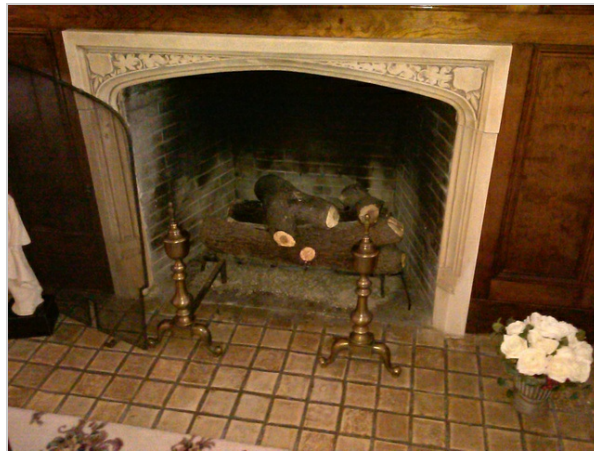
## Fireplace

A wood burning fireplace with chimney was located in the basement. The damper did appear to be fully functional. There was no visual evidence of creosote buildup in the firebox. There were not any cracks and/or missing mortar observed in the firebox. This fireplace was not lit and working during the inspection. There were no material defects in the visible portions of the fireplace during our inspection.

NOTE: The NFPA (National Fire Protection Association) recommends that a level II inspection of the fireplace be performed by a chimney specialist at every transfer of residential property. This will add to your inspection costs, however, it is the only way to be sure that the fireplace is in safe working order. For safe and efficient operation we recommend annual inspections by a qualified fireplace professional. A qualified fireplace professional will clean the interior if necessary, use specialized tools, testing procedures, mirrors and video cameras as needed to evaluate the fireplace system. NOTE: The U.S. Consumer Product Safety Commission (CPSC) recommends that every property should have at least one carbon monoxide (CO) alarm. CO is an odorless, colorless gas produced by burning any fuel, such as gas, oil, wood, coal.
