HOME INSPECTION REPORT

SAMPLE REPORT

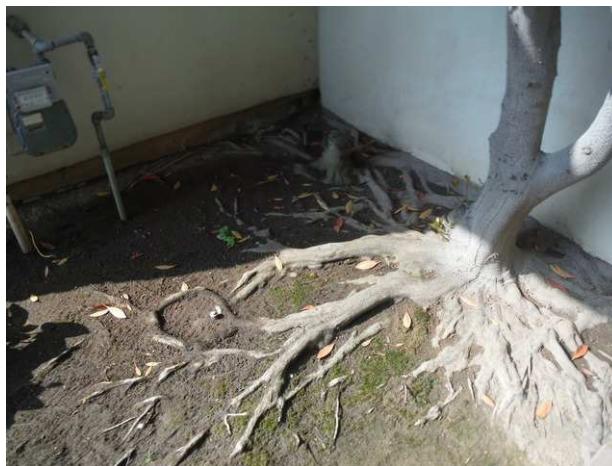
- The large tree roots located in the right side should be evaluated and if possible have the roots (or tree) removed by a licensed tree removal company.

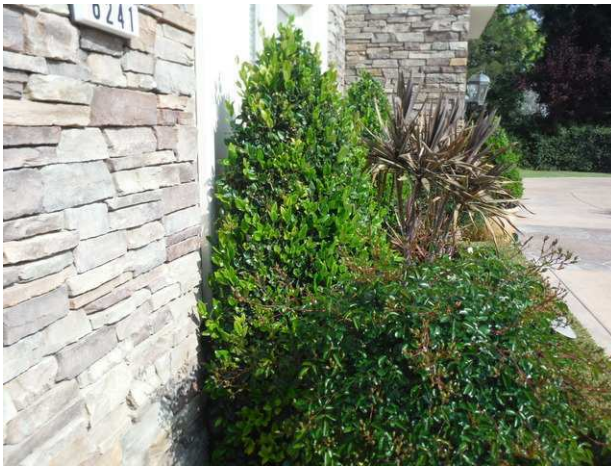
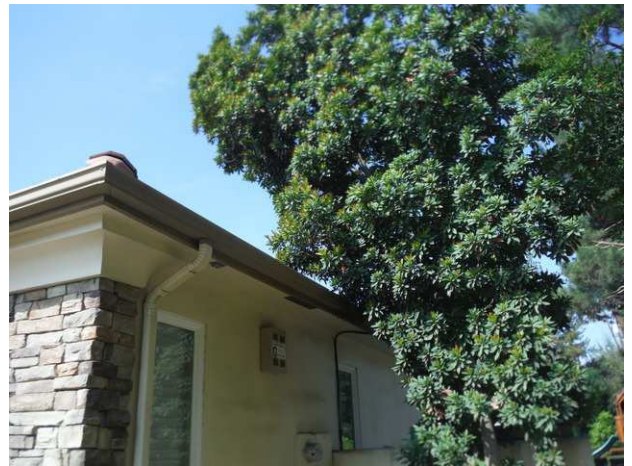
- There were tree branches / shrubs in contact with the home and roof on the front back and sides of the home. There were no debris on the roof. Debris from trees & shrubs can hold moisture and can prematurely wear out the siding and roof covering.

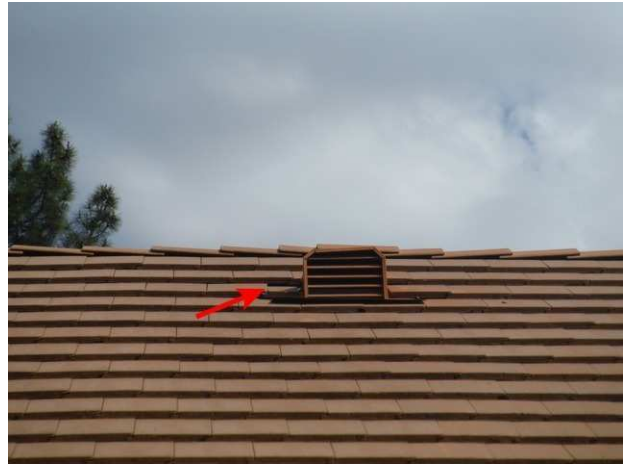
left side

- There are a few loose tiles observed on the front left and rear of the roof at the time of the inspection

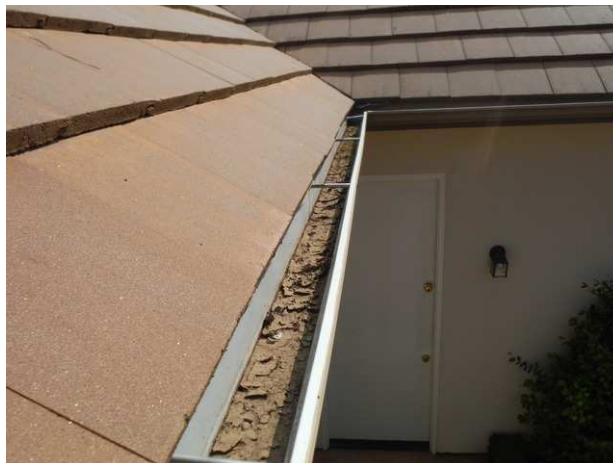
- The rain gutters were in need of cleaning in the rear right at the time of the inspection.

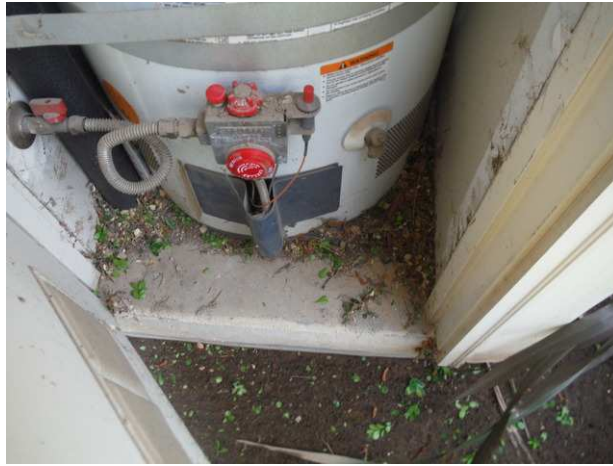
- Noted: The pilot light at the water heater was not lit at the time of the inspection. The pilot light was lit and did appear to be operational. The control setting for the water heater was set back to the pilot position. The water heater will need to be turned to the on position and the temperature control will need to be set.
- The pool house water heater closet has a build up of dust and debris below the tank and burner. Recommend cleaning of the closet area.

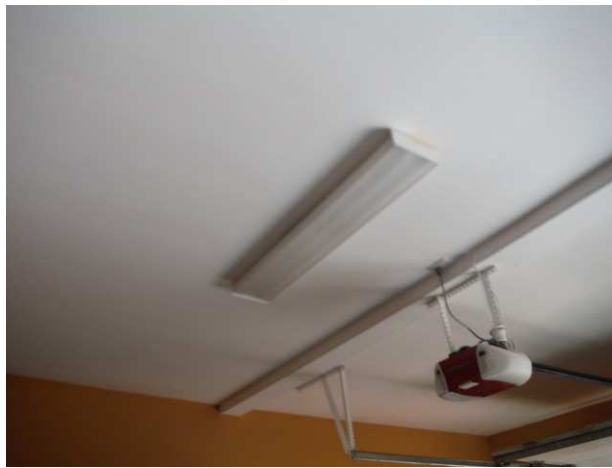
- The right side fluorescent light fixture in the three car garage is non functional.

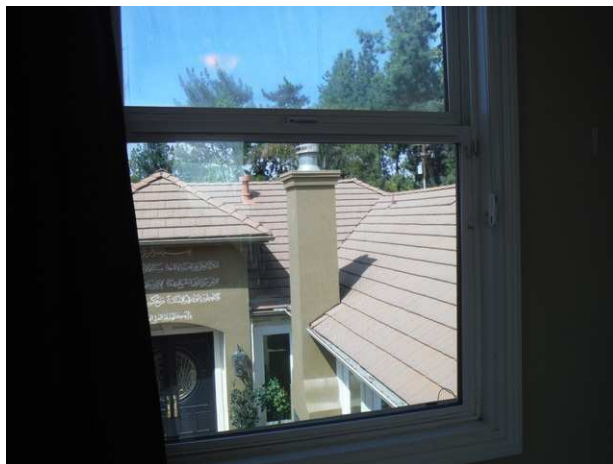
- The "Low e factor" in the two windows in the upper level detached bedroom may have lost some of its effectiveness. The "e" in low "e" stands for emissivity-the ability to to emit radiant energy. This coating layer allows light to penetrate the glass, but blocks most ultraviolet (UV) long wave energy, which we feel as heat during the summer months. During the winter months, heat from the room interior is reflected back into the room.

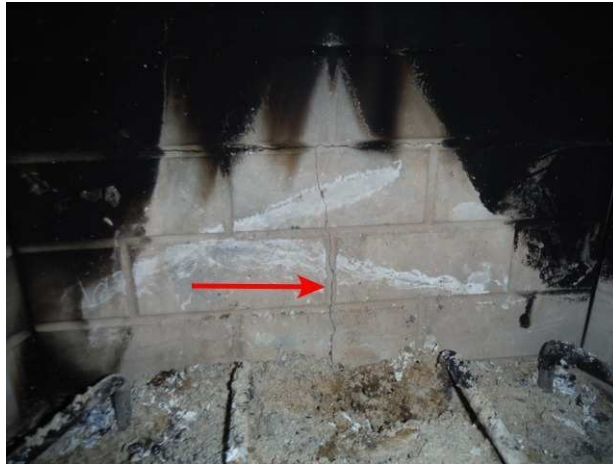
- There was a hairline crack observed at the rear refractory panel in the firebox .The panel felt secure. It is recommended that the firebox be monitored.

1. The water heater closet has a build up of dust and debris below the tank and burner. Recommend cleaning of the closet area.
2. The pool house will need a smoke alarm installed.
3. The rear refractory panel(s) is cracked and needs to be replaced. The fire place should not be used prior to replacement of the damaged panel.

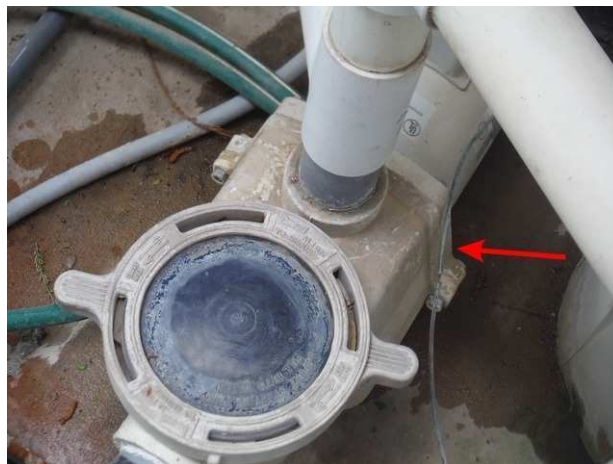
- There is a leak at the impeller at the pool pump motor.

1. There is a leak at the impeller at the pool pump motor.
2. The large tree roots located in the right side should be evaluated and if possible have the roots (or tree) removed by a licensed tree removal company.
