HomeTeam[®]

HOME INSPECTION REPORT

SAMPLE INSPECTION

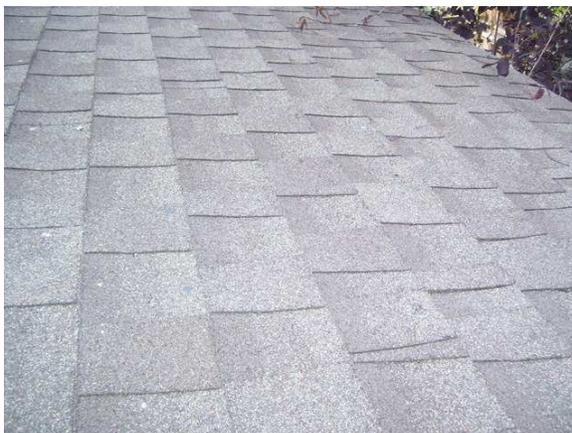
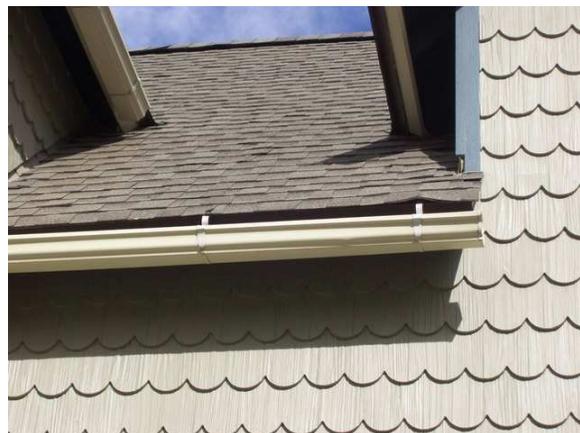
ROOF STRUCTURE

The roof was a gable, valley and shed design covered with asphalt/fiberglass shingles. Observation of the roof surfaces and flashing was performed from the ground level with the aid of binoculars and from the roof level. There was one layer of shingles on the roof at the time of the inspection.

There was light curling and moderate surface wear observed on the roof shingles at the time of the inspection. These conditions indicate the roof shingles were in the middle stages of their useful life. This visual roof inspection is not intended as a warranty or an estimate on the remaining life of the roof. Any roof metal should be kept well painted with a paint specially formulated for the use. There were no major visual defects detected on the exterior of the roof.

- At least one of the shingles at the right rear of the roof has slipped and it should be repaired by a qualified roofer.

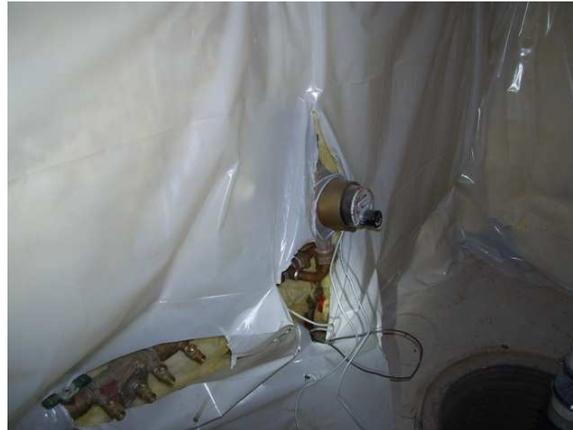
WATER METER - SHUTOFF

The water meter was located in the basement. The main water shutoff valve for the home was located adjacent to the water service entry point in the basement (behind the TV).

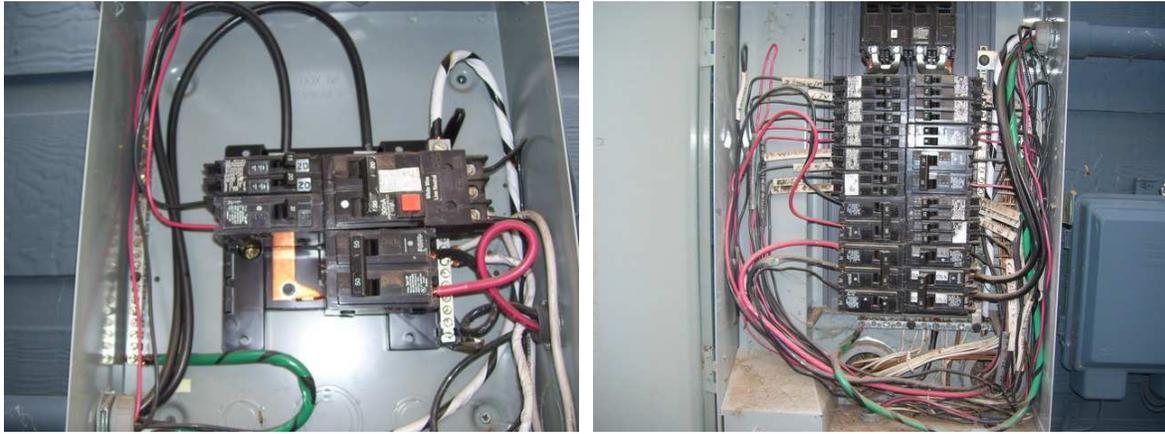
The underground electric service wire entered the home on the left side wall. The electric meter was located on the exterior wall. The main service disconnect was rated for 200 amps.

The service wire entered a Siemens service panel, located on the exterior wall with a 200 amp and 120/240 volt rated capacity. There was also a Siemens sub panel located on the exterior wall.

The branch circuits within both panels were copper. These branch circuits and the circuit breakers to which they were attached appeared to be appropriately matched. The visible house wiring consisted primarily of the Romex type and appeared to be in good condition.

- There were abandoned wires observed at the rear exterior of the home and in the utility room. These should be further reviewed by a licensed electrician.

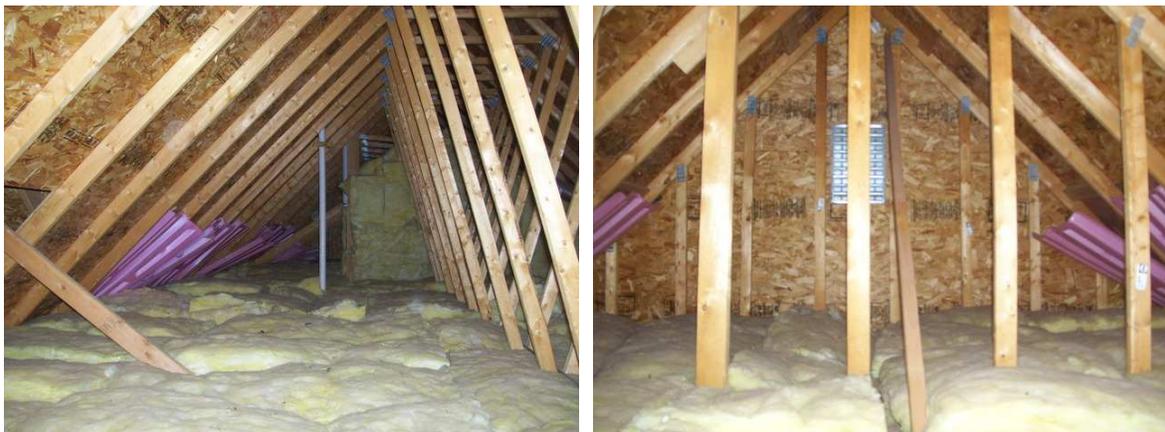
ATTIC STRUCTURE

The attic was accessed through a scuttle in the front bedroom closet. The attic above the living space was insulated with batted insulation, approximately 12-inches in depth. Ventilation throughout the attic was provided by gable, soffit and ridge vents. The roof structure consisted of two-inch by four-inch wood trusses spaced 24 inches on center and OSB (oriented strand board) sheathing.

Because of the configuration of the framing and absence of a catwalk, which limited access, it was not possible to inspect all areas of the attic. There was no moisture visible in the attic space. The absence of visible indications of moisture is not necessarily conclusive evidence that the roof is free from leaks. The only way to be sure a roof does not leak is to inspect the underside of the roof during a heavy rain. There were no major visual defects observed in the attic or roof structure.
