HomeTeam[®] INSPECTION SERVICE

HOME INSPECTION REPORT

On Thursday, March 14, 2019 HomeTeam Inspection Service made a visual inspection of **Service Service**, Wyoming, MI 49509. Enclosed please find a written, narrative report of our findings in accordance with the terms of our Inspection Agreement.

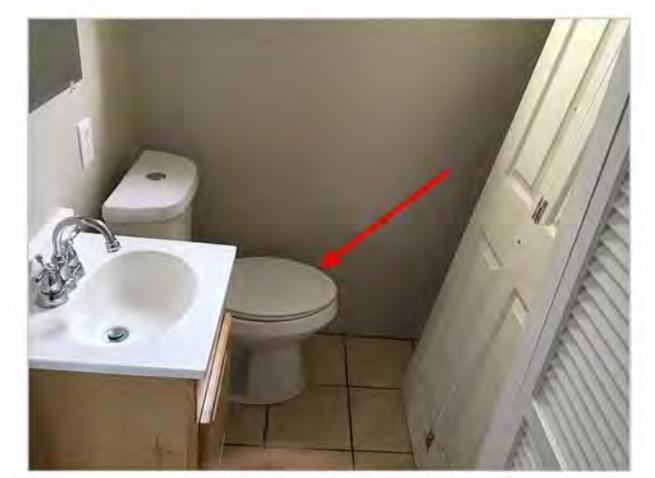
Half-bath off the kitchen

The toilet in the half bath is loose. Failure to secure the toilet may lead to leakage around the wax ring. The toilet should be secured.

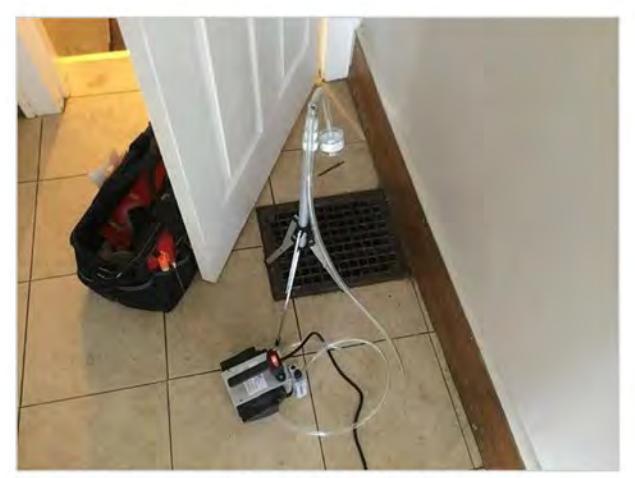
Kitchen Floor Duct

The overall total airborne spore count was higher on the interior of the structure than on the exterior.
