**123 Main St  
Anywhere, NC**

### *HOME INSPECTION REPORT*

File Number: **655439**

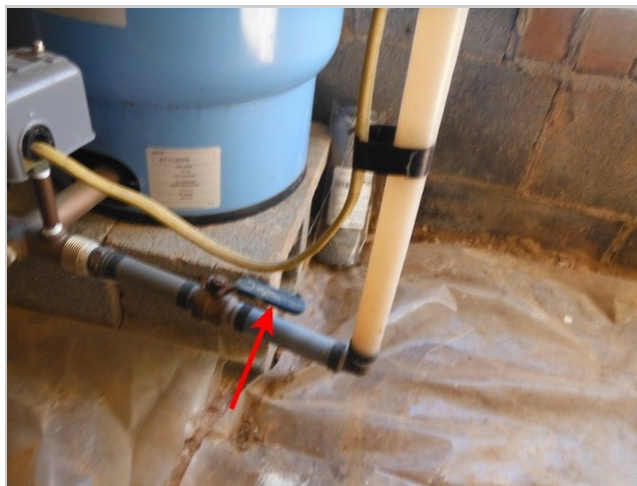
Water shut off-Crawlspace

The main water shutoff valve for the home was located in the crawlspace. Water shutoff valves are visually inspected only. No attempt is made to operate the main or any other water supply shutoff valves during the inspection. These valves are infrequently used and could leak after being operated. This is for your information.
