HOME INSPECTION REPORT

**123 Sample Drive
Anytown, IL 60000
Inspection #: XXXX**

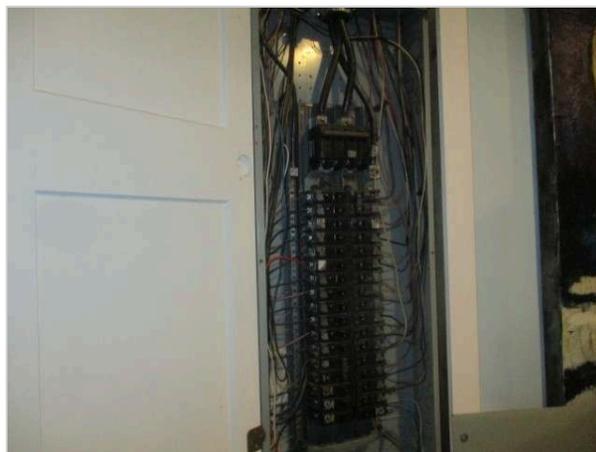
The underground electric service wire entered the home on the rear wall. The electric meter was located on the exterior wall. The service wire entered a Siemens service panel, located on the basement wall with a 200 amp and 120/240 volt rated capacity. The main disconnect was located inside the service panel. The branch circuits within the panel were copper. These branch circuits and the circuit breakers to which they were attached appeared to be appropriately matched. The visible house wiring consisted primarily of the rigid conduit type and appeared to be in good condition.
