# HomeTeam<sup>®</sup>

### HOME INSPECTION REPORT

Address of Inspection: 123 SAMPLE DRIVE

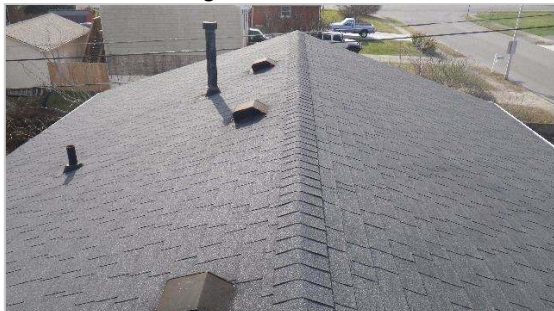
Figure Number 9

*Any roof surface metal, especially the flashings and valley materials should be kept well protected with a coating specifically formulated for that purpose.*

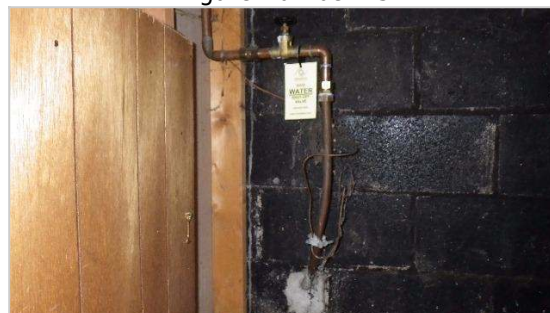
Figure Number 13

The location of the main water supply shut-off valve has been marked with an identification tag and should be noted by all occupants in case of an emergency situation concerning the water supply.

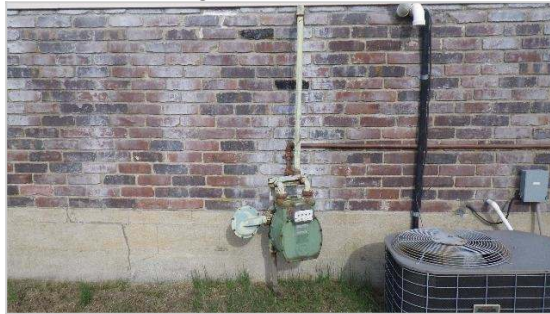
Figure Number 15

The control valve for the gas supply was located at the right exterior wall. The control valve should be located by all occupants in case of an emergency situation concerning the gas supply.

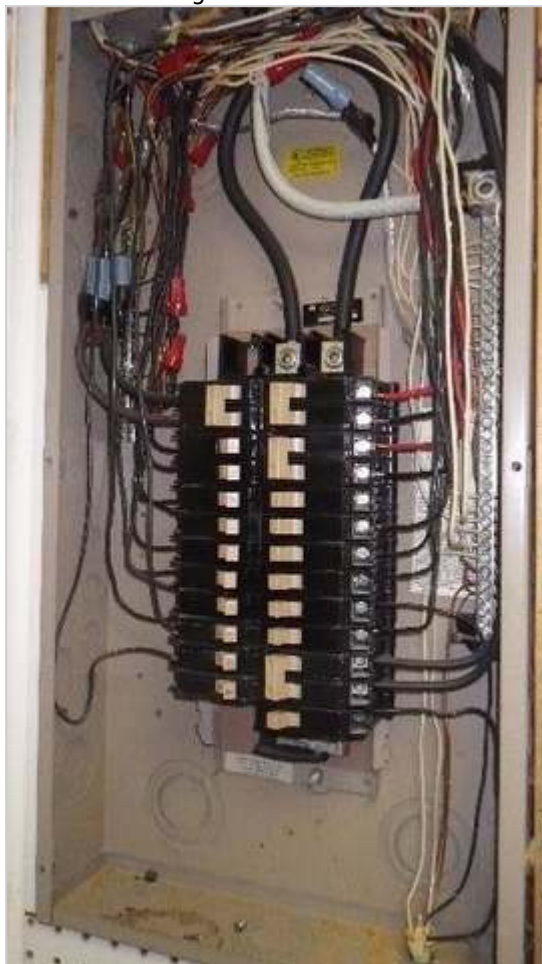
Figure Number 16

There were no major visual defects observed on the visible portions of the electrical system.

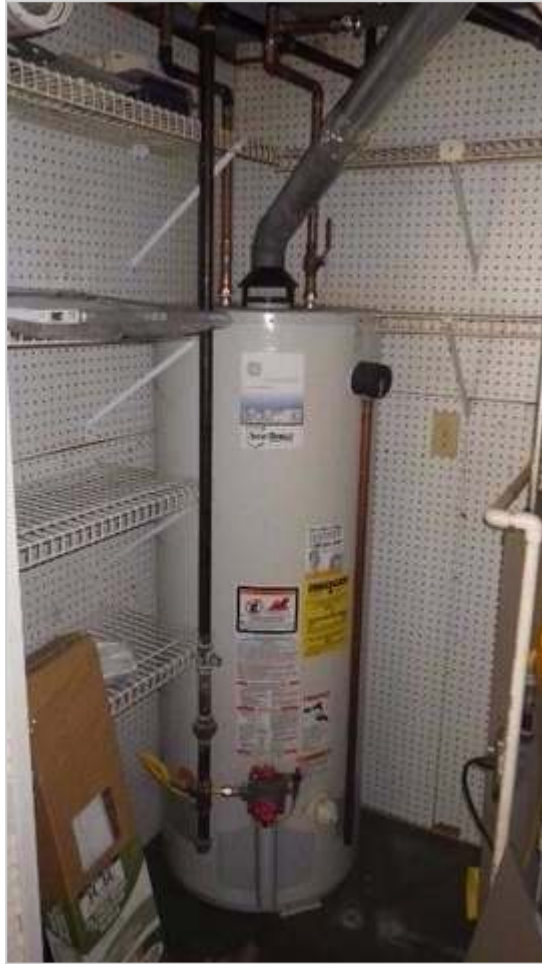
Figure Number 18

The gas-fueled water heater exhaust pipe was not secured with retaining screws at each joint in the pipe sections. Retaining screws should be installed to help prevent the exhaust vent pipe from being moved away from the vent opening which could allow combustion gases to seep into the living areas of the structure.

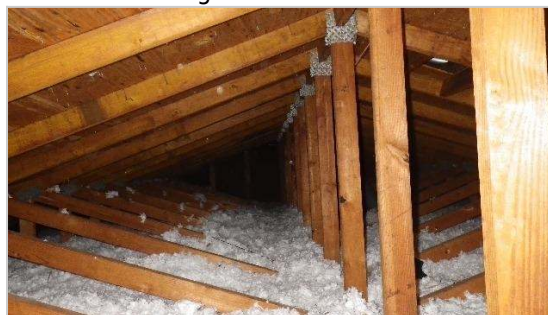
Figure Number 28

The hallway bathroom exhaust pipe and the microwave vent pipe were vented to the attic space. They should be properly vented to the exterior of the structure, which will help prevent moisture from accumulating in the attic space.

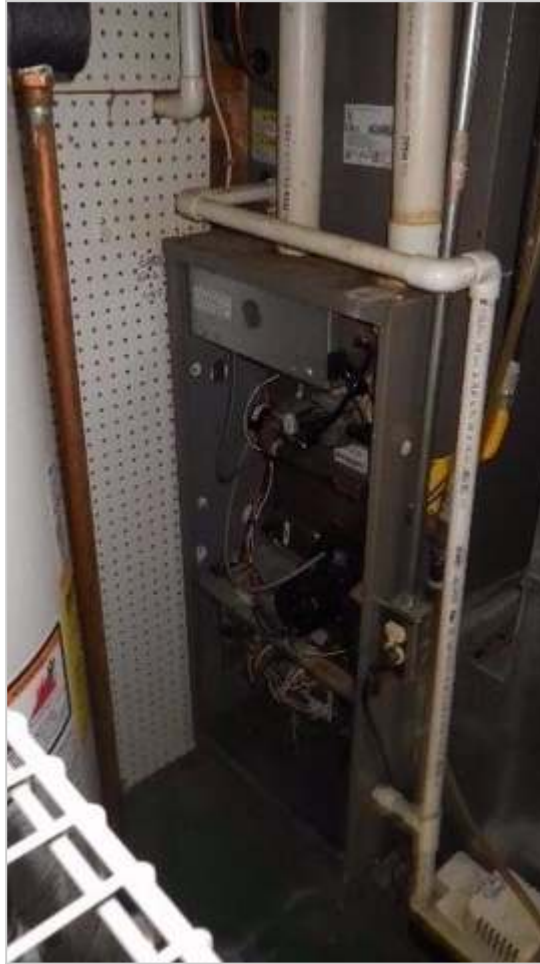
Figure Number 31

The heating system was functional at the time of the inspection.

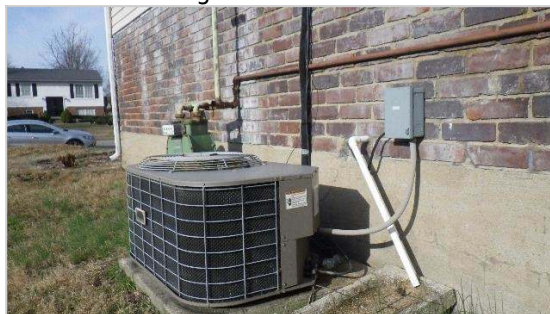
Figure Number 32

The cooling system was not tested for operation at the time of inspection due to the low outdoor temperature which was below 60 F.
