# HomeTeam<sup>®</sup>

### HOME INSPECTION REPORT

Thursday, December 5, 2019

**Bill Sample**  
**123 Sample Dr**  
**Anytown, KY 12345**  
**Reference Number: XX-XX-XX**

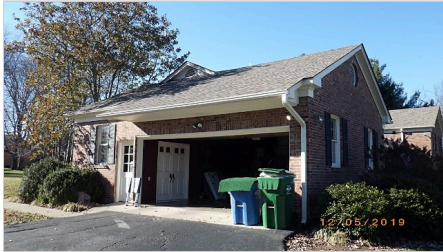
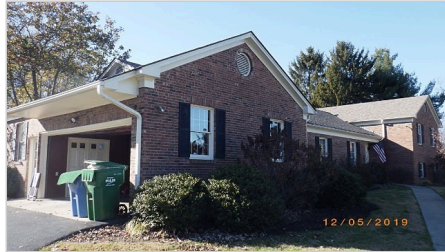
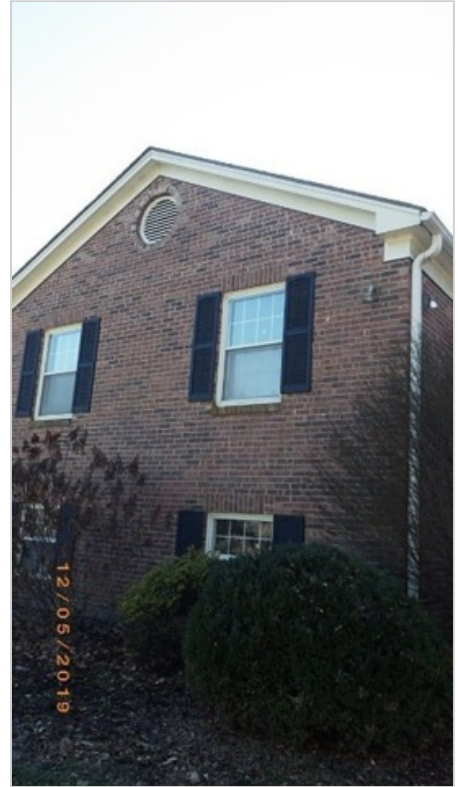
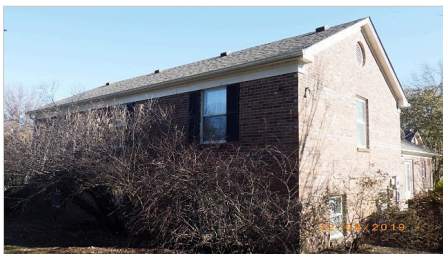
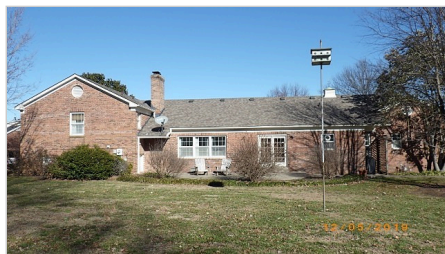
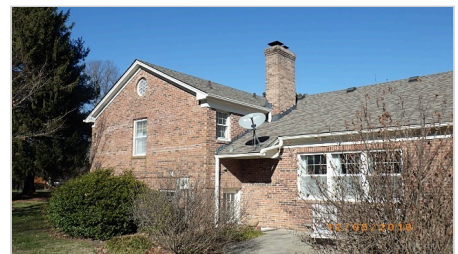
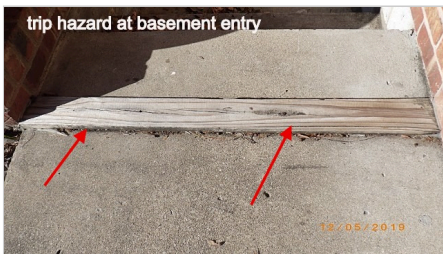
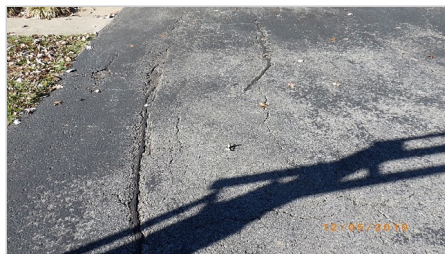
There was pitting and cracking at sections of the asphalt driveway.

*common for driveways and any horizontal masonry surfaces. Any cracks or separations in these types of surfaces should be caulked or sealed to help prevent water from entering the opening and freezing in the winter season, which may cause additional cracking, separations and or expansion.*

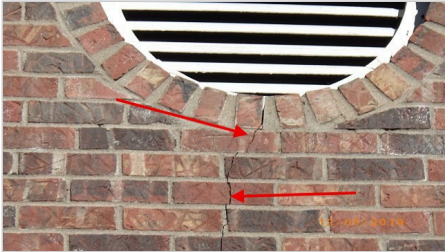
**Photo# 10**

There were brick and mortar separation-type cracks observed at the brick veneer. All cracks in the masonry should be sealed to help prevent further cracking from the freezing and thawing effects of ice.

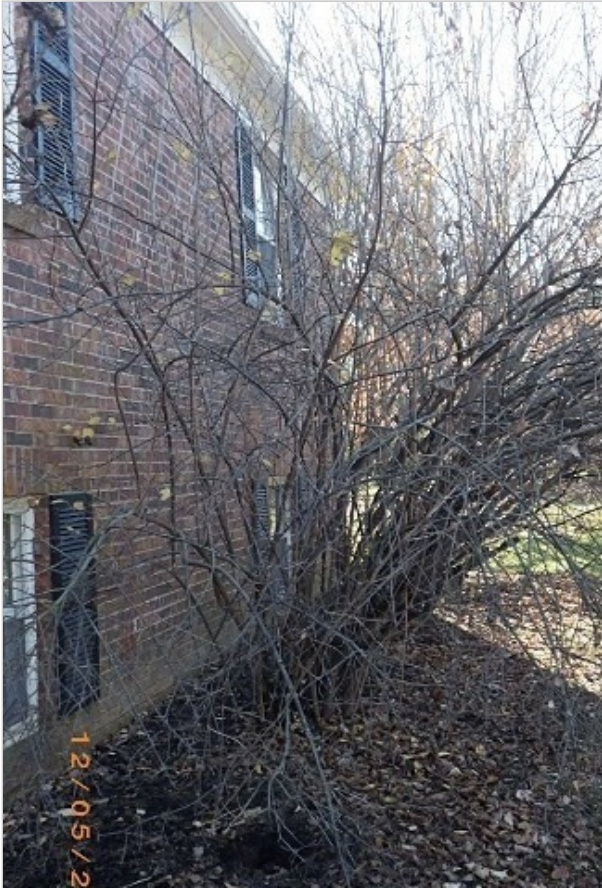
Photo# 13

Excessive vegetation was contacting and/or close to the structure. The vegetation may damage the structure and cause water retention at the foundation and should be trimmed or removed.

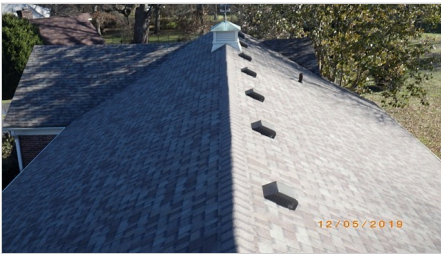
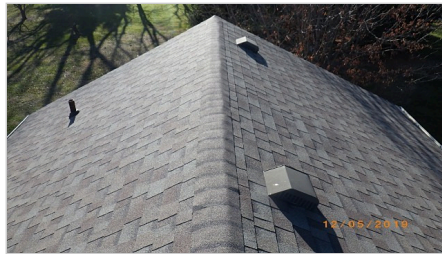
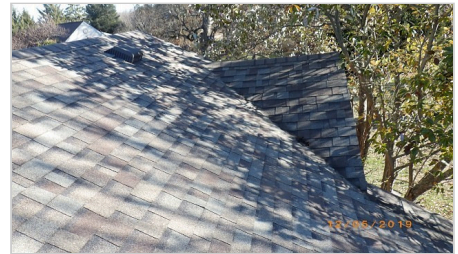
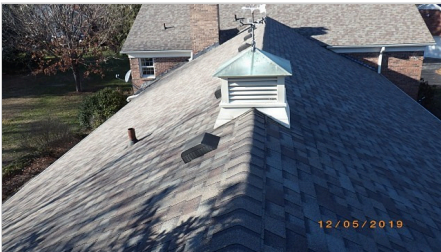
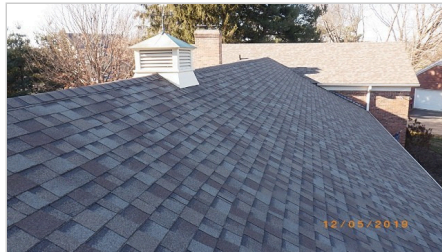
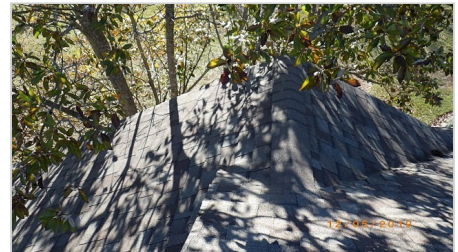
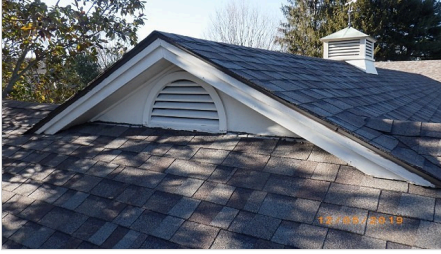
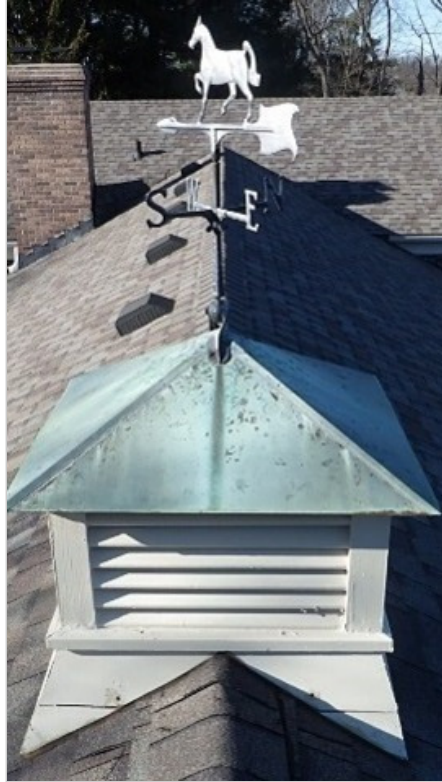
The metal step and counter flashing components (all around the roof surface) where the shingles contacted the vertical walls were not adequately sealed. The flashing had open gaps in the caulking or had pulled away from the wall. Repair or replacement should be made to help prevent water penetration into the structure.

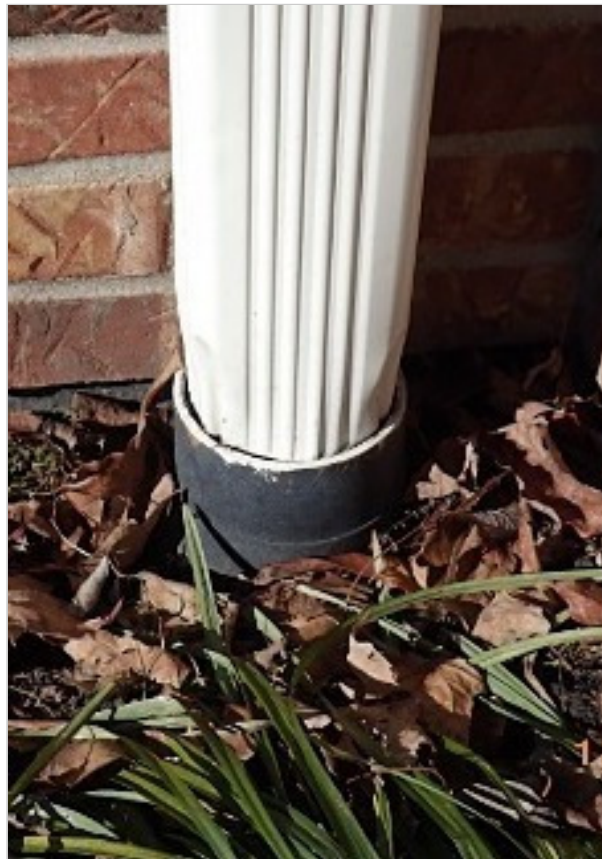
**Photo# 29**

Some of the gutter downspouts were connected to under-ground drainage pipes. The adequacy and capacity of the drainage pipes were not part of the inspection. After occupancy, please determine the exit point of the drainage pipes.

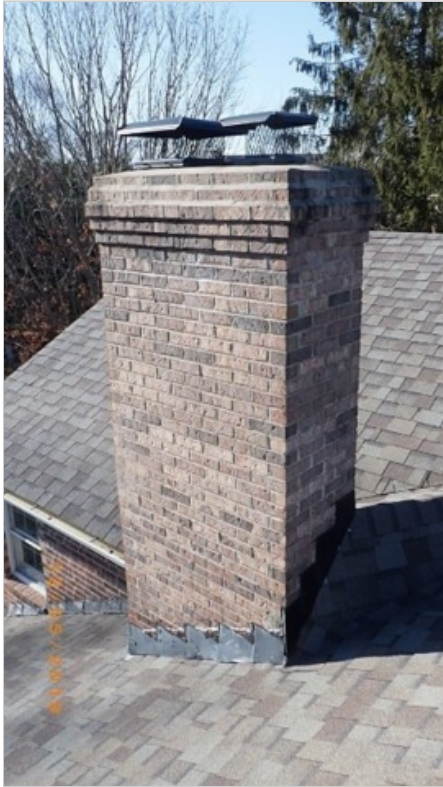
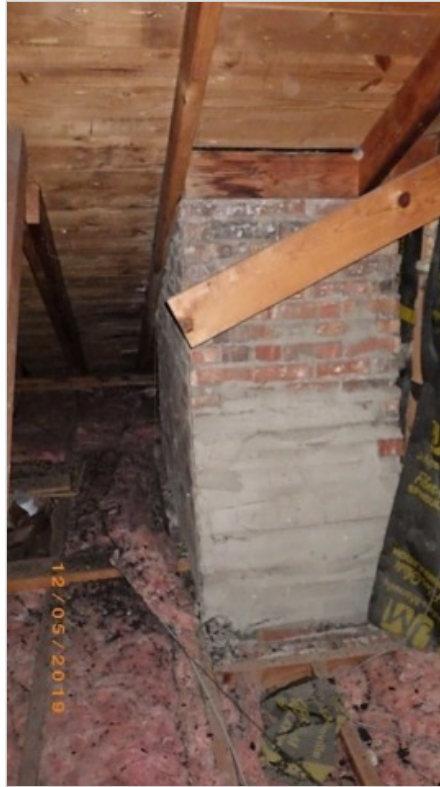
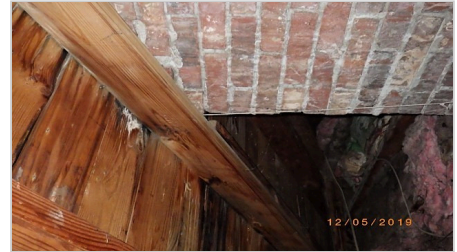
The metal flashing at the base of the chimney structure had pulled away from the chimney structure and was not adequately caulked. The flashing should be repaired or replaced as necessary to help prevent water penetration into the structure.

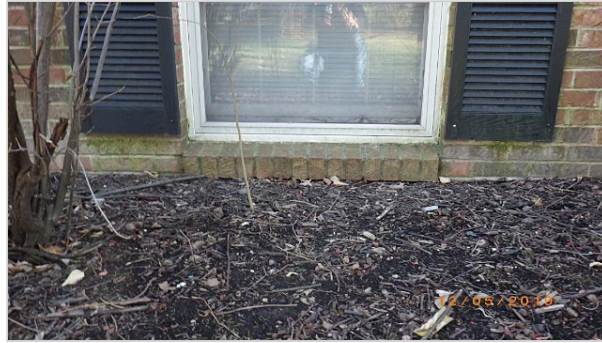
**Photo# 41**

**The soil at the perimeter of the foundation should be graded to a gentle slope, falling away from the foundation, in order to properly drain the ground surface water away from the structure. The slope should be about six-inches of vertical fall for every ten-feet of horizontal distance.**

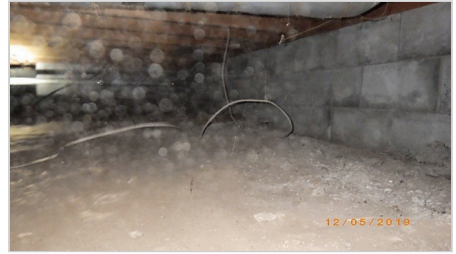
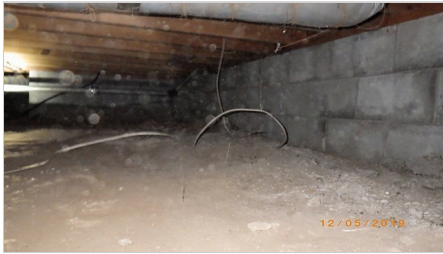
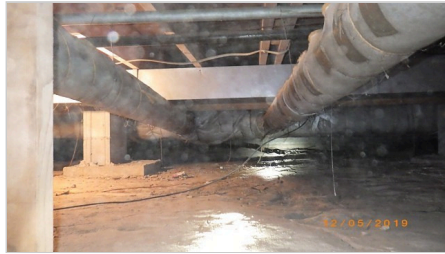
The crawl space did not appear to be adequately ventilated. The purpose of properly placed ventilators is to help to dissipate natural ground moisture through adequate airflow.

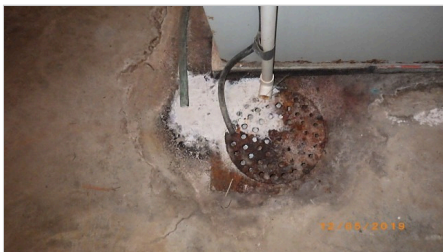
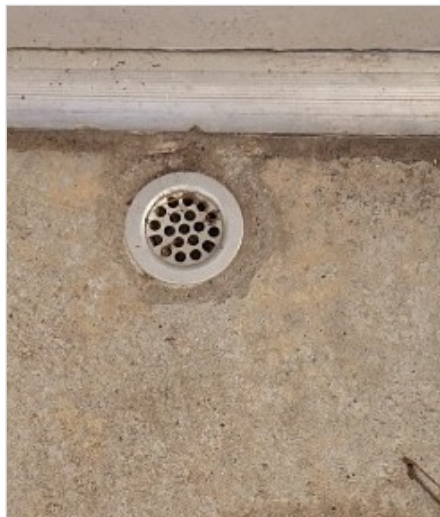
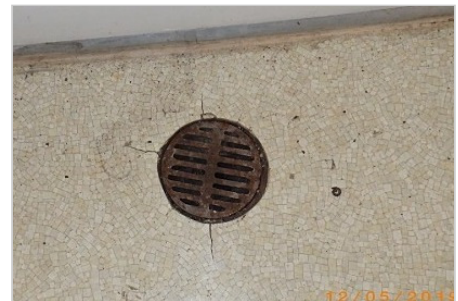
A floor drain was installed at the basement and at the exterior of the basement entry door of the structure. The function and adequacy of the floor drain was not checked. Please test the drain for proper operation upon taking possession of the structure. Floor drain outlets may backup and/or overflow at times of heavy rains or snow melts and should be monitored for continued and safe operation.

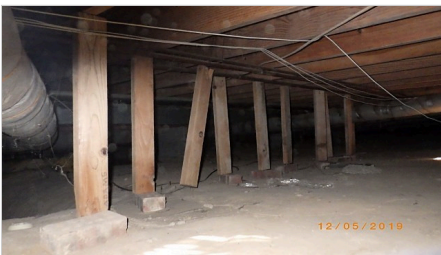
**Photo# 57**

The floor structure had been supported with additional vertical 2 x 4- inch boards under the family room and maybe the kitchen area. The purpose of the supports appeared to be bouncing floors. Footers were not installed under the supports. The supported area should be monitored for any structural movement and a reliable building contractor should be consulted for further analysis.

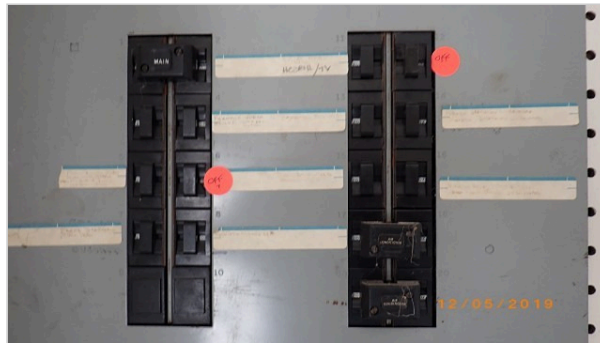
There were circuit breakers in the main electrical service panel that had two attached circuits (double wired). Each circuit should have its own dedicated breaker to prevent nuisance tripping and good terminal contact. One of the wires should be removed and connected to its own appropriately sized breaker by a licensed electrician.

- 1. There were circuit breakers in the main electrical service panel that had two attached circuits (double wired)  
Photo# 68

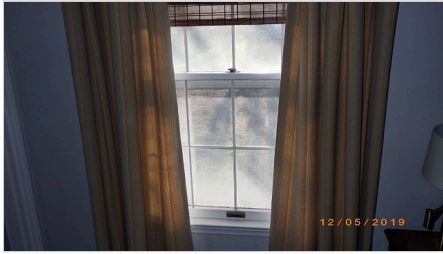
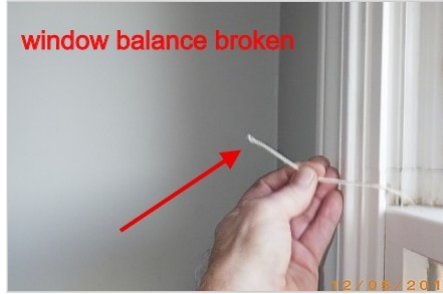
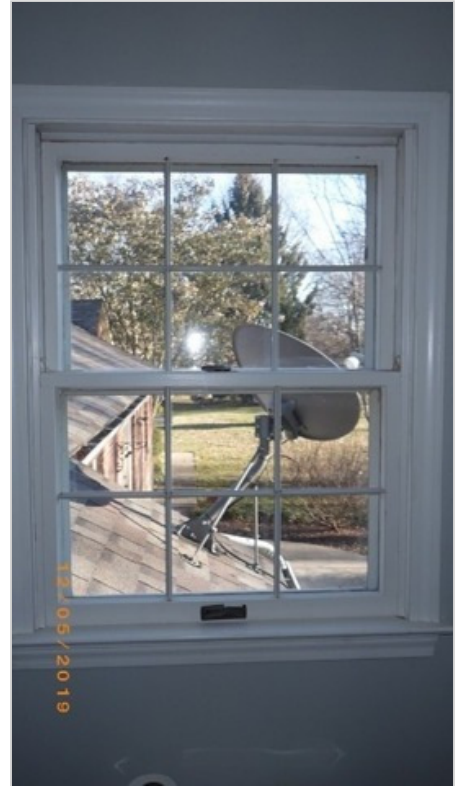
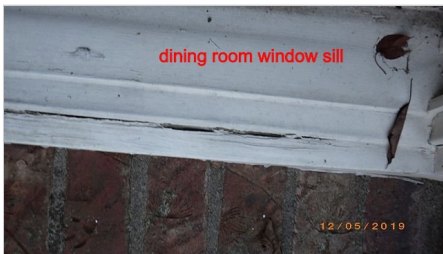
The ANDERSEN windows were in good condition, however, some of the windows were in need of cleaning, caulking and general maintenance. Some of the windows did not have storm windows attached. Some of windows had broken balances. Please contact the ANDERSEN window representative for further information and/or analysis of the windows.

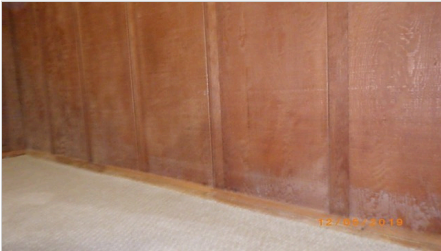
**Photo# 75**

The inspection of the interior wall of the basement was limited due to the wooden type paneling covering the walls. There were indications of water intrusion present on the paneling due to the negative grade of the soil surrounding the foundation.. It is suggested to remove the paneling and replace the damaged components (if any). Wooden components should not come in contact with the foundation wall and an adequate air space should e maintained between the foundation wall and the stud wall (air must be able to circulate).

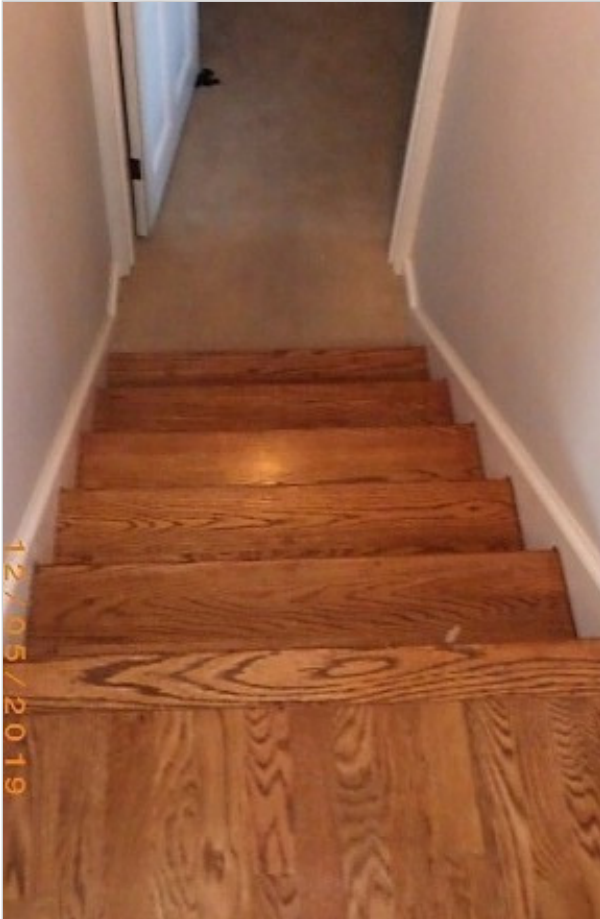
**Photo# 80**

The safety railing at the first level to the basement and at the exterior basement entry were not installed. For your safety, adequate railing should be installed.

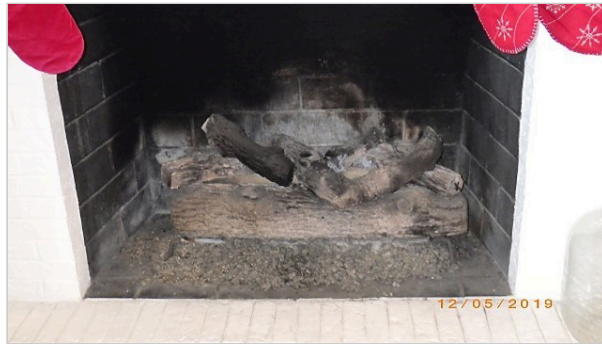
**Photo# 82**

There was a gas-fueled log equipped masonry fireplace located in the family room. The damper was damaged and was not functional appear to be functional. There was visual evidence of a creosote buildup in the firebox. There were no cracks observed in the firebox.

The masonry fireplace damper was not fully operable and there was an excessive amount of creosote in the firebox and flue. The masonry fireplace should be inspected by a qualified chimney sweep and make any necessary repairs.

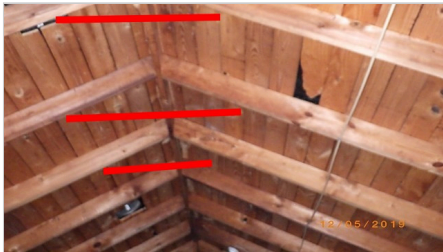
**Photo# 88**

The lower roof structure collar tie components were not installed. The collar ties act to "tie" the rafters to the ridge board and help in preventing the roof structure from spreading at the base where it meets the vertical wall. An adequate number of collar ties should be installed.

A couple of roof sheathing board were damaged and should be repaired to help prevent someone stepping through the shingles.

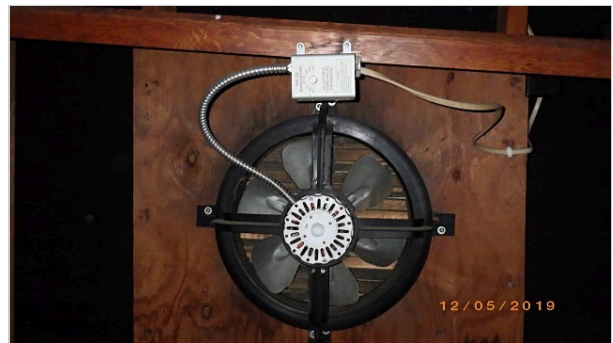
**Photo# 103**

The 2 electric powered attic ventilation fans in the attic space were not functional and should be repaired or replaced.

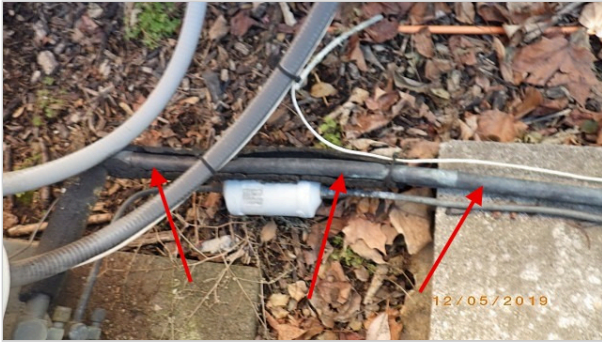
**Photo# 106**

The HVAC refrigerant line was missing some of the insulation at the exterior unit. At the interior, the insulation helps keep it from sweating; at the exterior, the insulation helps retain hot or cold liquid. Repair should be made and completely covered with insulation.

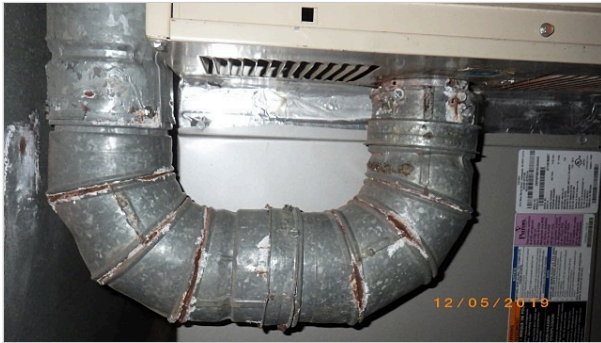
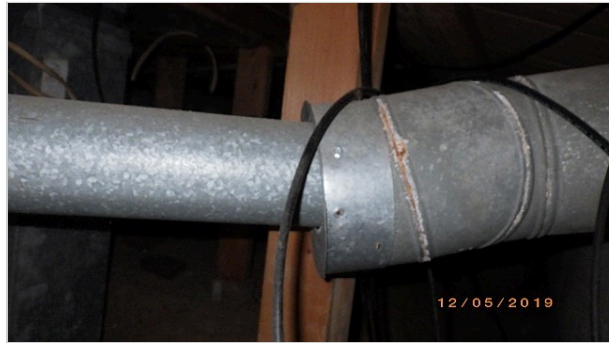
The first level gas-fueled furnace exhaust pipe was rusting. Holes in the exhaust vent pipe may cause combustion

gases to seep into the living areas of the structure. The rusting pipe should be monitored and repaired or replaced as necessary.

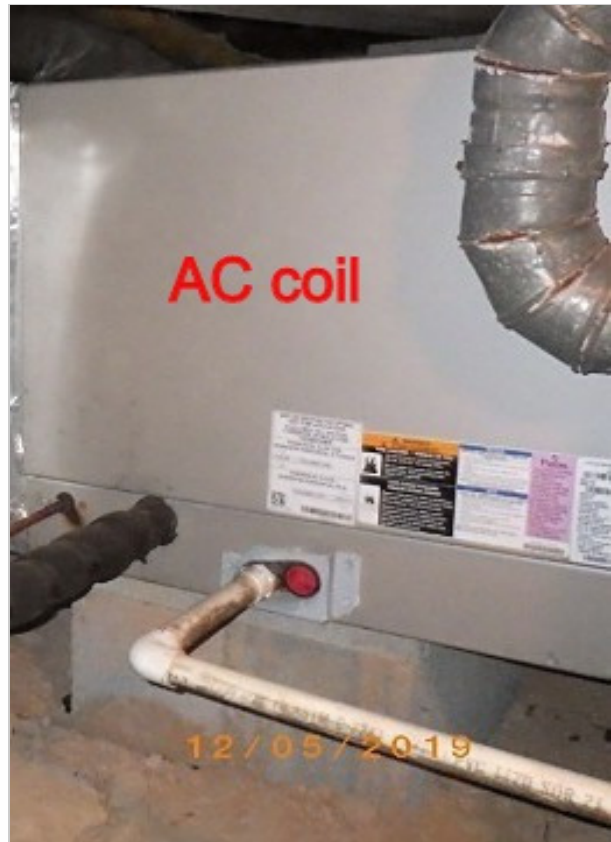
**Photo# 114**

The first level condensate line was not properly sloped for adequate drainage.

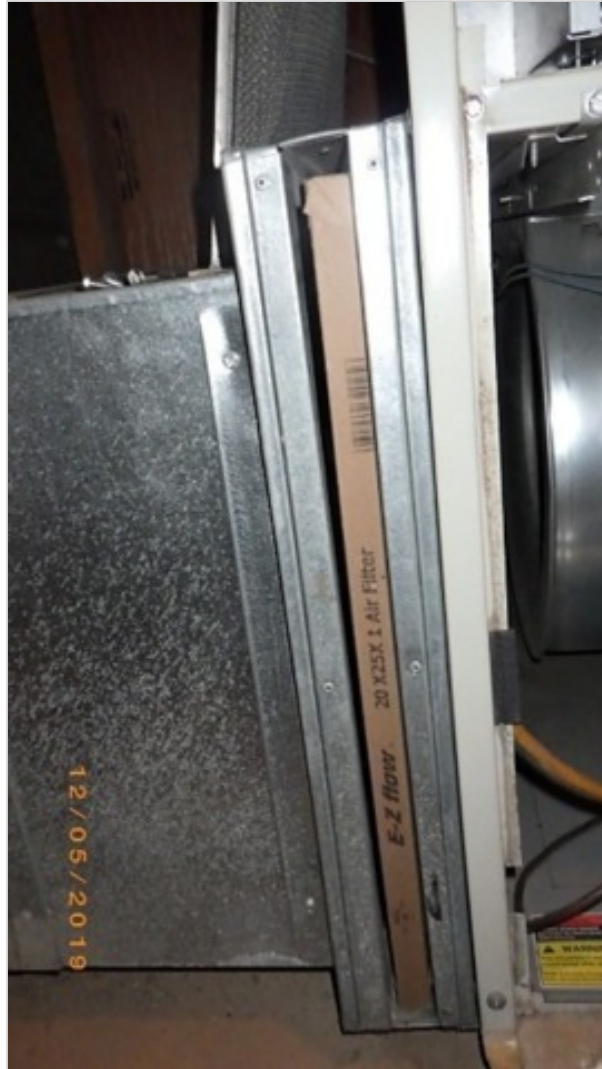
**Photo# 116**

The second level filter compartment door at the HVAC coil/air-handler unit in the basement was not installed. A roll of duct tape should be kept near the unit and used to seal the compartment to help prevent un-filtered air from being distributed throughout the structure.

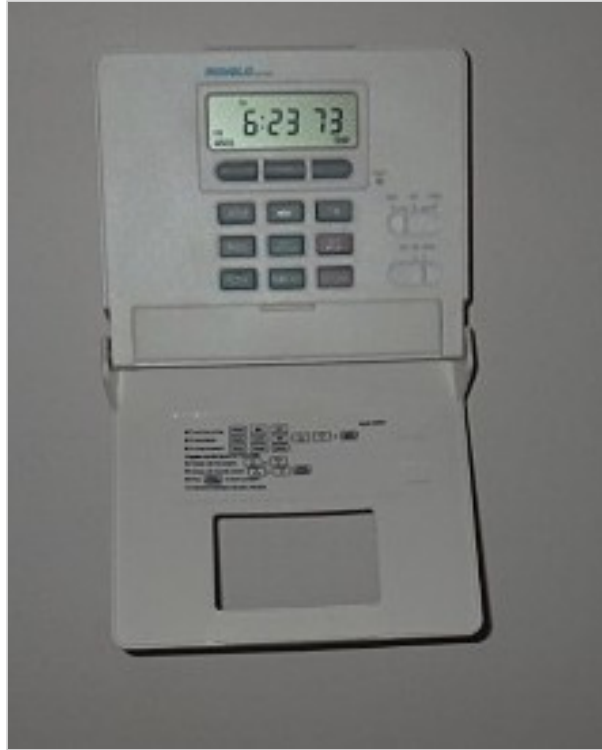
**Photo# 117**

The second level HVAC thermostat display would dim when using the controls. Repair or replace.

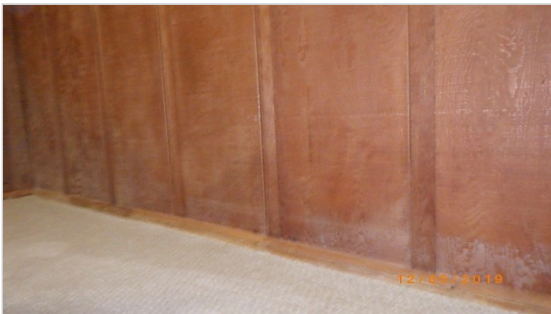
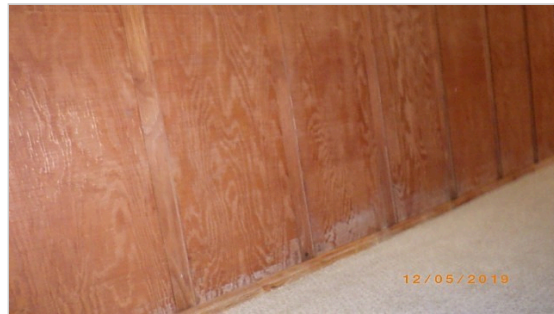
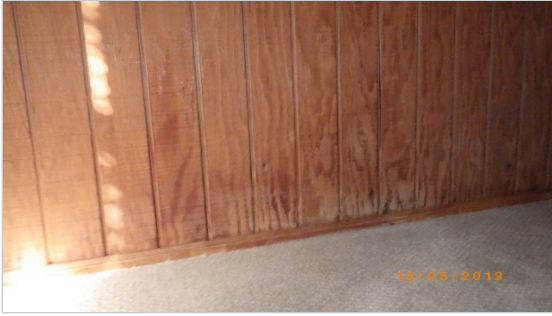
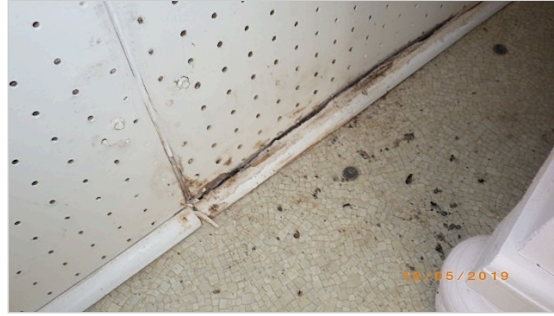
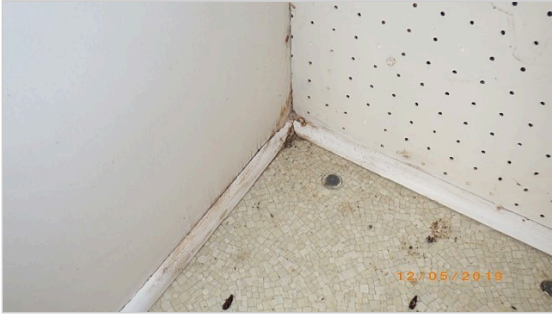
2. The inspection of the interior wall of the basement was limited due to the wooden type paneling covering the walls. There were indications of water intrusion present on the paneling due to the negative grade of the soil surrounding the foundation.. It is suggested to remove the paneling and replace the damaged components (if any). Wooden components should not come in contact with the foundation wall and an adequate air space should e maintained between the foundation wall and the stud wall (air must be able to circulate).

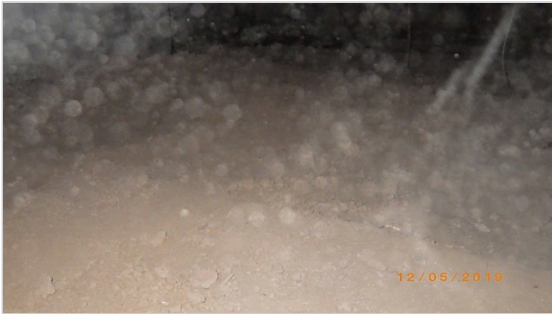
Photo# 47

- 1. The crawl space did not have a vapor barrier (usually a 6-mil plastic material) covering the majority of the ground in the crawl space.

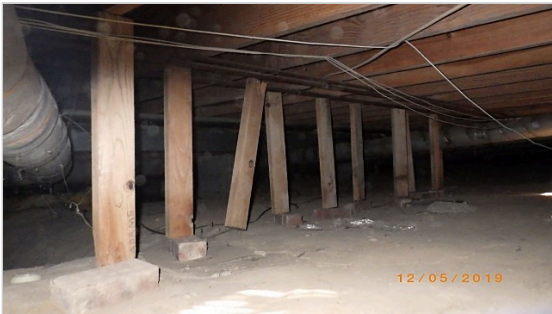
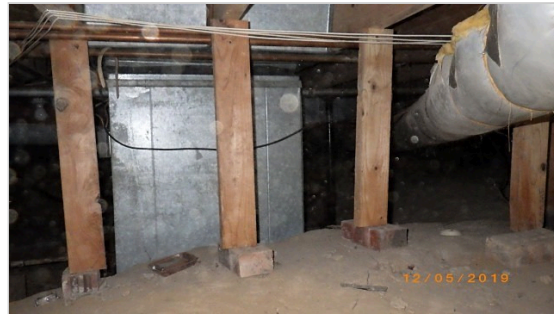
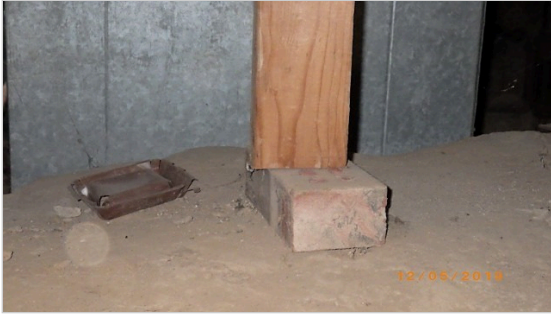
- 2. The floor structure had been supported with additional vertical 2 x 4- inch boards under the family room and maybe the kitchen area. The purpose of the supports appeared to be bouncing floors. Footers were not installed under the supports. The supported area should be monitored for any structural movement and a reliable building contractor should be consulted for further analysis.

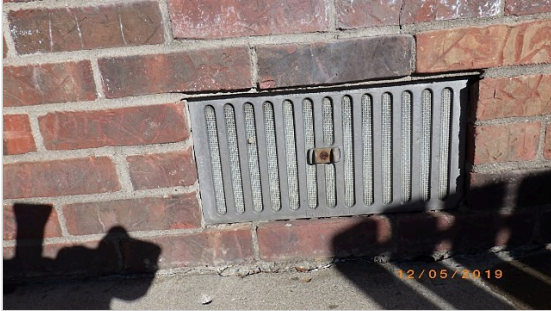
Photo# 48

3. Some of the crawl space ventilators were closed or blocked closed. Crawl space ventilators should remain fully open at all times.

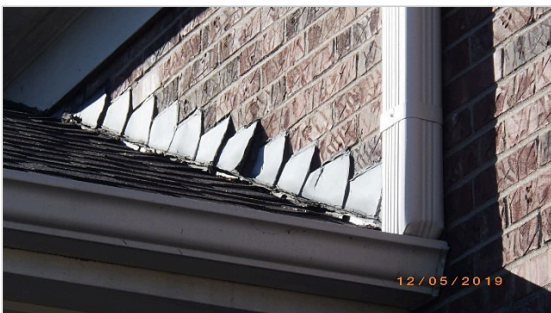
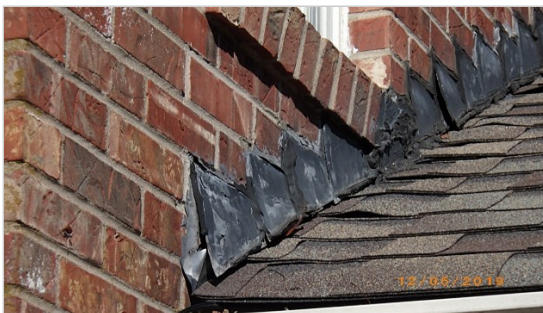
2. The metal step and counter flashing components (all around the roof surface) where the shingles contacted the vertical walls were not adequately sealed. The flashing had open gaps in the caulking or had pulled away from the wall. Repair or replacement should be made to help prevent water penetration into the structure.

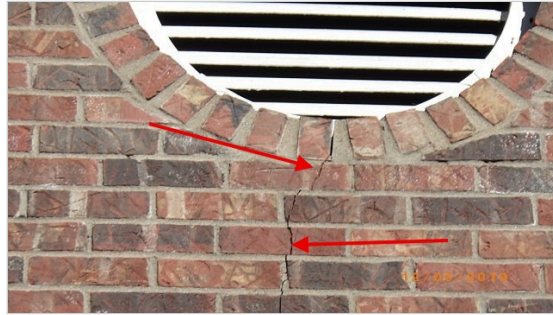
Photo# 11

1. There were brick and mortar separation-type cracks observed at the brick veneer.

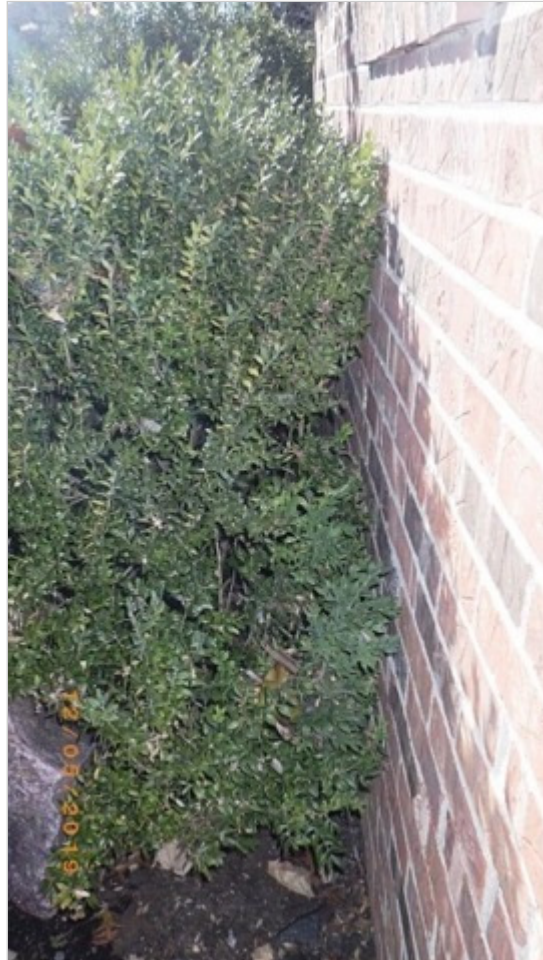
Photo# 13

2. Excessive vegetation was contacting the structure.

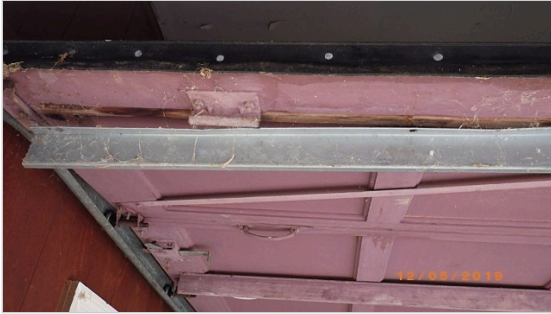
1. The garage door was functional at the time of the inspection, however, a support on the bottom panel was damaged. Please repair or replace as necessary.

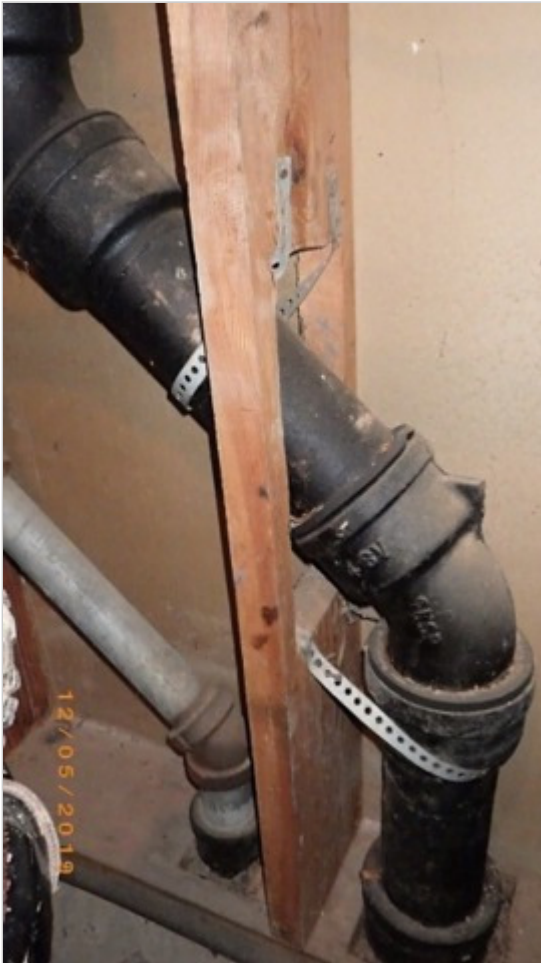
2. Main sewer line clean out at the front yard. Check with the sellers or a licensed plumber on information on the age and/or condition of the main sewer line.

1. Cast iron plumbing was installed in the structure. It has a tendency to crack after it ages and these cracks are not usually visually observable. A licensed plumber should be consulted before closing to fully inspect and electronically scope the plumbing system for damage, or other concerns.

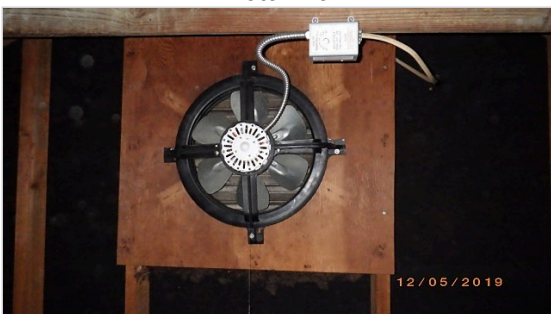
Photo# 103

- 1. The 2 electric powered attic ventilation fans in the attic space were not functional and should be repaired or replaced.

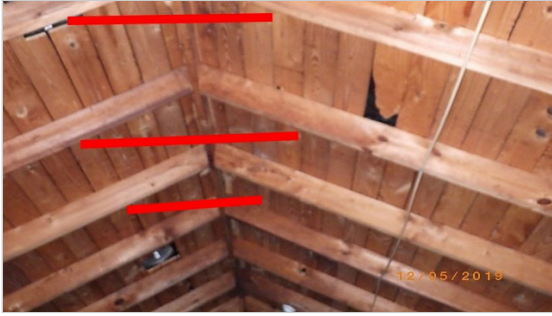
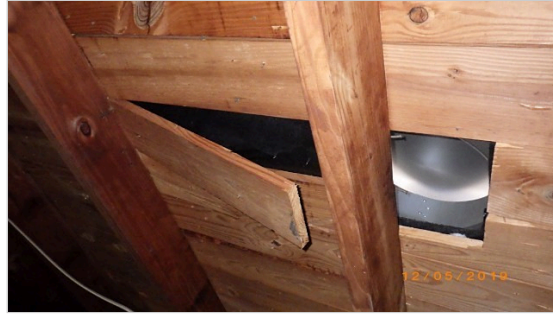
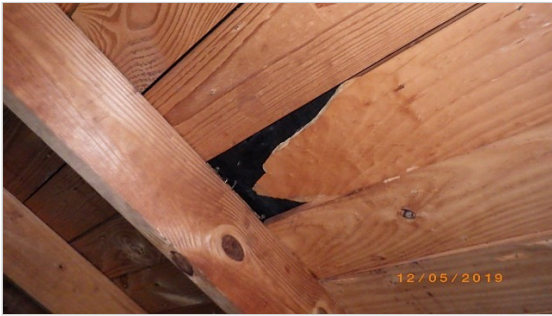
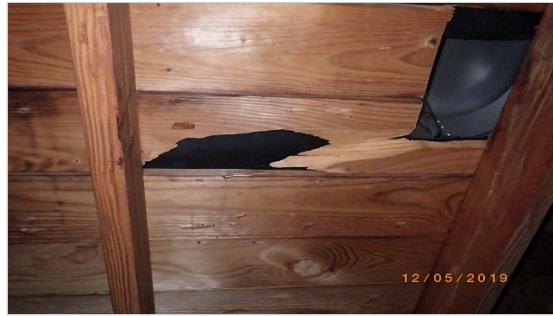
- 2. The lower roof structure collar tie components were not installed. The collar ties act to "tie" the rafters to the

ridge board and help in preventing the roof structure from spreading at the base where it meets the vertical wall. An adequate number of collar ties should be installed. A couple of roof sheathing board were damaged and should be repaired to help prevent someone stepping through the shingles.

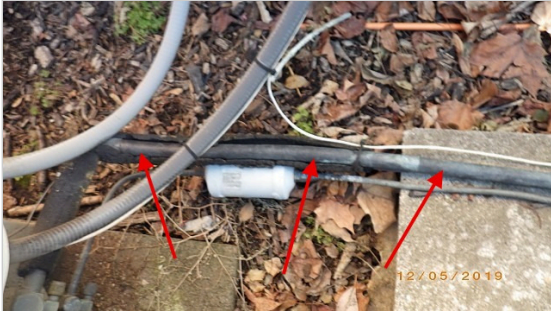
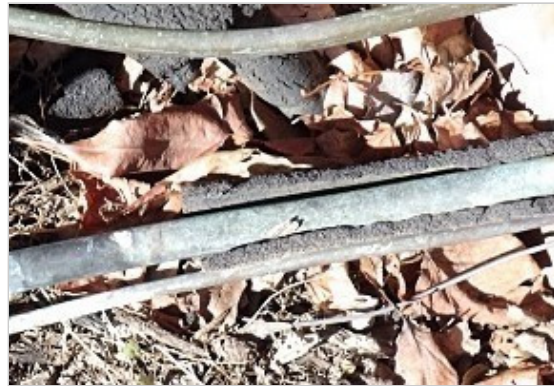
1. The first and second level heating systems were functional at the time of the inspection, but had exceeded their average normal operating life and should be monitored for continued operation. The second level cooling system was not tested for operation due to the low outdoor temperature which was below 60 F. It had also exceeded its average normal operating life and should be monitored for continued operation.
2. The first level condensate line was not properly sloped for adequate drainage.
3. The HVAC refrigerant line was missing some of the insulation at the exterior unit.

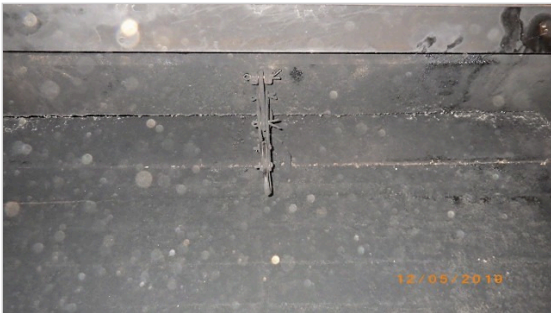
Photo# 83

1. There did not appear to be a sufficient amount of GFCI receptacles installed throughout the structure. Install as considered necessary.
2. There did not appear to be a sufficient amount of smoke alarms installed throughout the structure. It is recommended to install more smoke alarms for safety.
3. The masonry fireplace damper was not fully operable and there was an excessive amount of creosote in the firebox and flue. The masonry fireplace should be inspected by a qualified chimney sweep and make any necessary repairs.

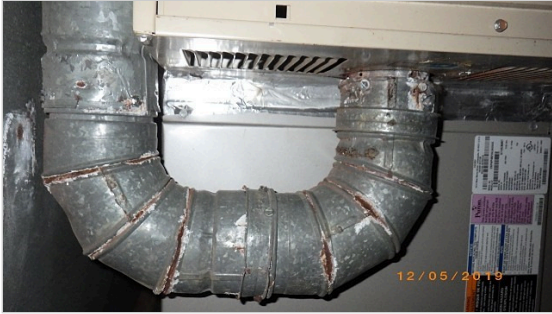
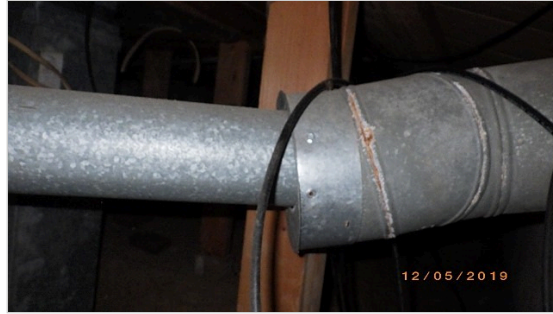
4. The first level gas-fueled furnace exhaust pipe was rusting. Holes in the exhaust vent pipe may cause combustion gases to seep into the living areas of the structure. The rusting pipe should be monitored and repaired or replaced as necessary.

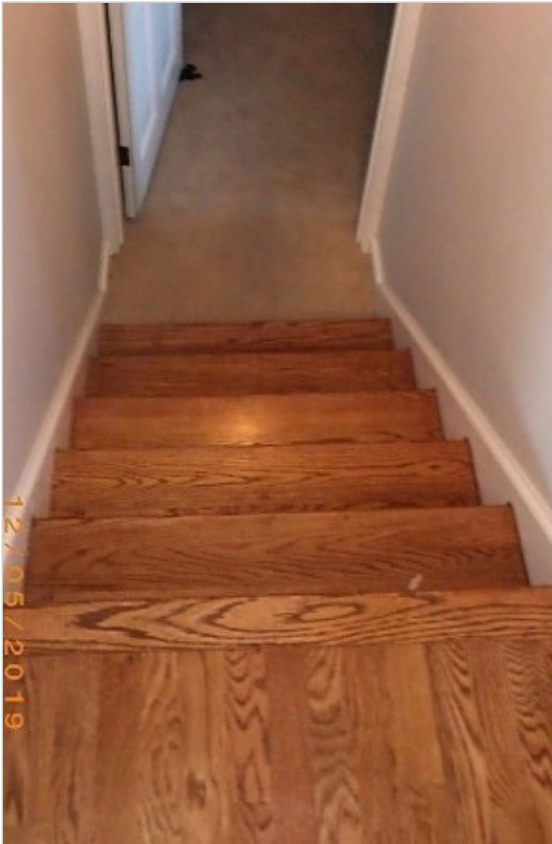
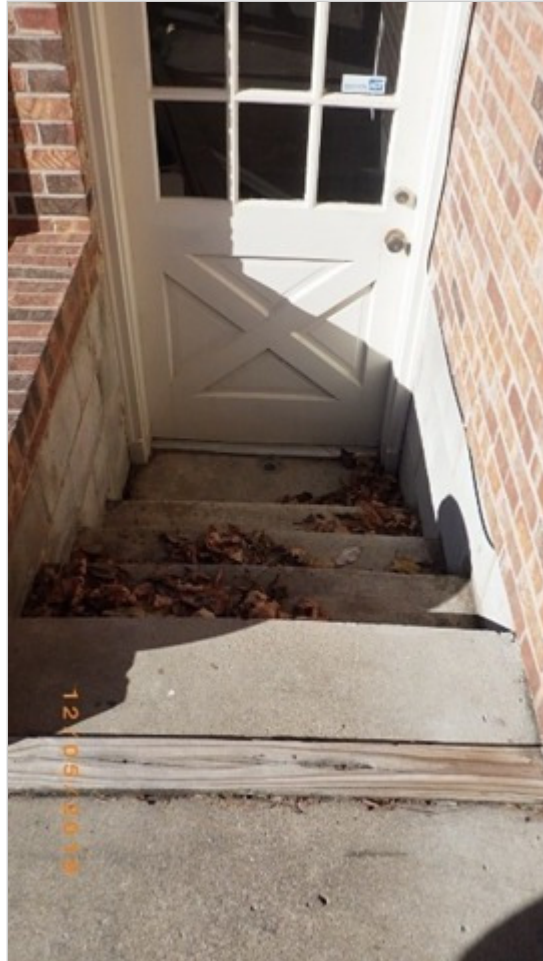
5. The safety railing at the first level to the basement and at the exterior basement entry were not installed. For your safety, adequate railing should be installed.
