HOME INSPECTION REPORT

On Sunday, August 28, 2022 The HomeTeam Inspection Service made a visual inspection of 123 Sample Street, City, ST 12345. On the following pages please find a written, narrative report of our findings in accordance with the terms of our Inspection Agreement.

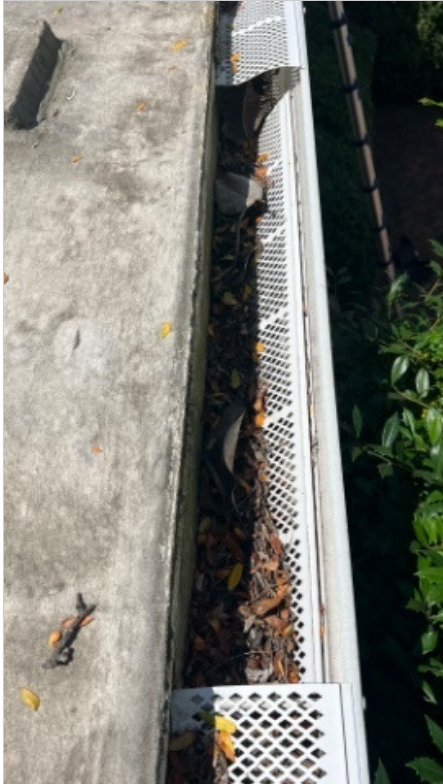
Photo# 24

Some sections of the gutters were slightly damaged and/or not securely attached to the structure. The damaged components should be repaired or replaced as necessary to help provide adequate drainage of the roof surface water away from the structure.

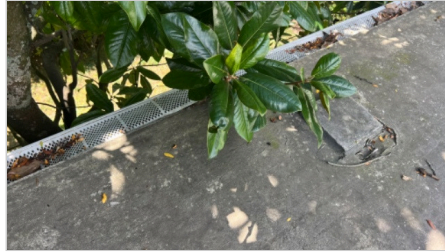
Photo# 25

The downspouts were directing roof surface water toward the foundation and the walkway. They should be extended farther away to help prevent erosion and water penetration.

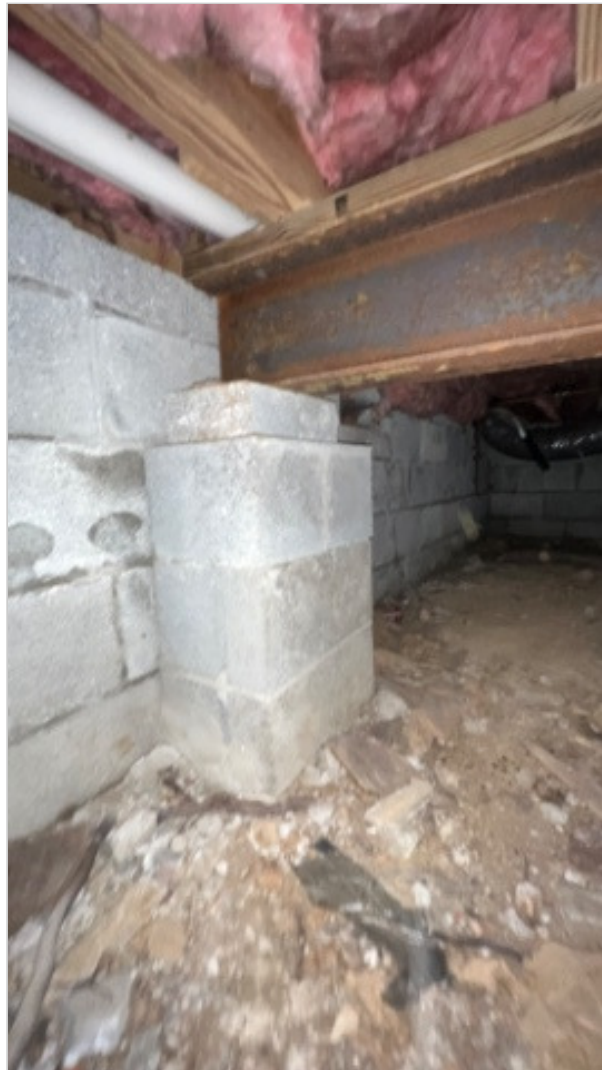
Photo# 44

There were no major visual defects observed on the visible portions of the floor structure components.

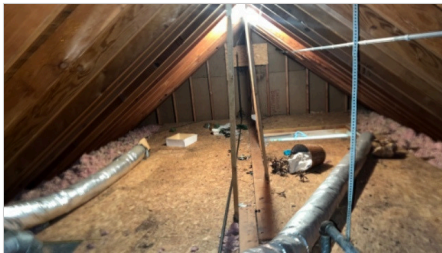
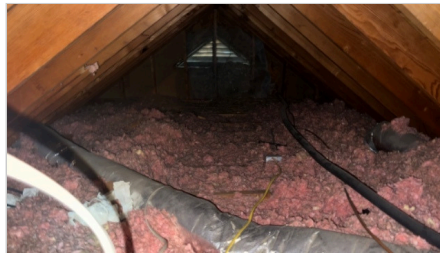
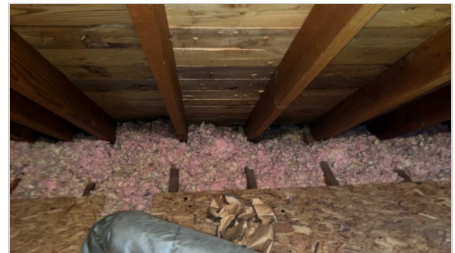
There did not appear to be adequate ventilation at the attic space, which may be significantly deficient. The back gable vent was blocked and there were no soffit vents. It is recommended to provide ventilation to the attic space to help maintain the longevity of the roofing structure and roofing shingles. 3- electric powered attic vents should be installed with a thermostat and a humidistat. (approx cost \$500 each installed).

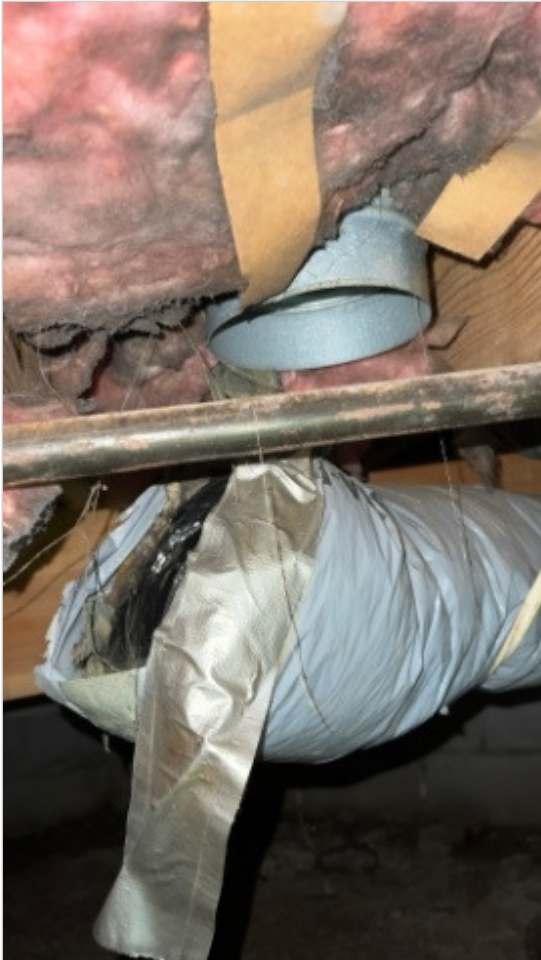
Photo# 65

2. A section of HVAC duct was unattached and the main trunk line was damaged at the master area crawl space.

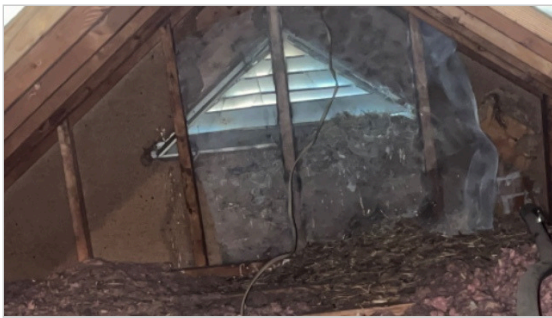
Photo# 63

1. There did not appear to be adequate ventilation at the attic space, which may be significantly deficient. The back gable vent was blocked and there were no soffit vents. It is recommended to provide ventilation to the attic space to help maintain the longevity of the roofing structure and roofing shingles. 3- electric powered attic vents should be installed with a thermostat and a humidistat. (approx cost \$500 each installed).
