### *HOME INSPECTION REPORT*

The inspected property consisted of a ranch wood-framed structure with plywood siding / cladding that was occupied at the time of the inspection. Minor, exterior type caulking and maintenance, painting are common on most homes and may be present but may or may not be specifically identified in this report. The approximate temperature at the time of the inspection was 70-75 degrees Fahrenheit, and the weather was sunny and clear. The utilities were on at the time of the inspection. The buyer was present during the inspection. The home was situated on a lightly sloped lot. The general grade around the home appeared to be mostly adequate to direct rain water away from the foundation. The age of the home, as reported by the building permits was said to be 37 years old.

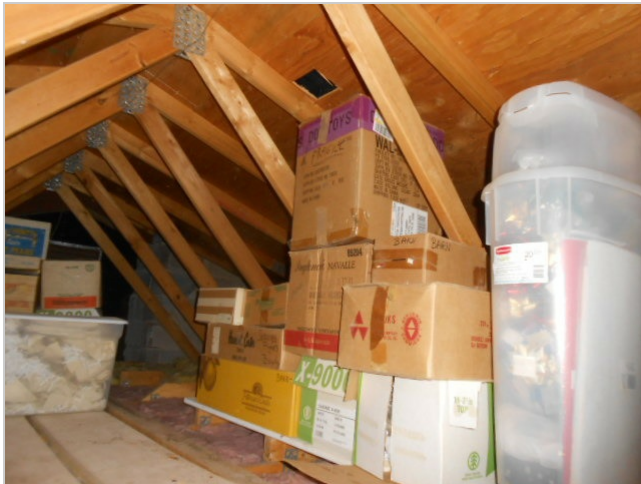
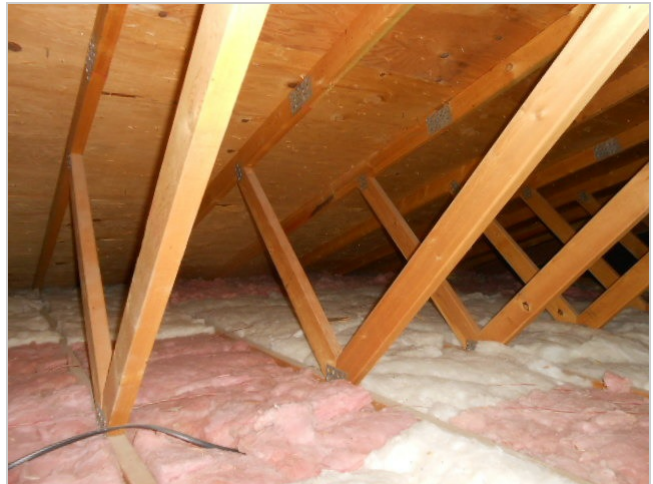
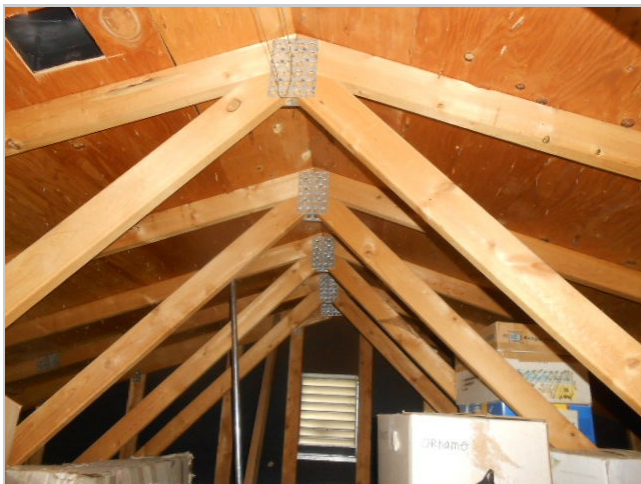
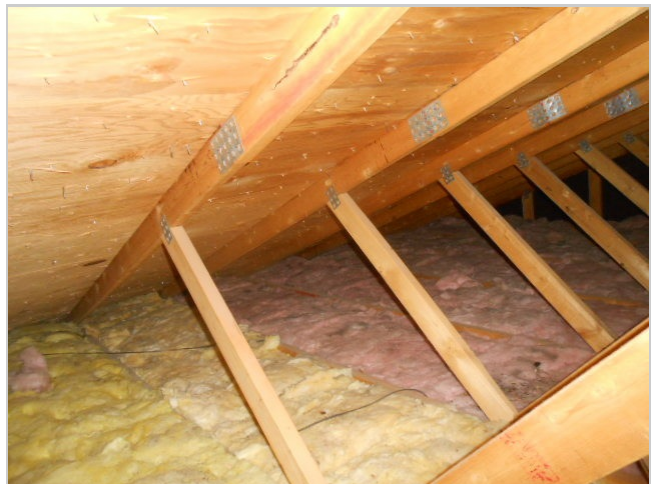
The attic was accessed through a scuttle in the garage and hallway. The attic above the living space was insulated with batted fiberglass insulation, approximately 6-inches in depth. Ventilation throughout the attic was provided by gable and roof vents.

The roof structure consisted of two-inch by four-inch wood trusses spaced 24 inches on center and plywood sheathing. Because of the configuration of the trusses and absence of any catwalk, which limited access, it was not possible to inspect all areas of the attic. There was no moisture visible in the attic space. There were no major visual defects observed in the attic or roof structure.
