HOME INSPECTION REPORT

Address of Inspection: **123 Sample Drive, Louisville, KY**

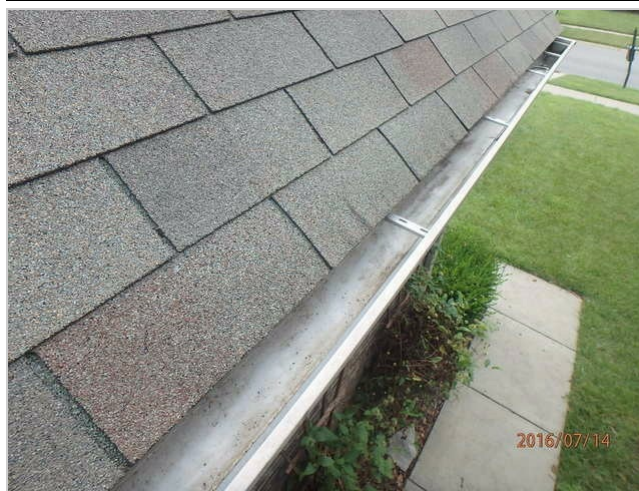
Photo 7

gutters

Several downspouts were draining at or too close to the base of the foundation. To reduce the likelihood of water problems at the base of the home, all roof drainage should be directed at least six feet from the base of the foundation.

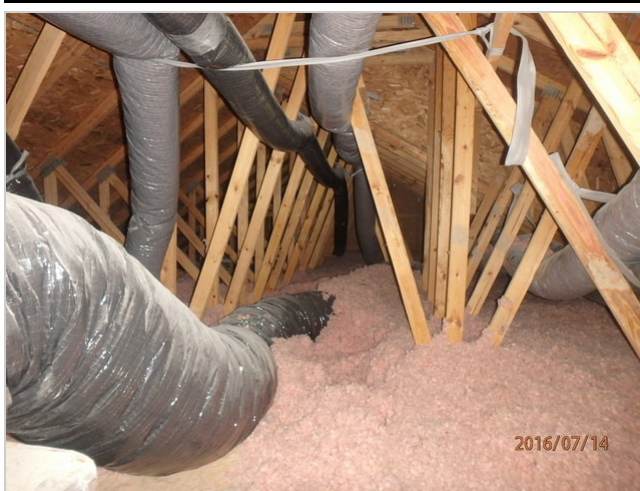
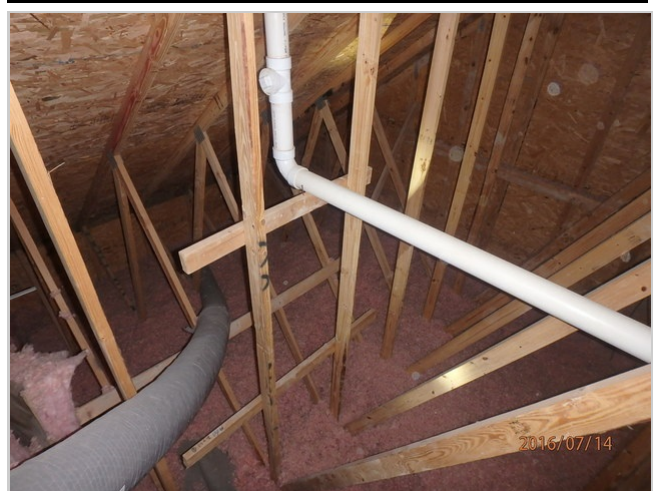
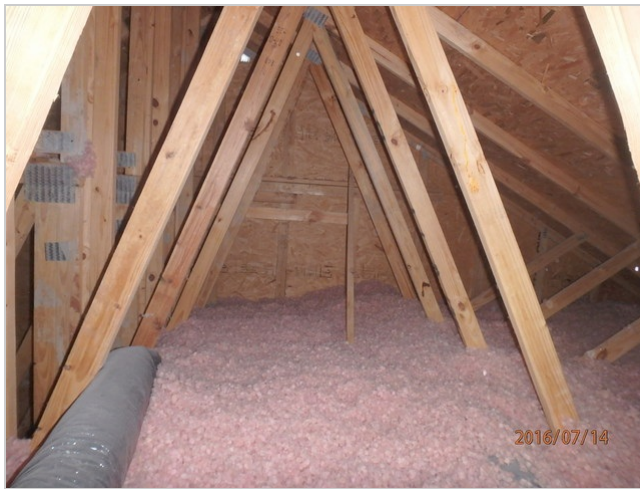
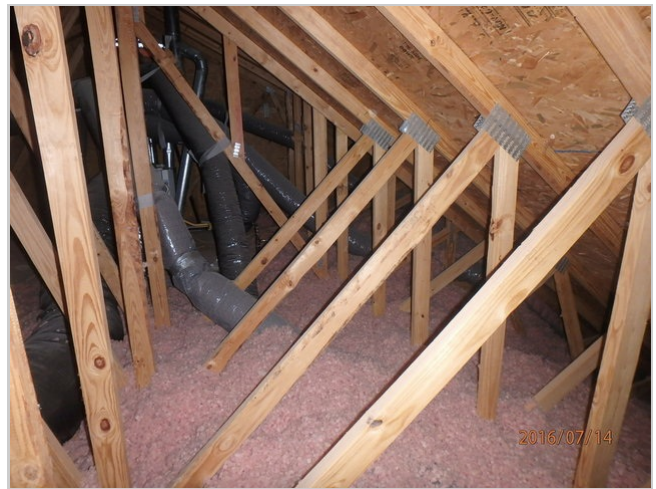
Parts of the attic show signs of previous water intrusion. The areas were dry at the time of the inspection. The buyer should maintain vigilance in monitoring the areas for any recurrence of the previous issue and should rectify any issues immediately upon observing them.

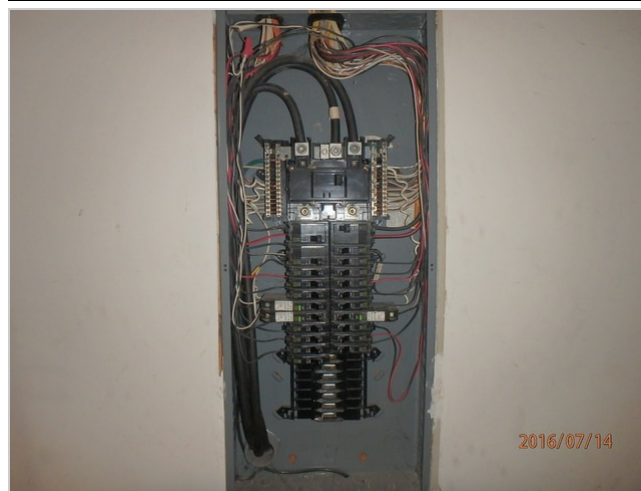
Photo 17

The electrical service appeared to be adequate. As a reminder, alarms, electronic keypads, remote control devices, landscape lighting, telephone and television wiring are beyond the scope of this inspection.

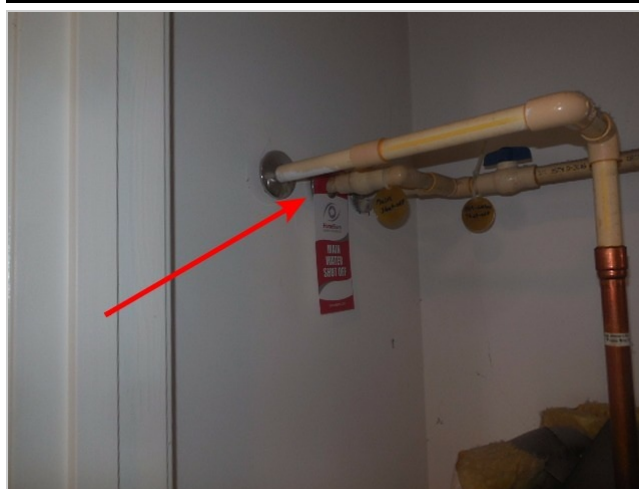
Photo 21

Main water shut off.

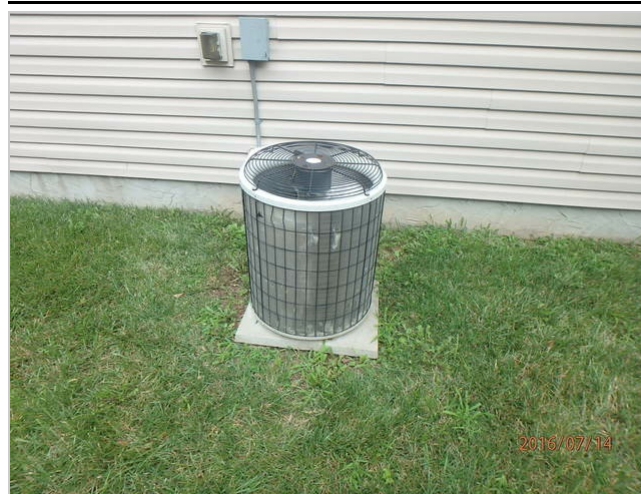
Photo 27

The electric outdoor air conditioner condensing unit was a Payne, Model Number PA10JA036C and Serial Number 4104E13255. The unit is located on the left side of the home. This unit is approximately 12 years old. Periodic preventive maintenance is recommended to keep this unit in good working condition, and HomeTeam strongly recommends partnering with a reputable HVAC company for routine maintenance for the heating and cooling systems in the fall and spring. The air conditioning system was tested and found to be functional. As a reminder, this is functionality test and visual inspection only; we do not check suction pressures, contactor amps, or refrigerant levels. If a more detailed inspection is required, please consult with an HVAC company.

The temperature split for the air conditioner was measured at several locations and was approximately 10 degrees F, which is normal.
