HOME INSPECTION REPORT

SAMPLE REPORT

Address of Inspection: **1234 Fifth Street**

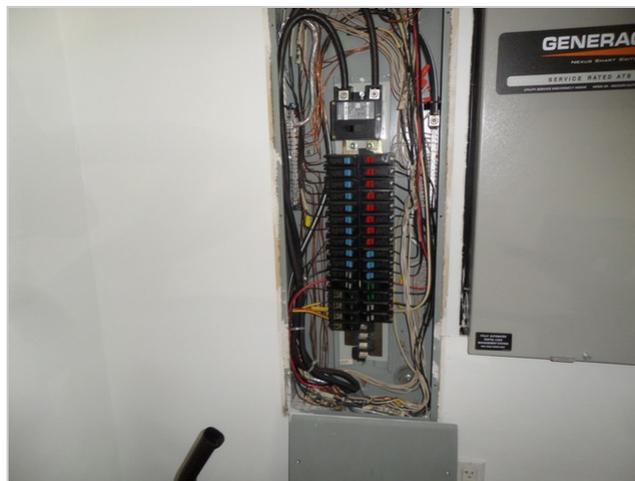
The service wire entered a Cutler Hammer service panel, located on the garage wall with a 200 amp and 120/240 volt rated capacity. The branch circuits within the panel were copper. These branch circuits and the circuit breakers to which they were attached appeared to be appropriately matched.

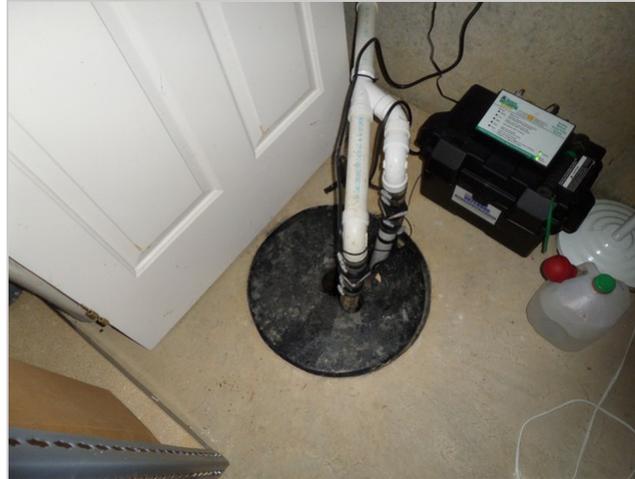
There was a sump pump located in the basement. The sump pump was functional. There was a battery backup system in the sump pit.

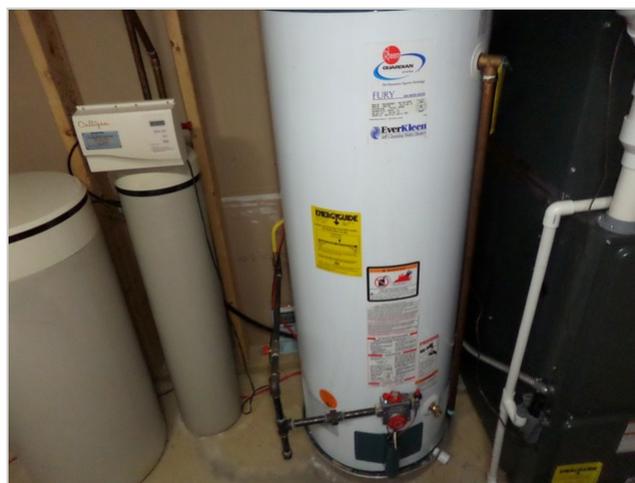
There was a lot of corrosion on the cold water supply line to the water heater. Recommend further evaluation by a qualified plumber.

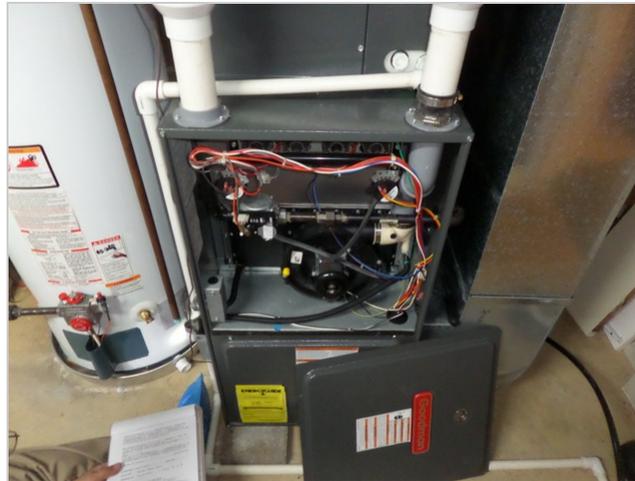
The home was heated by a Goodman natural gas forced air furnace, serial number 0611638294, model number GMH950904CXAVA which is 8 years old. The unit was located in the basement of the home. It has an approximate net heating capacity of 96,000 BTUH.

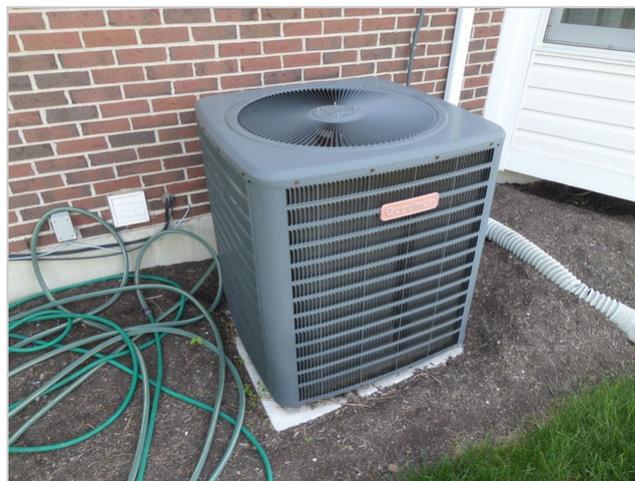
The electric outdoor air conditioner condensing unit was a Goodman, Model Number GSC140421AB and Serial Number 0702047626. The unit is located in the back of the home. This unit is approximately 7 years old. Periodic preventive maintenance is recommended to keep this unit in good working condition. The forced air cooling system was tested and found to be functional. The home inspection does not include a heat-gain analysis, cooling design or adequacy evaluation, energy efficiency assessment, installation compliance check or refrigerant evaluation.
