### HOME INSPECTION REPORT

Address of Inspection: **2113 Bates Way**

**2113 Bates Way  
Norman, OK 73071  
Inspection #: 01174098**

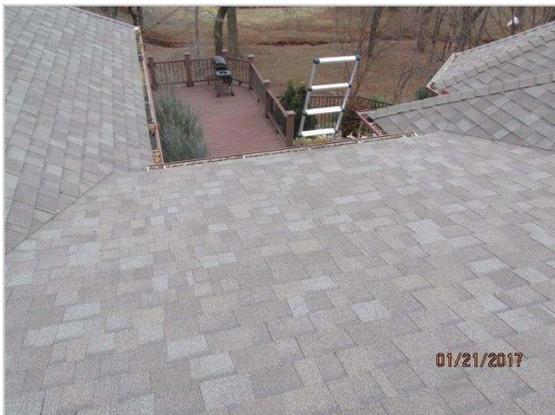
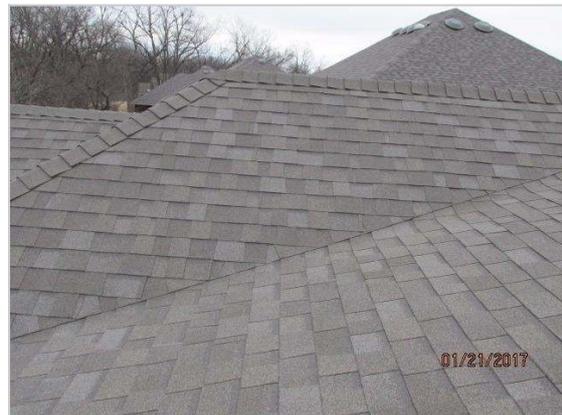
- **The flashing around the vent on the rear side of the roof was lifting and should be sealed back down to prevent leakage. \$150**

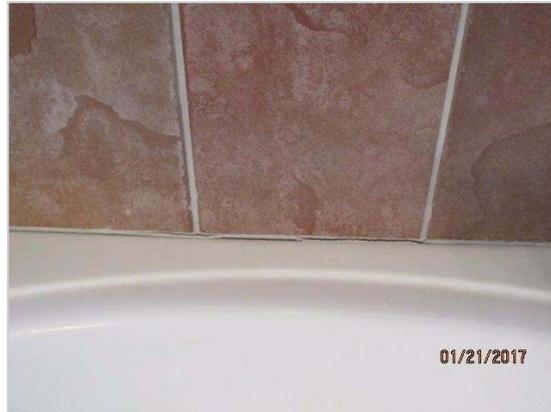
- **There was a crack in the grout around the jetted tub that we recommend sealing. It was caused by minor settlement of the tub and not from foundation movement. \$25**

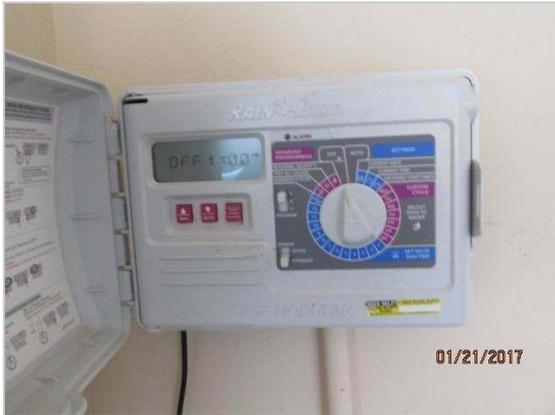
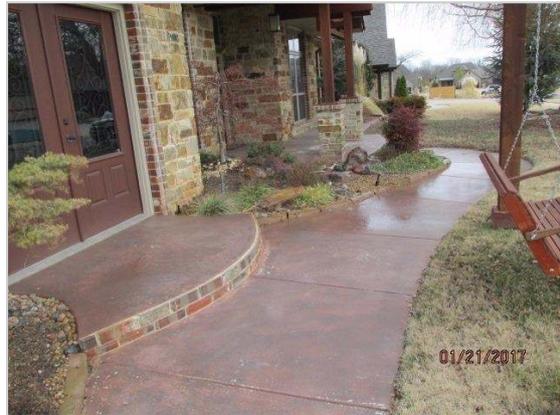
- **There were several sprinkler heads that need to be adjusted and some that were not functional. I recommend the entire system is gone through and repaired as needed by a qualified sprinkler system contractor. \$200**
