On Thursday, June 6, 2019 The HomeTeam Inspection Service made a visual inspection of 123 Sample Drive, Anytown, WI 12345. Enclosed please find a written, narrative report of our findings in accordance with the terms of our Inspection Agreement.

HOME INSPECTION REPORT

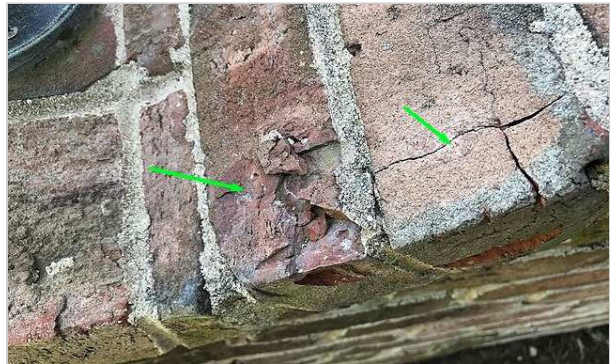
Photo 2

near front entrance - right side

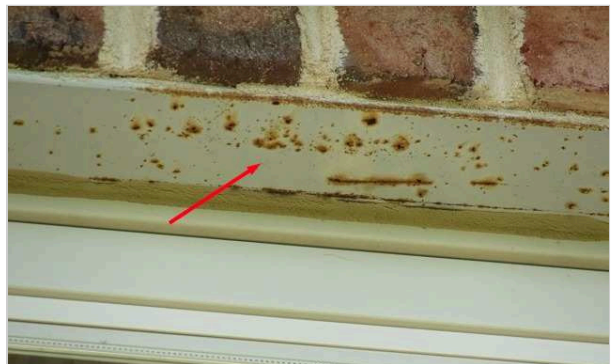
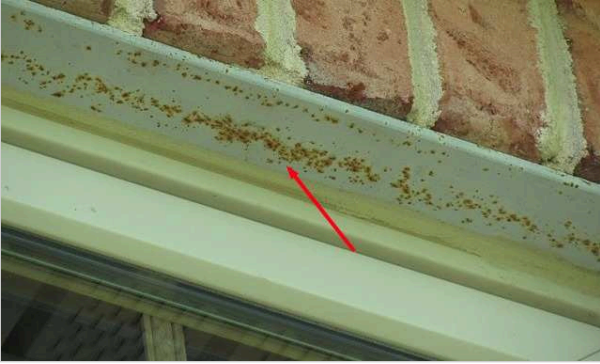
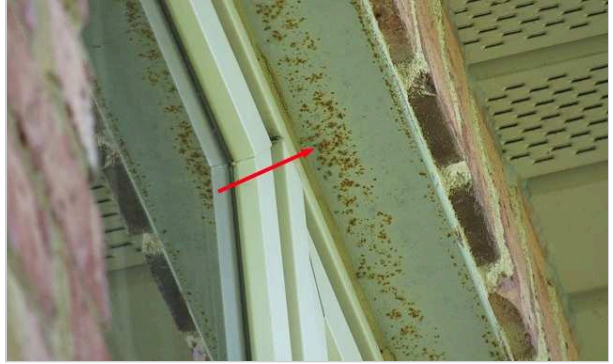
Peeling paint, weathered and/or rotted wood and cracked or missing caulking were present on the exterior of the home. In order to preserve the life of the exterior surfaces and materials, all areas should be scraped, sealed, and painted after any damaged wood is repaired and any areas of cracked or missing caulking resealed to help prevent moisture intrusion. These are routine maintenance items.

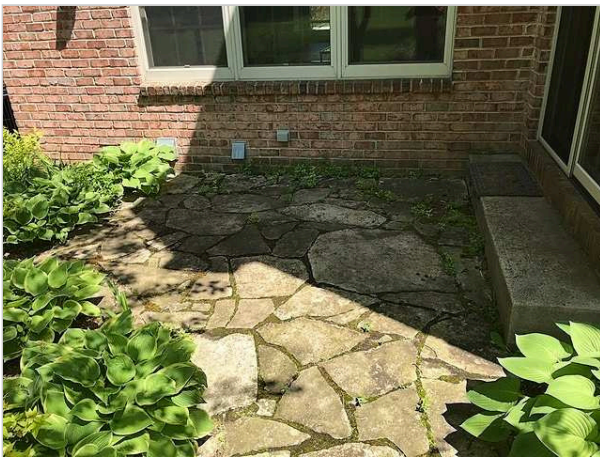
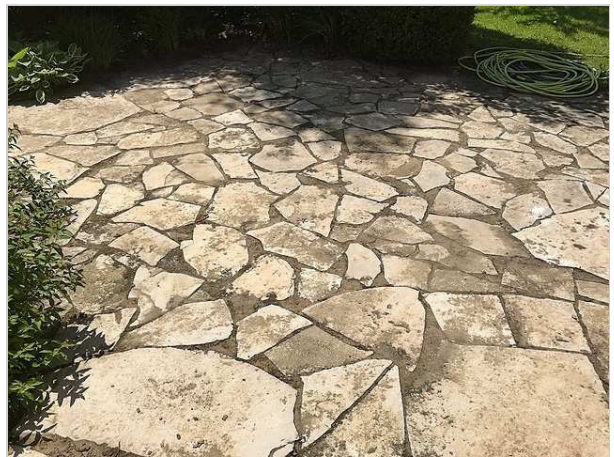
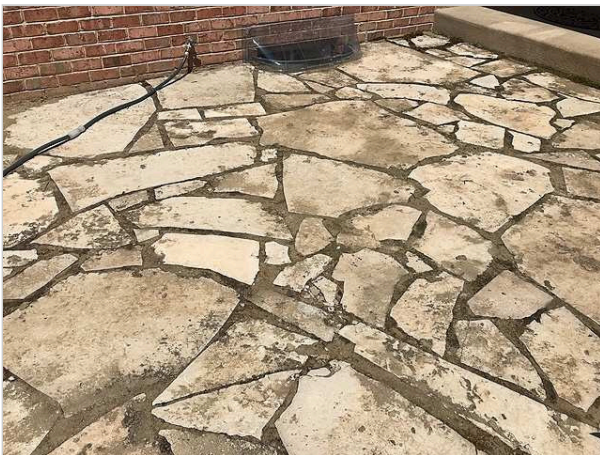
A flagstone patio was located in the back of the structure. There did not appear to be significant deterioration of the deck surface. A patio should be cleaned and sealed regularly to prevent deterioration.

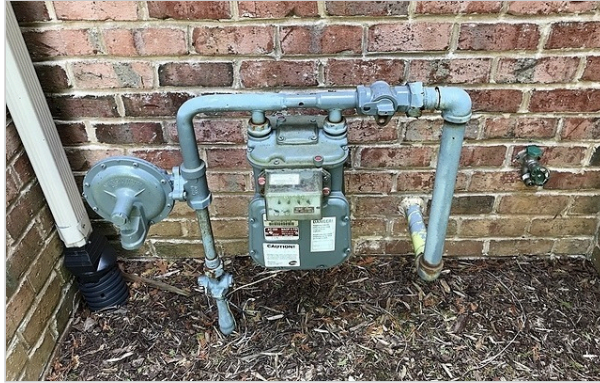
Photo 19

The gas meter and main shutoff were located on the right exterior wall. There was no noticeable odor of gas detected at the time of the inspection.

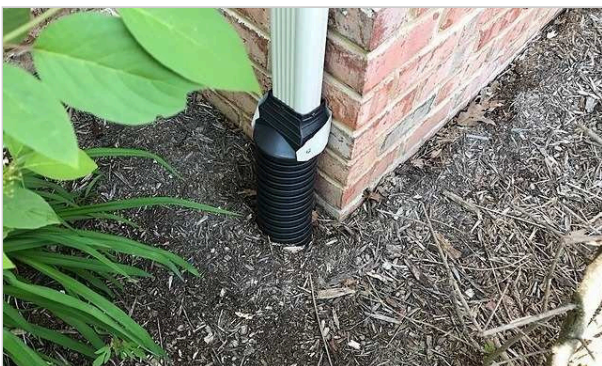
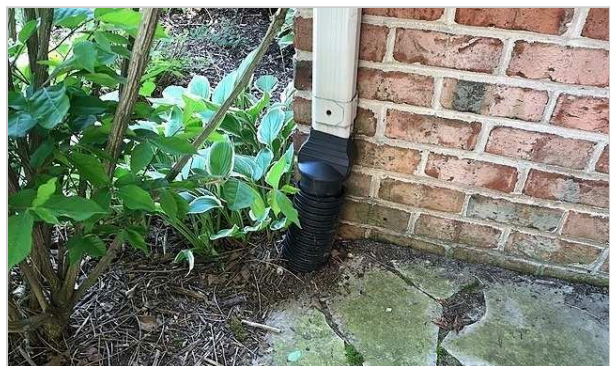
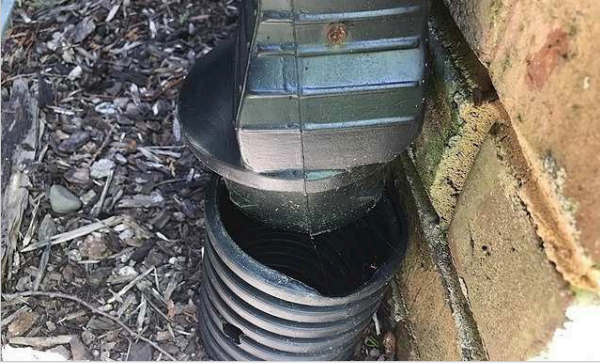
Some of the downspouts around the structure are draining into the ground with no conclusive termination point. While this is a common practice in many municipalities and a current construction trend, HomeTeam recommends ensuring the termination points for all downspouts are far enough from the structure and configured in such a way as to ensure water flows away from the foundation during periods of rain.

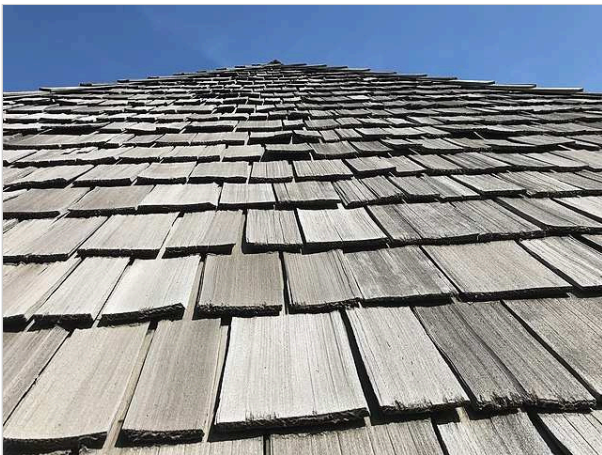
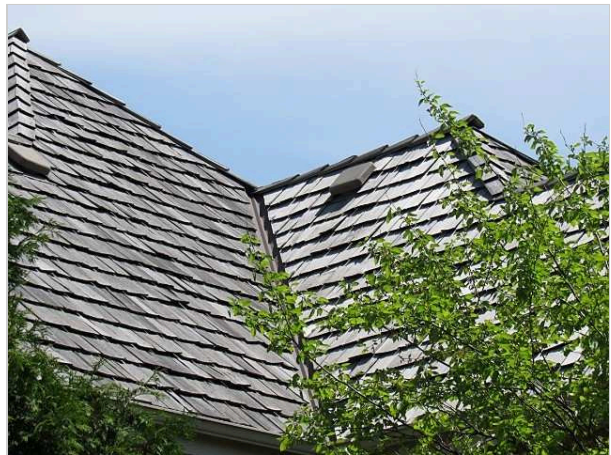
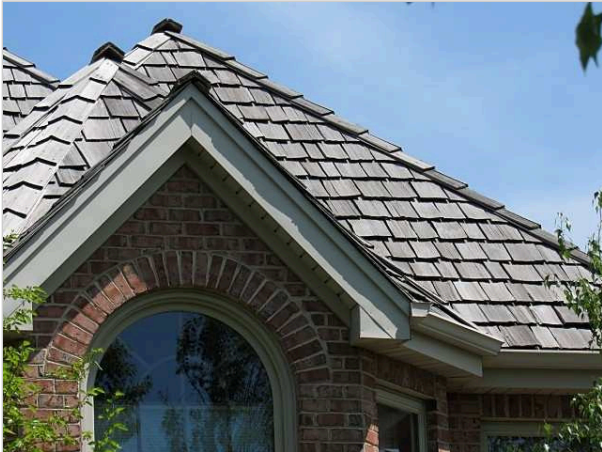
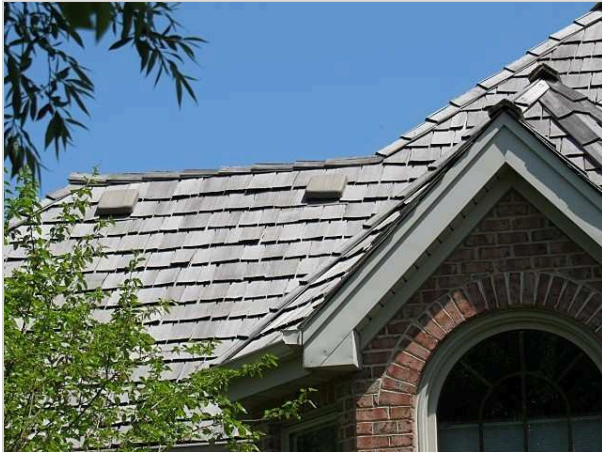
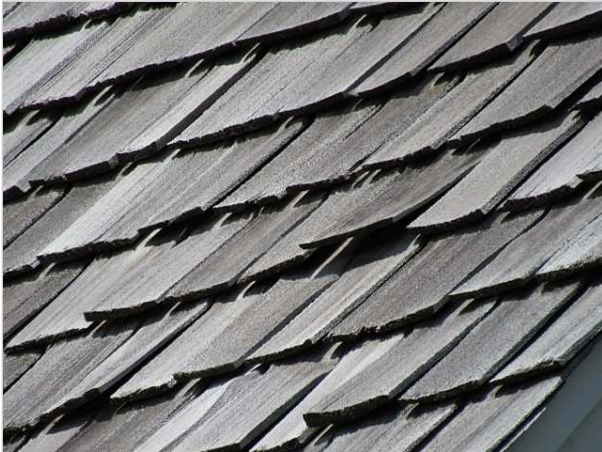
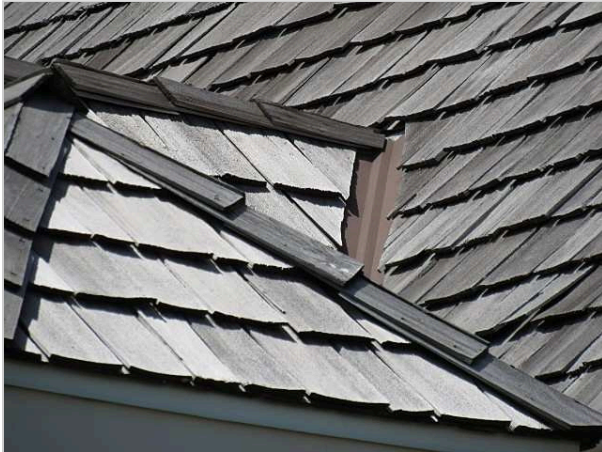
Several areas of the roofing shingles showed significant signs of cupping, curling, checking and/or splitting. In some cases, cleaning and preservation applications can extend the life of shake roofs. In others, areas of the roof may need to be repaired or replaced. HomeTeam recommends the roof be further evaluated by a qualified roofing contractor for estimates on repair or replacement. Depending upon further assessment, this may become a material defect.

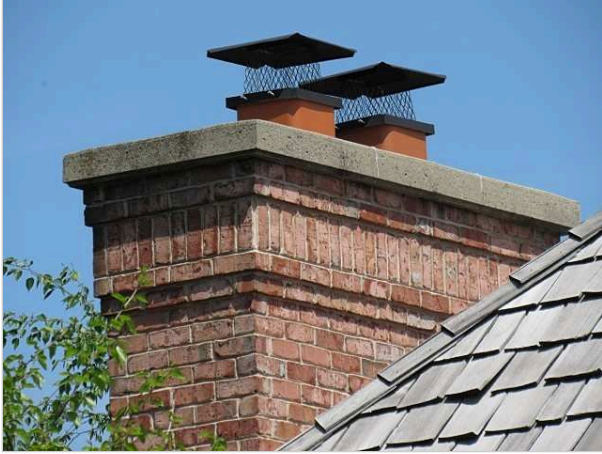
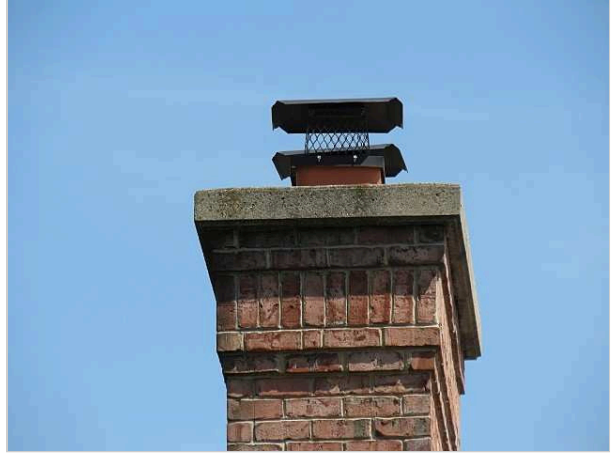
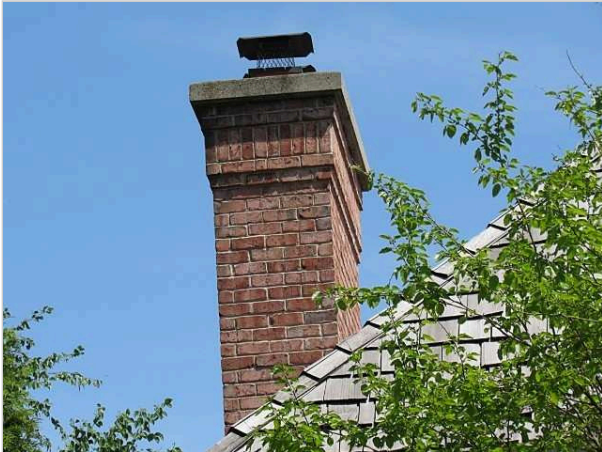
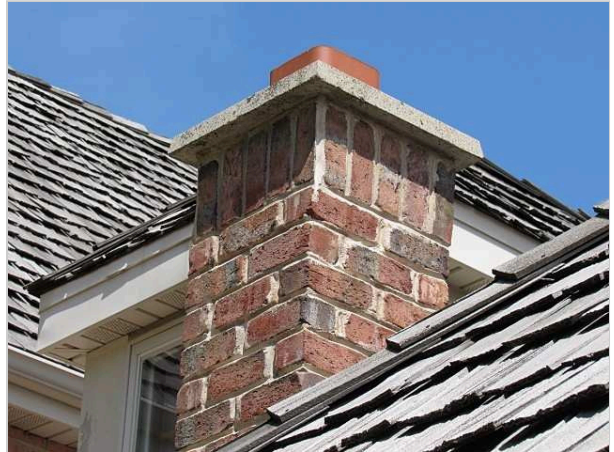
The structure had two chimneys. Observation of the chimneys was made from the ground with the aid of telephoto lenses. The flashing around the roof penetration points was not fully observable.

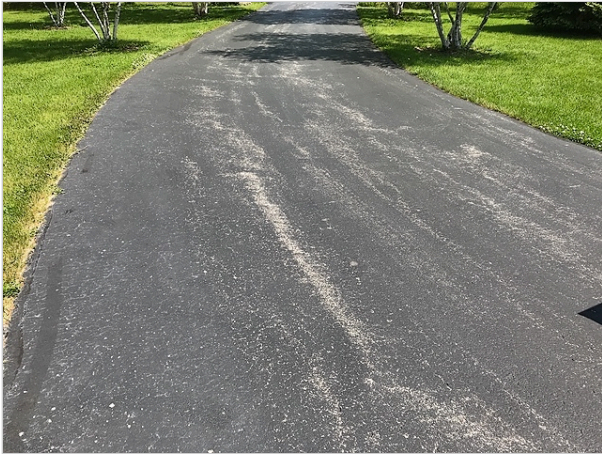
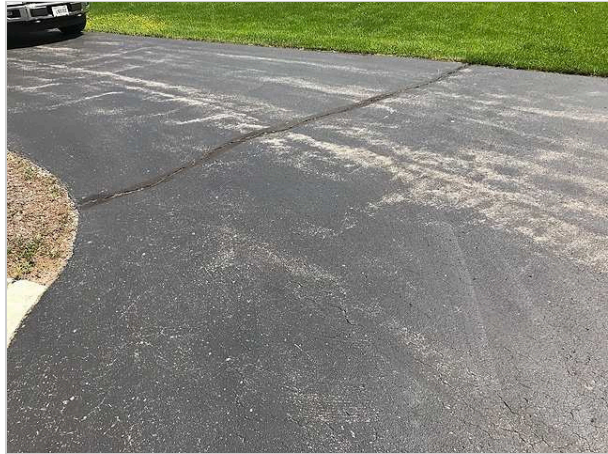
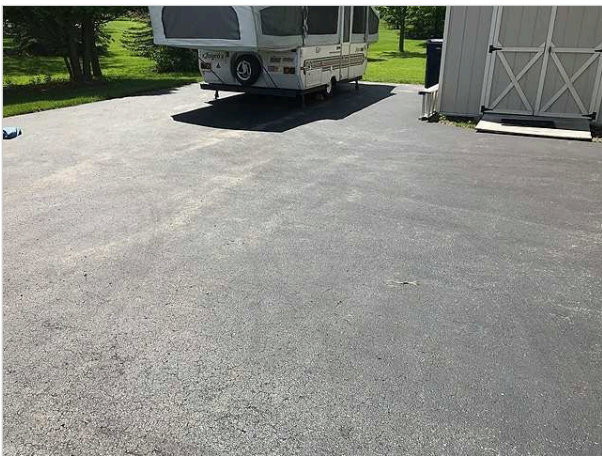
An asphalt driveway is present on the left side of the structure. Cracks and spalling were observed on the driveway. Surface defects in driveways develop and progress with age and are considered normal as long as they do not create a safety hazard. Sealing defects may help slow the rate of deterioration.

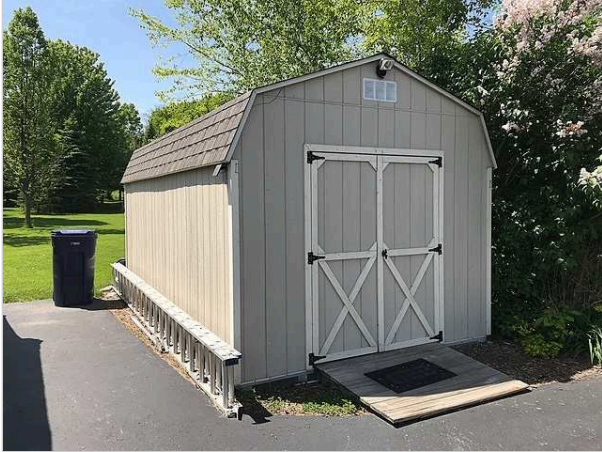
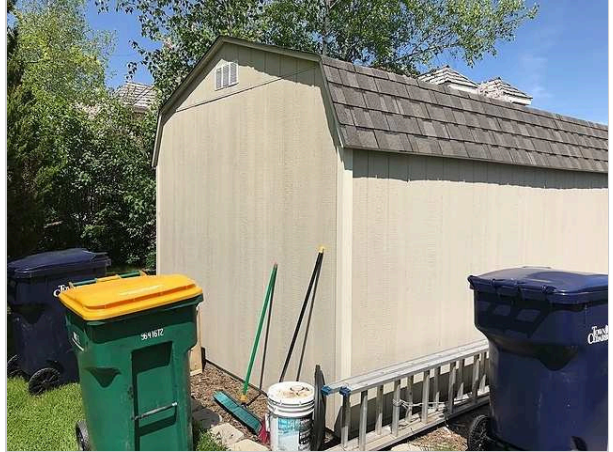
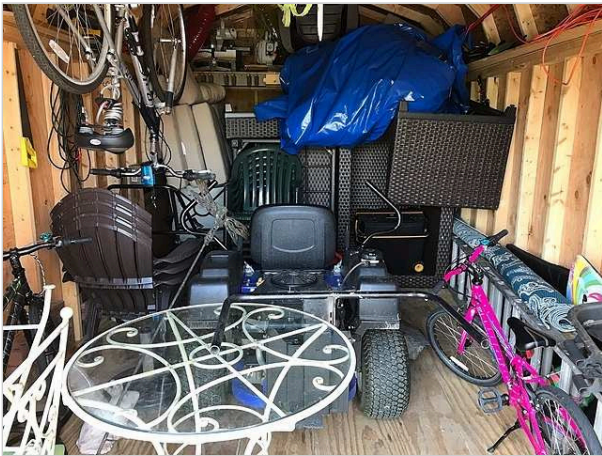
The wood framed shed sat on a wood platform. The roof was a barn style design covered with asphalt fiberglass shingles. The shingles appeared to be near the middle of their useful life. The doors to the shed were functional. There did not appear to be any electric utility ran to the shed.

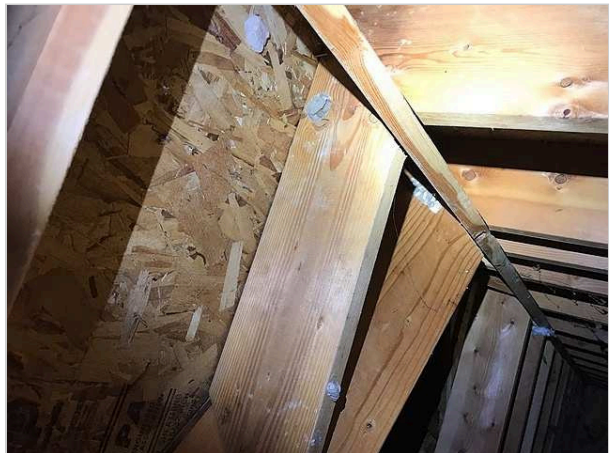
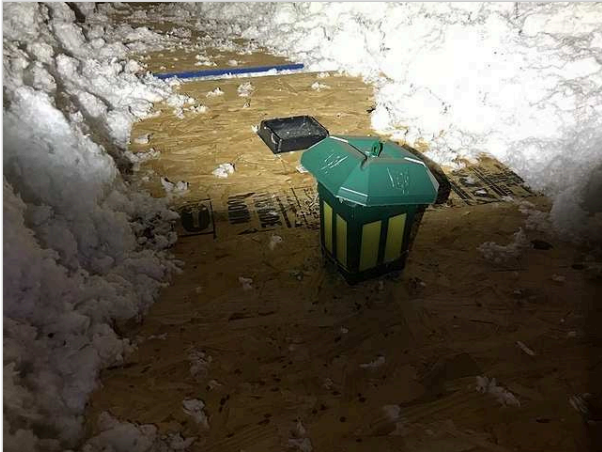
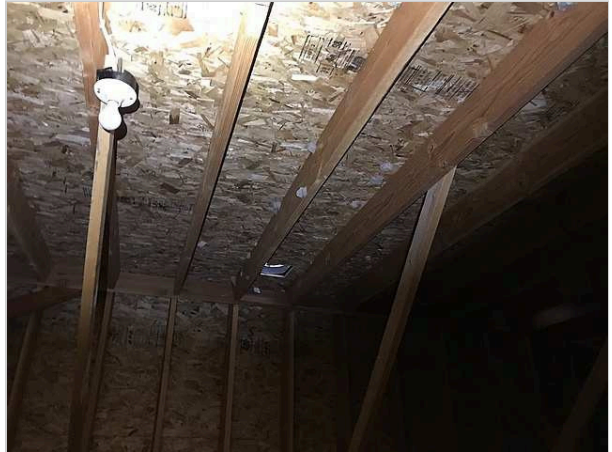
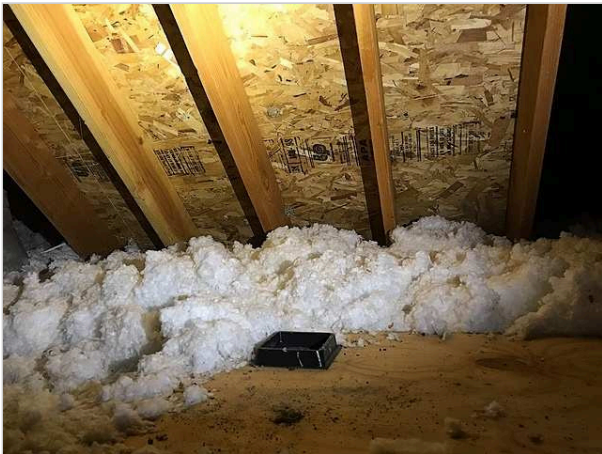
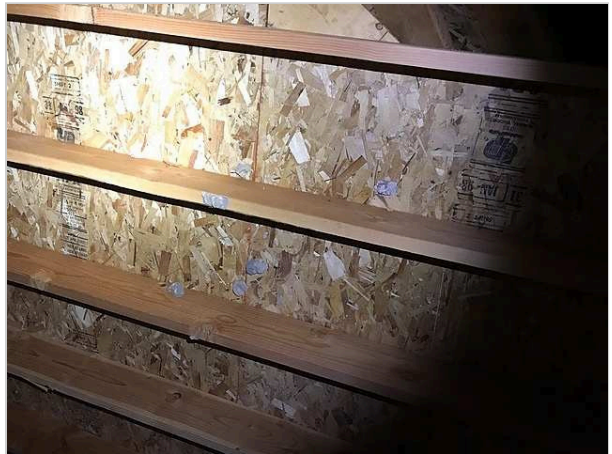
The attic has active mud dauber wasp nests. While not a usually aggressive species, they can sting and anyone with an allergy to wasp venom may have a severe reaction to their sting. Additionally signs of mouse intrusion were noted in the insulation. No live animals were noted. HomeTeam recommends consulting with a qualified pest control contractor for removal of the wasp nests and sealing of the openings to the area once it is determined the area is completely free of the wasps and animals.

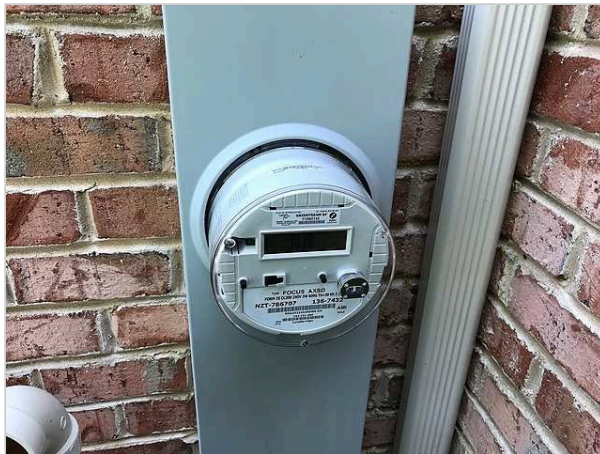
Photo 78

The underground electric service wire entered the structure on the right wall. The electric meter was located on the exterior wall.

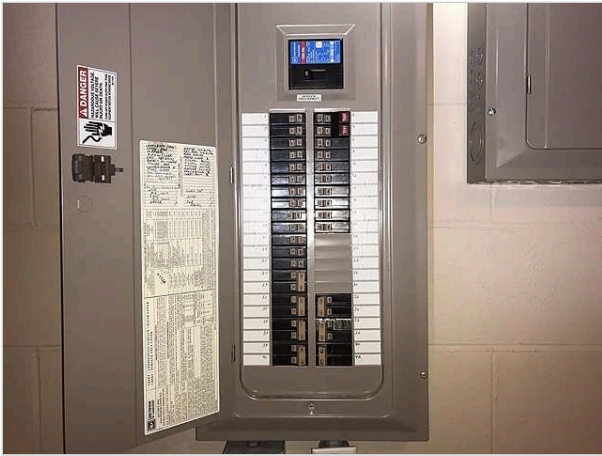
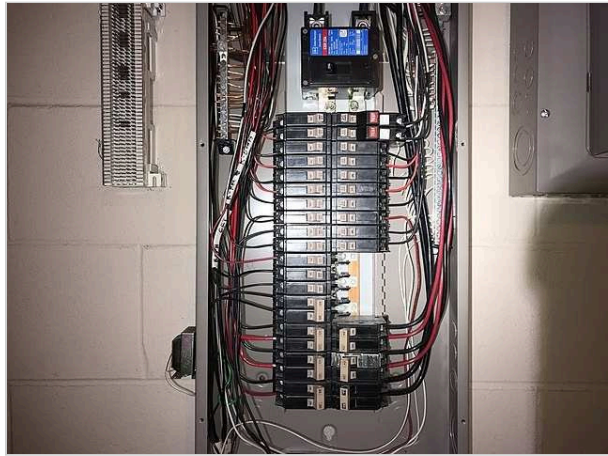
The service wire appeared to be 120/240 volt and 200 amp and entered a Cutler Hammer service panel, located on the right basement wall. The main service disconnect was 200-amp rated and was located in the main panel. The branch circuits within the panel were copper. These branch circuits and the circuit breaker to which they were attached appeared to be appropriately matched. The internal components of the service panel, i.e. main lugs, bus bars, etc were in good condition.

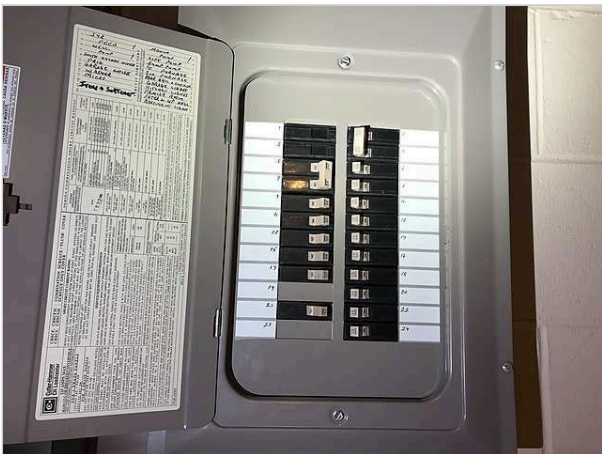
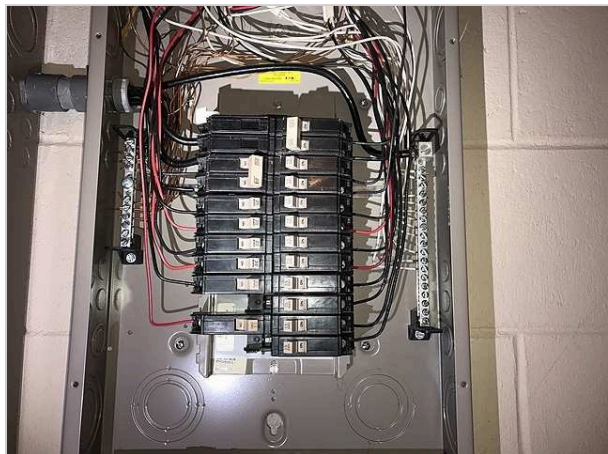
An electric service sub-panel was located next to the main service panel, and was manufactured by Cutler Hammer. The service wire appeared to be rated for 100 amps. The disconnect switch for this panel was located in the main panel, and was rated at 100 amps. The branch circuits within the panel were copper. These branch circuits and the circuit breaker to which they were attached appeared to be appropriately matched. The visible wiring consisted primarily of the NM (non-metallic) type and appeared to be in good condition.

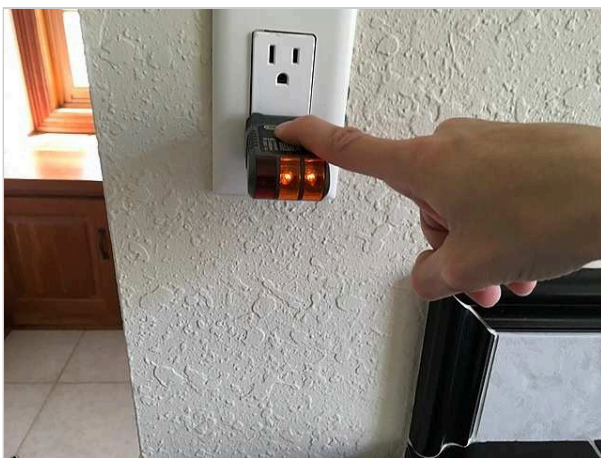
Photo 83

The master bathroom lacks GFCI protection. Installation of GFCI's in kitchens, baths, garages, basements, outdoor receptacles, and any other high-risk areas, will increase the overall safety of the electrical system. A qualified electrician should be consulted when working on or updating the electrical system in your home.

Master bath outlet left side not gfci

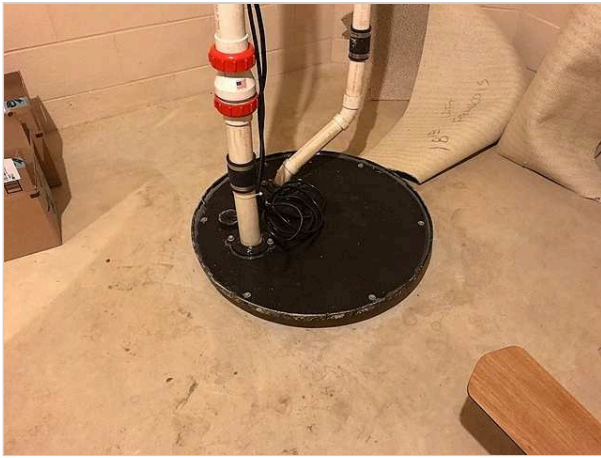
Photo 89

Ejector pump

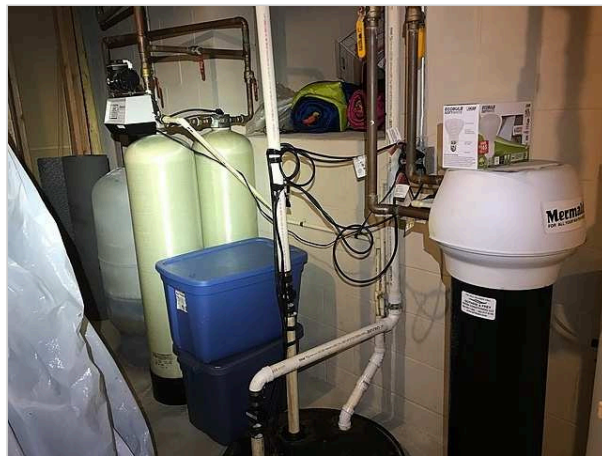
Photo 93

A water softener and filter system is present in the home. The water softener and filters are outside the scope of a home inspection but should be checked for functionality and correct installation and operation.

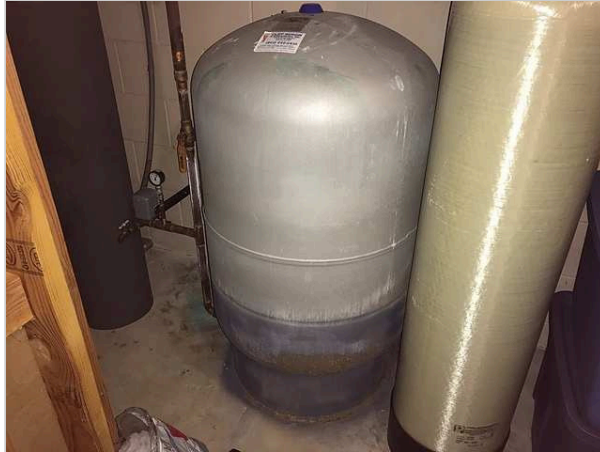
Photo 94

The main water shutoff valve for the structure was located adjacent to the water service entry point on the right wall in the basement. Water shutoff valves are visually inspected only. No attempt is made to operate the main or any other water supply shutoff valves during the inspection. These valves are infrequently used and could leak after being operated.

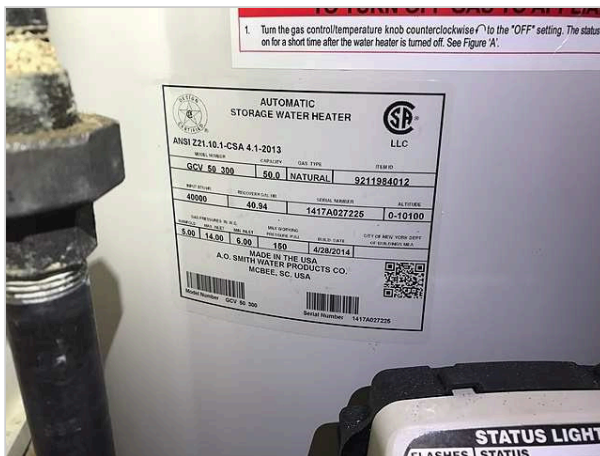
Photo 95

A 50 gallon capacity, natural gas water heater was located in the basement. The water heater was manufactured by A. O. Smith, model number GCV 50 300 and serial number 9211984012. Information on the water heater indicated that it was manufactured 5 years ago. Hot water temperature was approximately 122 degrees F.

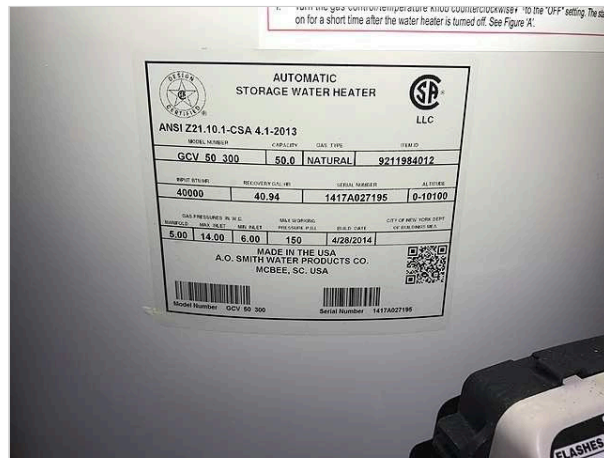
Photo 96

A 50 gallon capacity, natural gas water heater was located in the basement. The water heater was manufactured by A. O. Smith, model number GCV 50 300 and serial number 9211984012. Information on the water heater indicated that it was manufactured 5 years ago. Hot water temperature was approximately 122 degrees F.

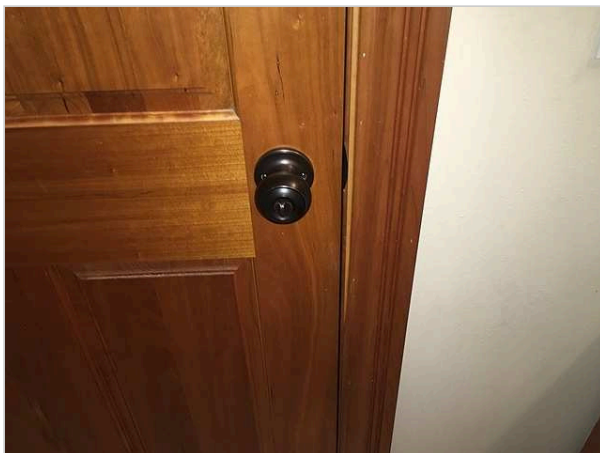
Photo 99

NOTE: The door to the upstairs hall bathroom does not latch. The door, frame, and/or latching mechanism should be adjusted to allow for proper operation of the door.

Hall bath door to the right upstairs does not latch.

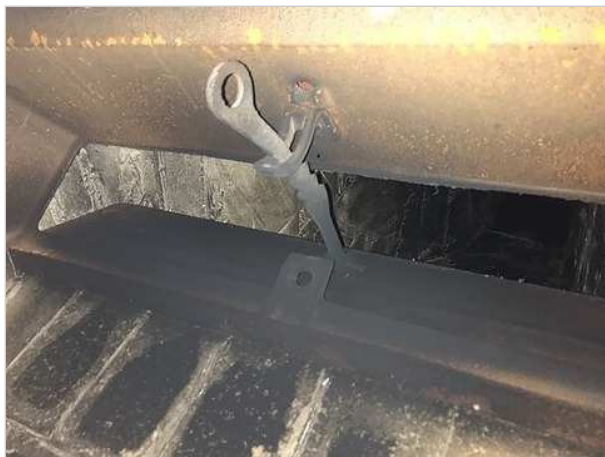
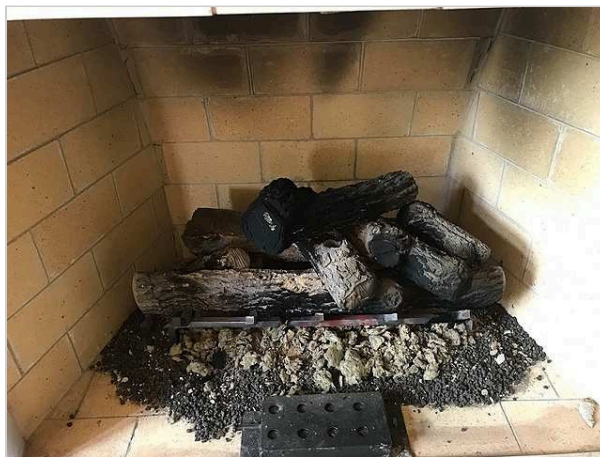
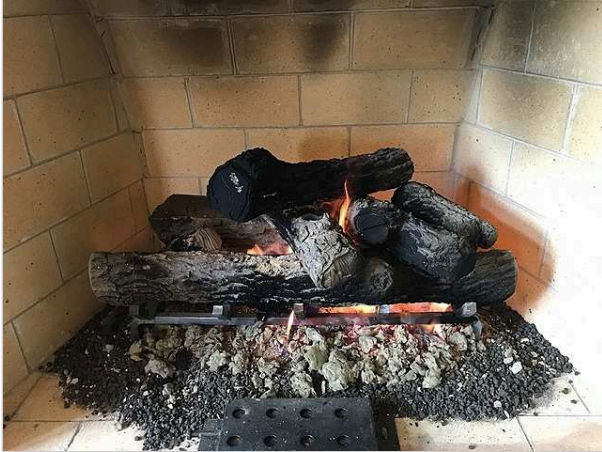
A vented fireplace insert with natural gas fuel supply was located in the living room. The chimney/flue was masonry material. The unit was operated and was functional. Be sure to read and understand the operating procedures prior to operating the unit. There were no material defects observed on the gas fireplace. If the fireplace is used for burning wood, special precautions should be taken, including a full assessment by a chimney sweep for suitability and any configuration changes that should occur. Often, gas fireplaces that have not been operated for a prolonged time require an extended number of attempts before they will light. This is often due to air in the lines that requires time to purge.

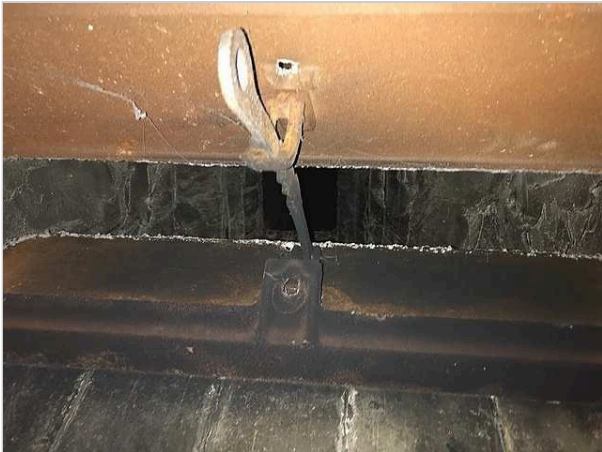
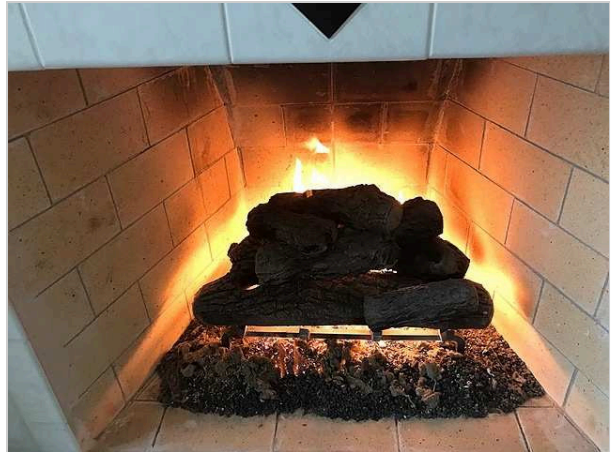
A vented fireplace insert with natural gas fuel supply was located in the master bedroom. The chimney/flue was masonry material. The unit was operated and was functional. Be sure to read and understand the operating procedures prior to operating the unit. There were no material defects observed on the gas fireplace. If the fireplace is used for burning wood, special precautions should be taken, including a full assessment by a chimney sweep for suitability and any configuration changes that should occur. Often, gas fireplaces that have not been operated for a prolonged time require an extended number of attempts before they will light. This is often due to air in the lines that requires time to purge.

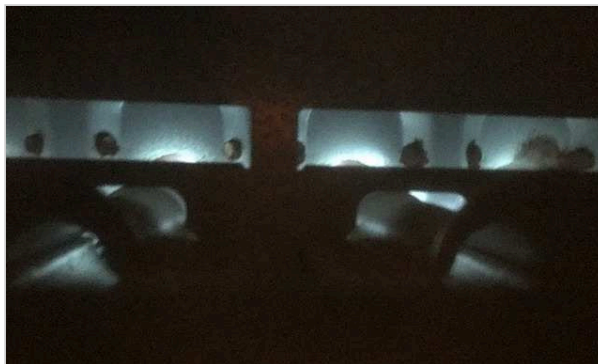
Photo 107

Evidence of prior water was present inside the furnace compartment. The condition may have been caused by a condensate leak in the furnace and/or air conditioning condensate drain lines. Water inside the furnace compartment can damage the furnace cabinet or other operational components and should be repaired. Consult with a qualified HVAC contractor to determine the source of the water and the best course of action should the issue reoccur.

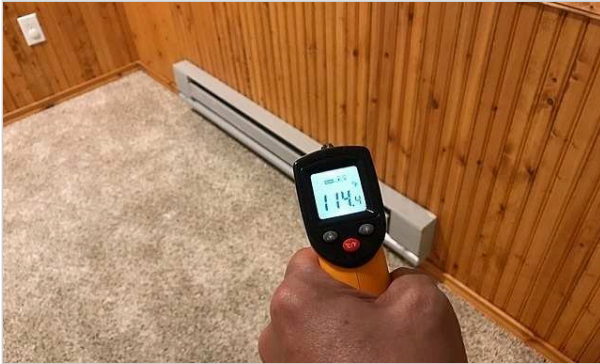
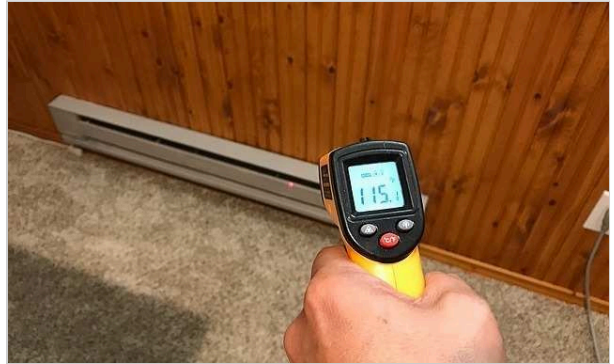
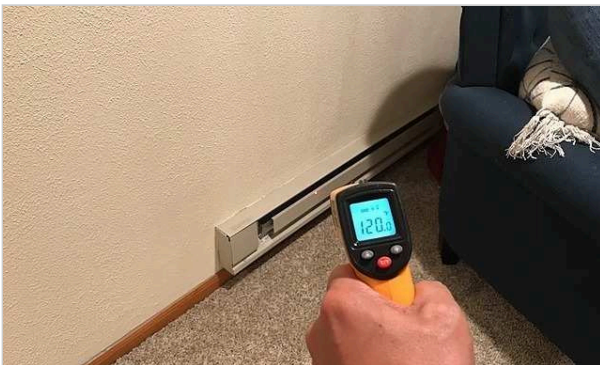
A supplemental heating system consisting of electric baseboard units controlled by wall mounted thermostats was present in the basement in several locations. The thermostats were turned up during the inspection and appeared to be functional. Electrical heating units require minor servicing and upkeep. The metal fins within the units should be kept clean and the surrounding area should be left open to allow for sufficient airflow.

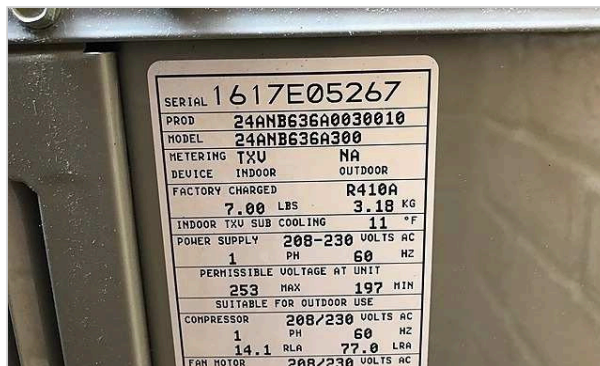
Photo 115

The electric outdoor air conditioner condensing unit was a Carrier, Model Number 24ANB636A300 and Serial Number 1617E05267. The unit is located on the right side of the structure. This unit is approximately 2 years old. Periodic preventive maintenance is recommended to keep this unit in good working condition, and HomeTeam strongly recommends partnering with a reputable HVAC company for routine maintenance for the heating and cooling systems in the fall and spring. The air conditioning system was tested and found to be functional. As a reminder, this is functionality test and visual inspection only; we do not check suction pressures, contactor amps, or refrigerant levels. If a more detailed inspection is required, please consult with an HVAC company.

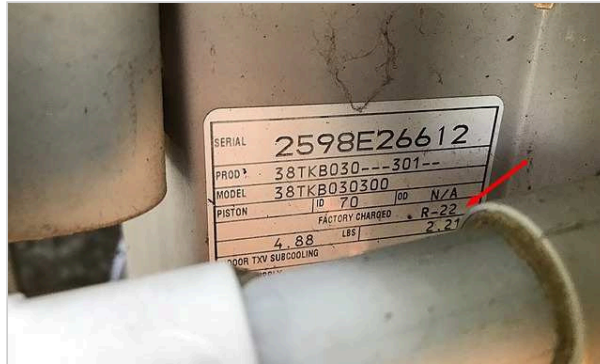
Photo 116

The electric outdoor air conditioner condensing unit was a Carrier, Model Number 38TKB030300 and Serial Number 2598E26612. The unit is located on the right side of the structure. This unit is approximately 21 years old. Periodic preventive maintenance is recommended to keep this unit in good working condition, and HomeTeam strongly recommends partnering with a reputable HVAC company for routine maintenance for the heating and cooling systems in the fall and spring. The air conditioning system was tested and found to be functional. As a reminder, this is functionality test and visual inspection only; we do not check suction pressures, contactor amps, or refrigerant levels. If a more detailed inspection is required, please consult with an HVAC company.

The air conditioner may be past its design life. Unless noted otherwise, the system was functional at the time of the inspection. As with a light bulb that functions normally one day but the next may not turn on, a system's age is a helpful factor that assists in budgeting for eventual replacement, as are changes in regulations, most notably the Clean Air Act which will require the phasing out of R22 freon by the year 2020.
