HOME INSPECTION REPORT

Address of Inspection: 123 Sample Drive

Monday, April 16, 2018

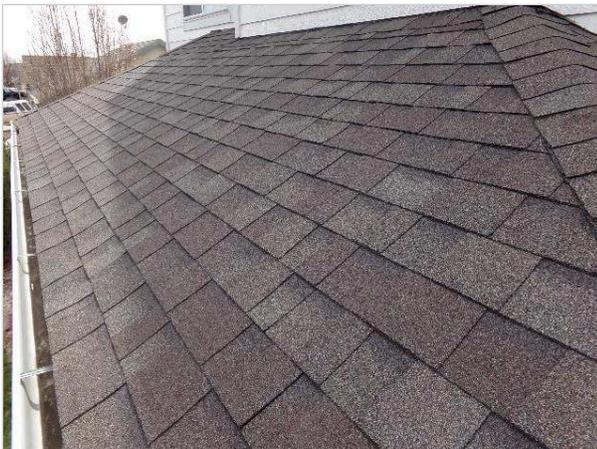
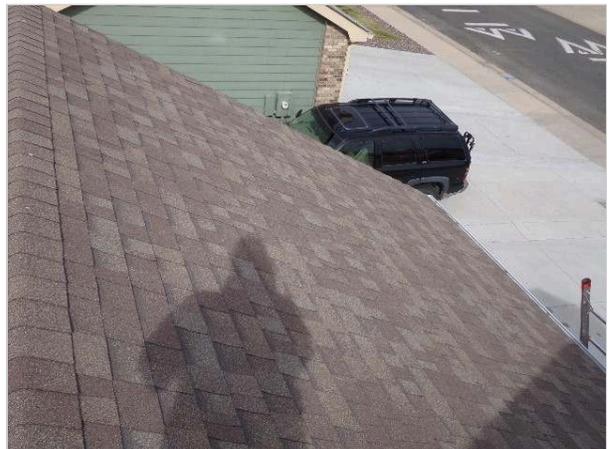
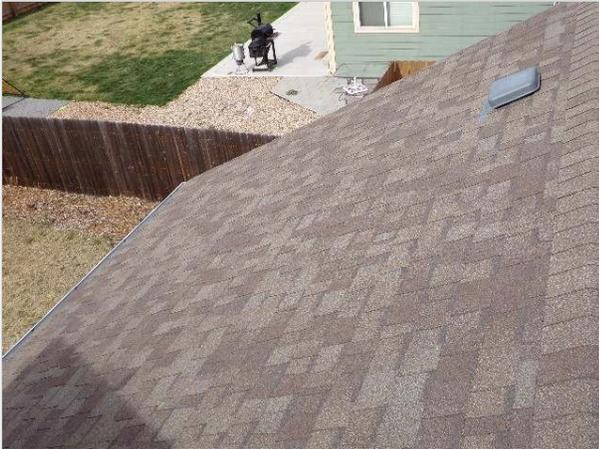
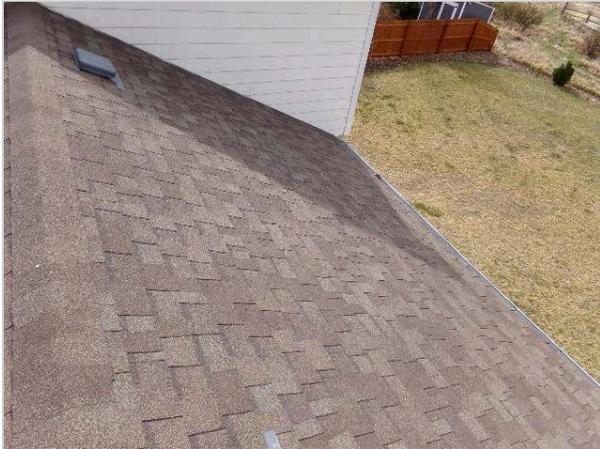
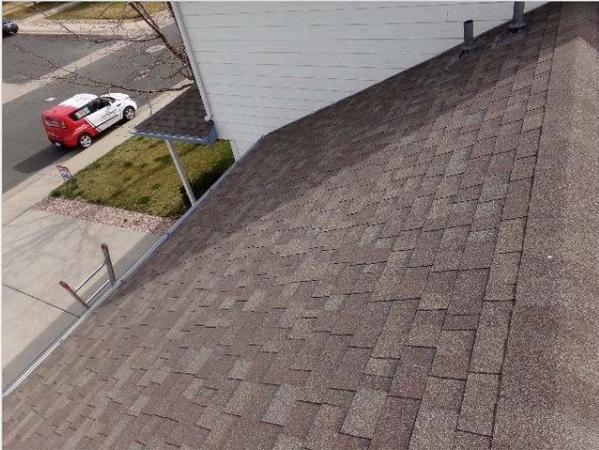
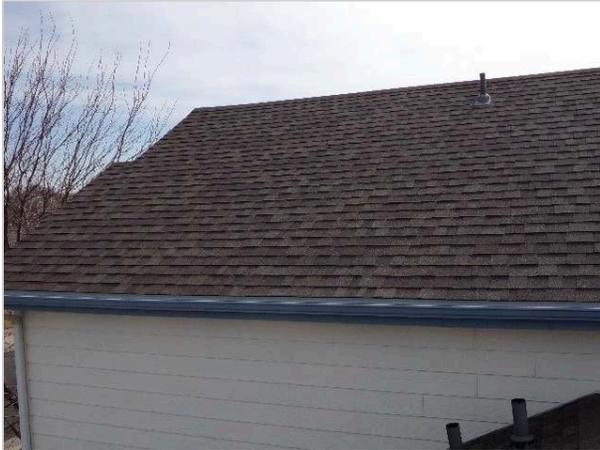
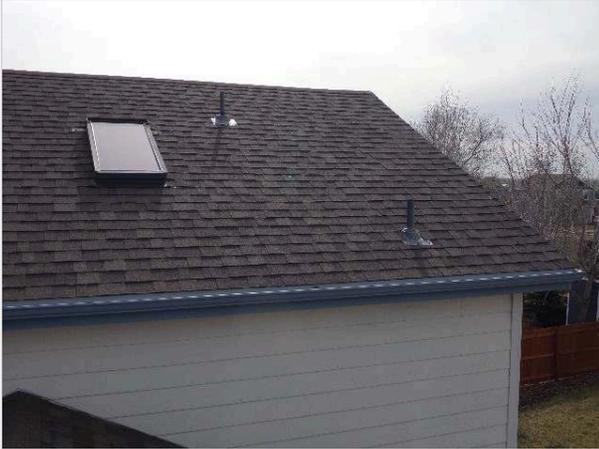
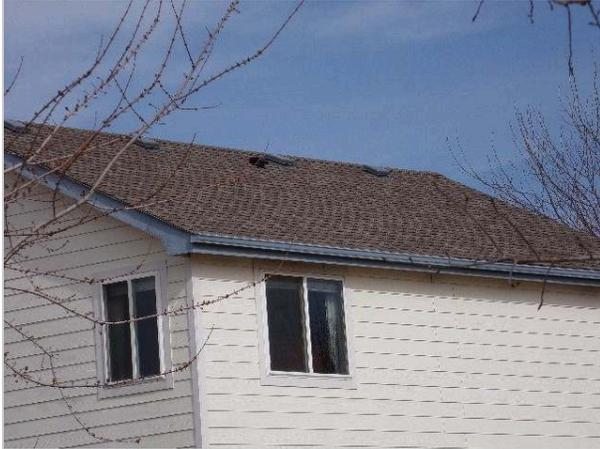
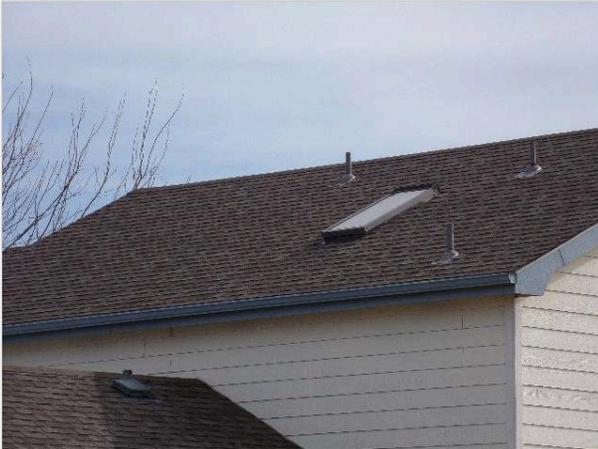
The roof was a gable and hip design covered with asphalt/fiberglass shingles. Observation of the roof surfaces and flashing was performed while on the roof and from ground level with the aid of binoculars. The age of the roof covering was unknown. There was one layer of shingles on the roof at the time of the inspection.

There was no curling and no significant surface wear observed on the roof shingles at the time of the inspection. These conditions indicate the roof shingles were in the first half of their useful life. All roof penetrations appeared to be flashed properly, and no missing shingles were observed.

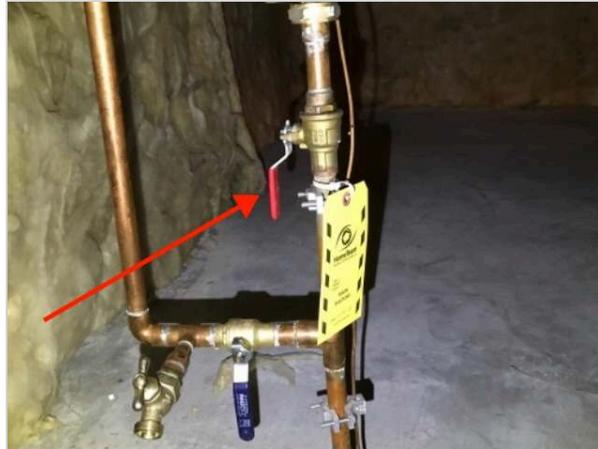
Photo 29

The main water shutoff valve for the home was located adjacent to the water service entry point in the crawlspace. The shutoff valve was tagged for your future reference.

Main water shutoff valve

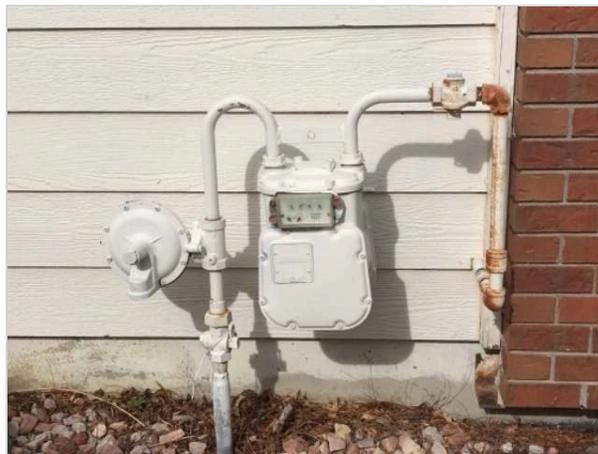
Photo 30

The natural gas meter was located on the left exterior wall. Although no actual testing was performed to detect the presence of gas fumes, there was no noticeable odor of gas detected at the time of the inspection.

- *CSST gas piping (Corrugated Stainless Steel Tubing) was in use in this home. The potential exists for lightning strikes to cause arcing at the CSST gas piping that may result in perforation of the pipe, gas leaks and fire. Proper adherence to the manufacturer's bonding instructions should lower the risk of electrical arcing and related damage. Proper bonding and grounding of the product can only be determined by a licensed electrical contractor. More information is available at <http://www.csstsafety.com>. If this is a concern to you I recommend this installation be further evaluated and corrective action taken as needed.*

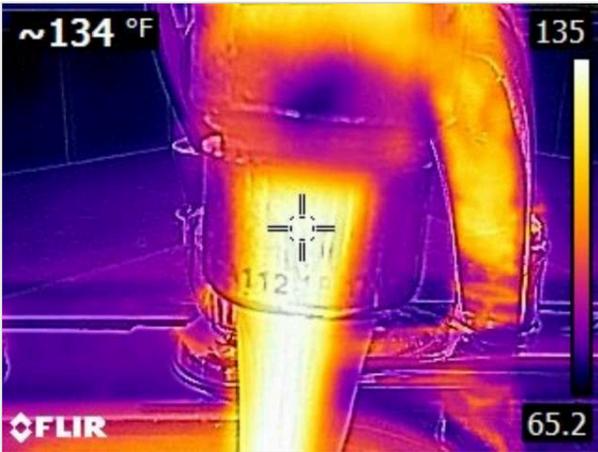
Photo 37

A temperature and pressure relief valve (T&P) was present on the water heater. Because of the lime build-up typical of T&P valves, we do not test them. The water temperature at the tap was 130-135 degrees. The water heater was functional.

Thermal image

- For safety reasons an overflow leg should be attached to the T&P valve and it should terminate within a few inches of the floor.

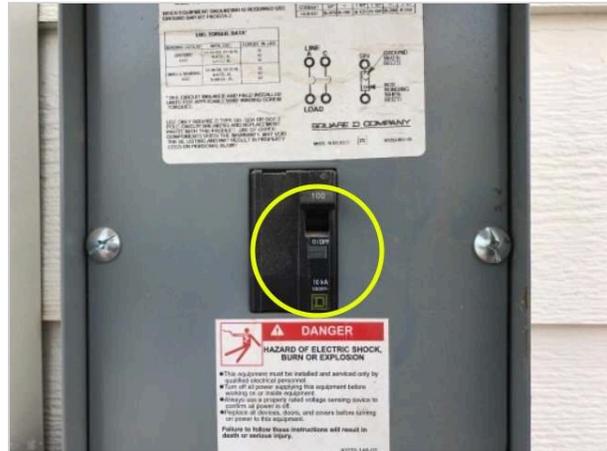
Photo 41

The underground electric service wire entered the home on the right side wall. The electric meter was located on the exterior wall. The main service disconnect was rated for 100 amps.

Main service disconnect

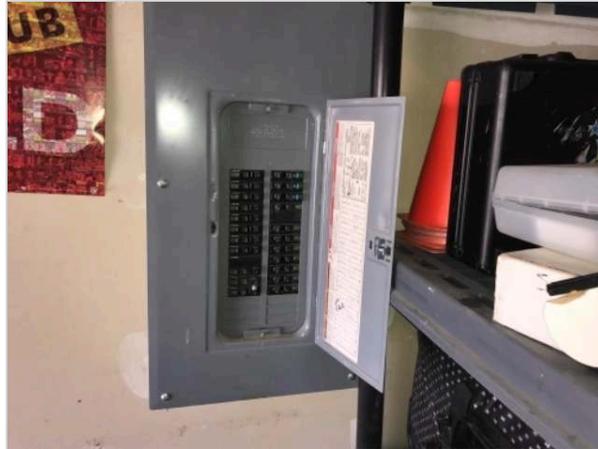
Photo 42

The service wire entered a Square D service panel, located on the garage wall with a 125 amp and 120/240 volt rated capacity.

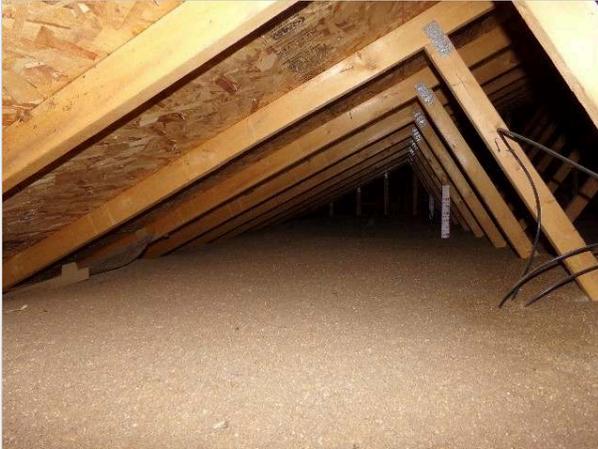
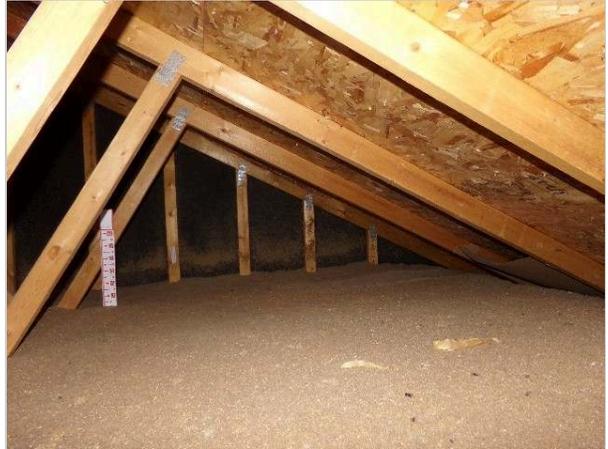
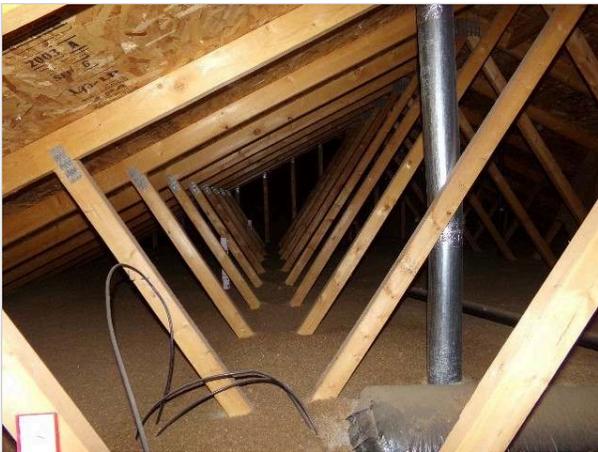
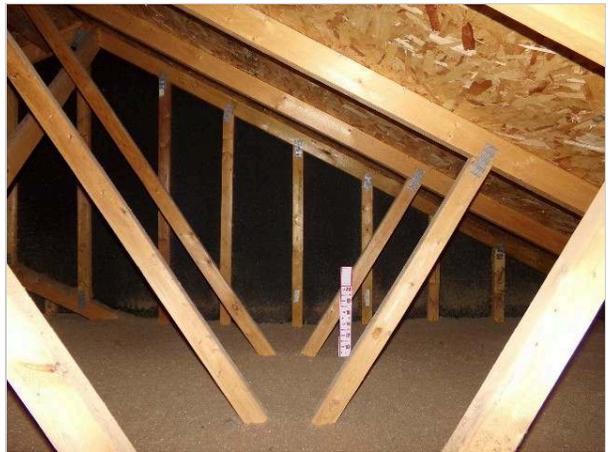
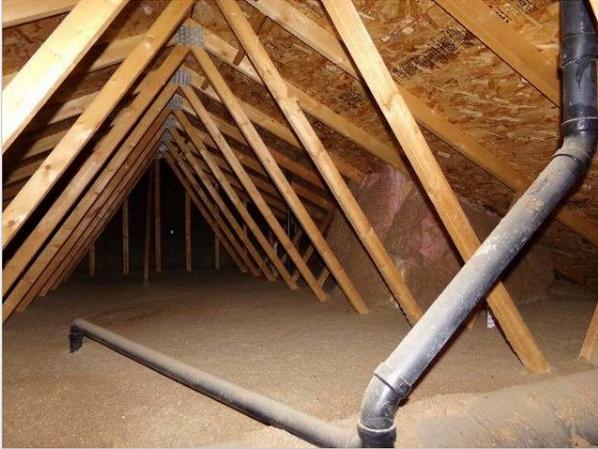
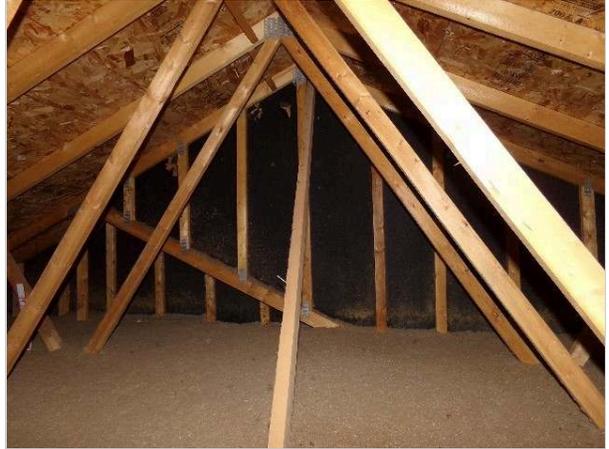
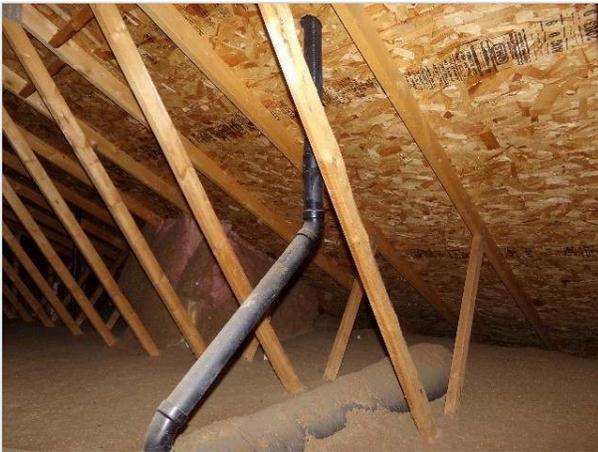
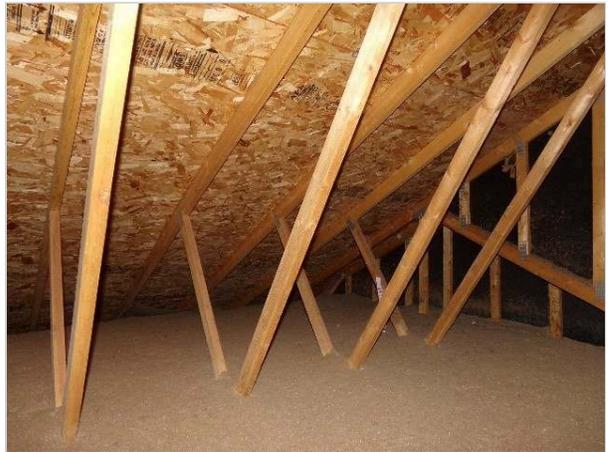
The attic was accessed through a scuttle in the upper level bedroom. The attic above the living space was insulated with blown insulation, approximately 8 to 10-inches in depth. Ventilation throughout the attic was provided by soffit and roof vents. The roof structure consisted of two-inch by four-inch wood trusses spaced 24 inches on center and OSB (waferboard) sheathing.

Because of the configuration of the framing and absence of a catwalk, which limited access, it was not possible to inspect all areas of the attic. There was no moisture visible in the attic space. The absence of visible indications of moisture is not necessarily conclusive evidence that the roof is free from leaks. The only way to be sure a roof does not leak is to inspect the underside of the roof during a heavy rain. There were no material defects observed in the attic or roof structure.

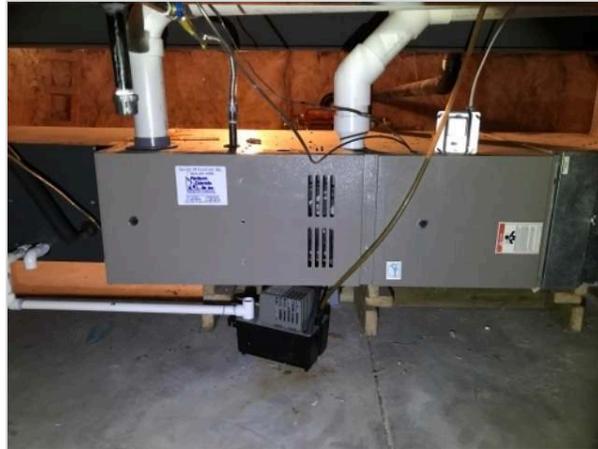
Photo 56

The home was heated by a Goodman natural gas forced air furnace, Model Number GMNT060-3B and Serial Number 0310981324, which is fifteen years old. The unit was located in the crawl space of the home. It has an approximate gross heating capacity of 60,000 BTUH's and is rated for 90+ percent efficiency.

The heating system was operated and inspected by the HomeTeam. A carbon monoxide test was conducted at the supply registers. The test recorded 0 ppm. No active gas leaks were detected at the gas line fittings. The heating system was found to be functional. There were no material defects observed in the visible portions of the furnace.

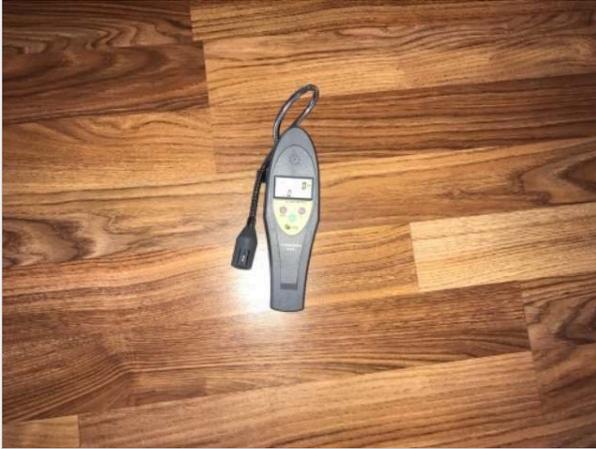
Photo 59

- The furnace is dirty and it should be cleaned and serviced.

NOTE: The average life of a gas-fired furnace is 18 to 24 years, but heat exchangers can fail at any time. The interior of a furnace heat exchanger is not visible and its condition is beyond the scope of this visual home inspection. Without disassembling this furnace, a thorough inspection of the heat exchanger is not possible. The absence of detectable carbon monoxide is not conclusive evidence the heat exchanger is intact. If this is a concern to you I recommend this furnace, including the heat exchanger, be further inspected by a licensed HVAC contractor prior to closing to ensure safe operation.

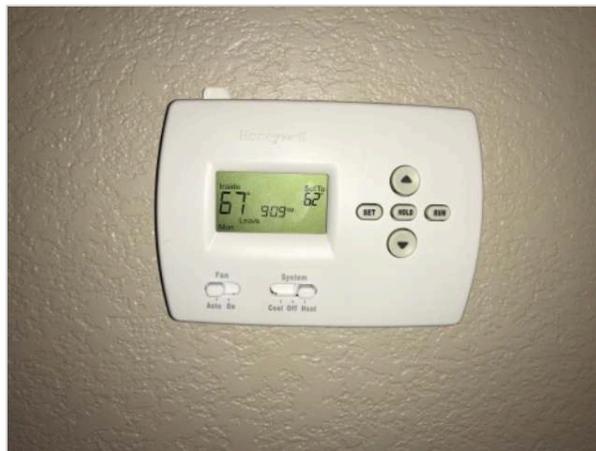
Photo 62

The control for the heating and air conditioning system was a 24-volt programmable thermostat located on the main level hallway wall. The thermostat was manufactured by Honeywell and was found to be in working order.

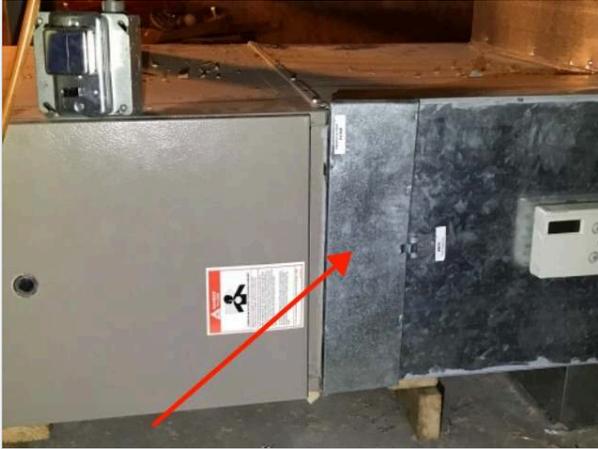
Photo 63

The 14x25x1-inch disposable filter was located in the ductwork adjacent to the furnace. The furnace filter should be checked and replaced on a regular basis to maintain the efficiency of the system. The efficiency rating of the filter is not within the scope of this inspection.
