### *HOME INSPECTION REPORT*

*This summary provides a simplified overview of the results of the Friday, June 29, 2018 inspection at 123 Main Street, Anywhere, VA 11111. Be sure to read the full body of the inspection report; it contains much more detail about the property. Any additional evaluations we've recommended must be performed prior to the conclusion of the inspection contingency period.*

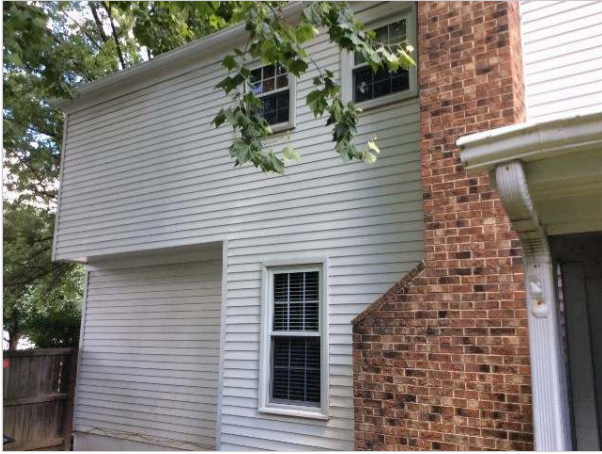
**Missing mortar was evident on the brickwork on the back of the home.** There were also loose bricks noted. Small amounts of missing mortar are usually inconsequential. Extensive amounts of missing mortar can permit water intrusion. Consult with a qualified masonry contractor for repair estimates.

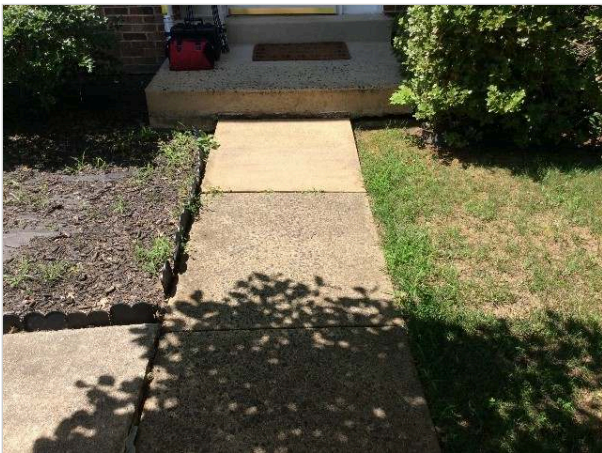
- **Trip hazards were present on the walkways** around the house. The hazards can be repaired using a suitable or similar surfacing material to "feather" the out-of-level condition to make a smooth transition.

**Trip hazards were present on the walkways** around the house. The hazards can be repaired using a suitable or similar surfacing material to "feather" the out-of-level condition to make a smooth transition.

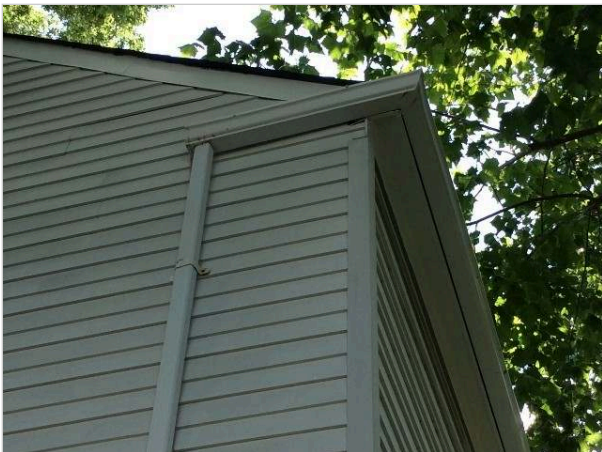
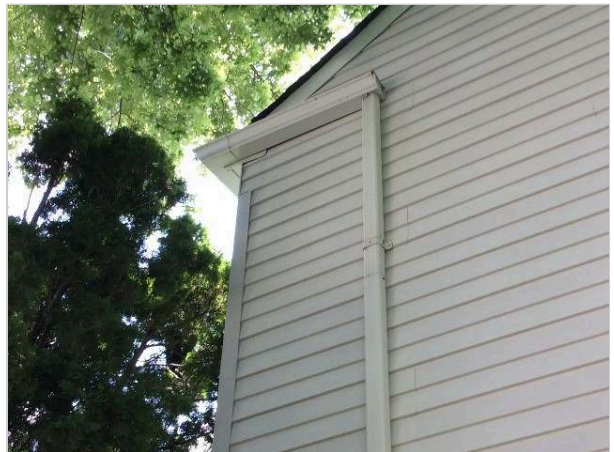
The roof drainage system consisted of aluminum gutters and downspouts which appeared to be functional but in need of repair at the time of the inspection. Gutters and downspouts should receive routine maintenance to prevent premature failure. There were no material defects observed on the visible portions of the gutters or downspouts.

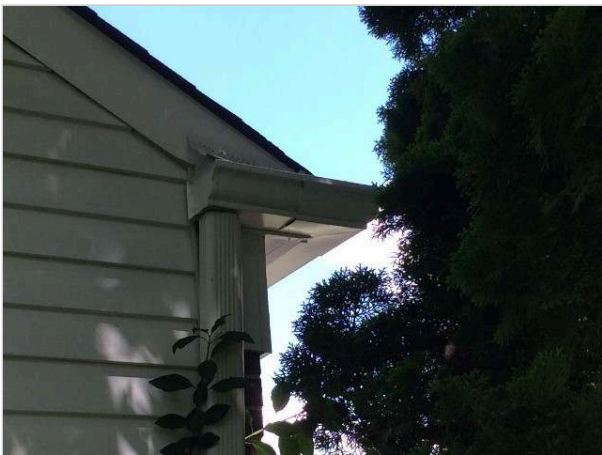
One downspout is draining directly onto the roof surface. This decreases the life of the roofing shingles dramatically. HomeTeam suggests extending the downspout to a lower gutter.

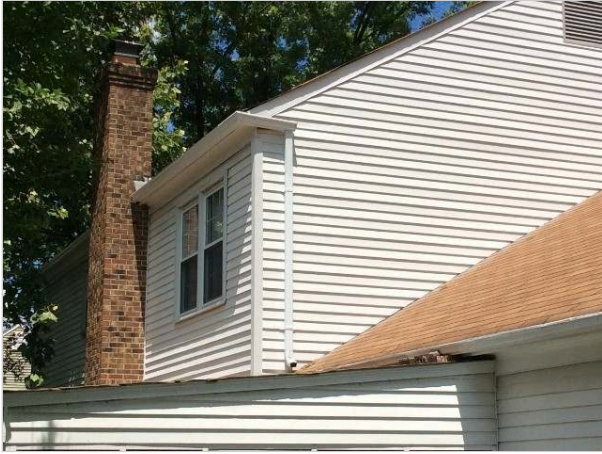
**Several downspouts were draining at or too close to the base of the foundation.** To reduce the likelihood of water problems at the base of the structure, all roof drainage should be directed at least six feet from the base of the foundation.

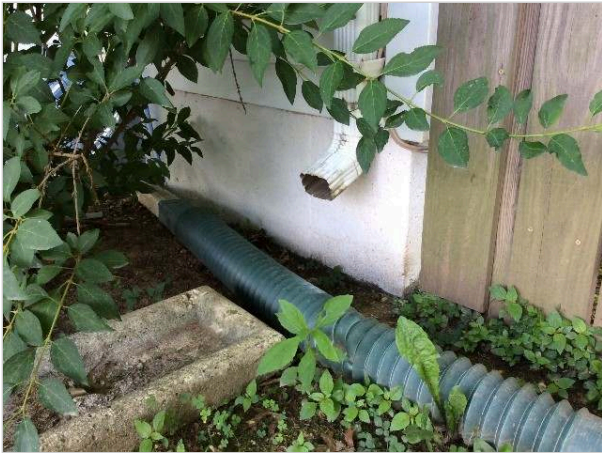
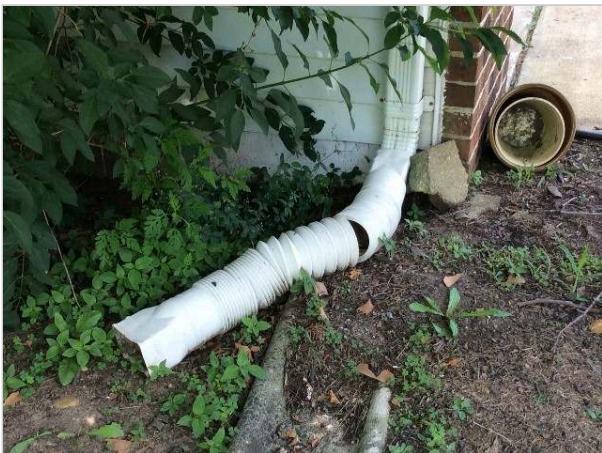
**At least one exterior downspout is not properly secured to the structure** and should be secured to prevent downspout and gutter damage.

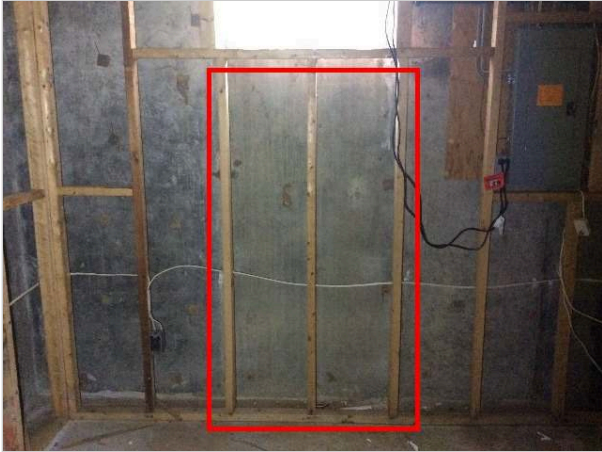
The basement recently had all of the finished walls and flooring removed due to a serious water infiltration issue. There were stains on the exposed slab and walls where water entered the basement. There was a musty, damp odor and dehumidifiers were present in the basement. Mold-like substance was identified in numerous locations in the basement. The exterior window wells have small sump pumps there to assist in removing water. However, the lip of the exterior guard is at the same level as the ground, thus allowing water to enter the well easily. This water infiltration event required the entire finished basement to be removed due to water damage and will continue to be a problem unless it is addressed. HomeTeam recommends consulting a waterproofing company for recommendations and repairs.

Evidence of water and mud infiltration to the basement was visible under all three basement windows.

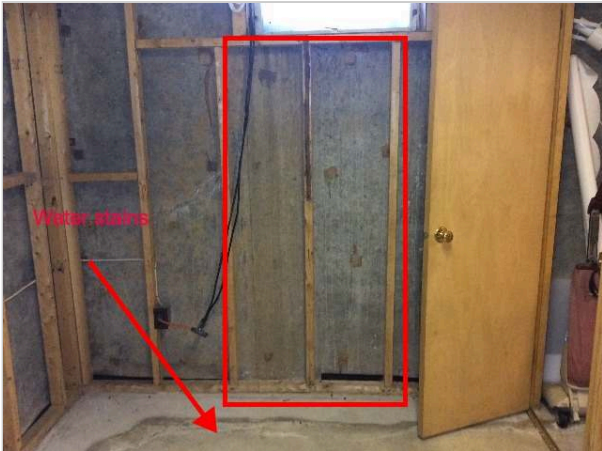
Water stains on the floor and mud and water stains on the wall below window

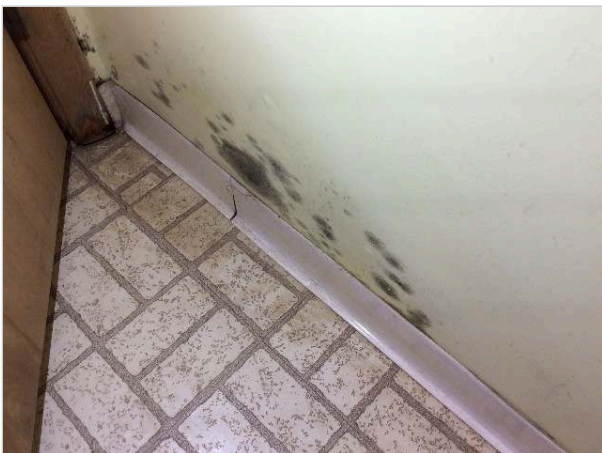
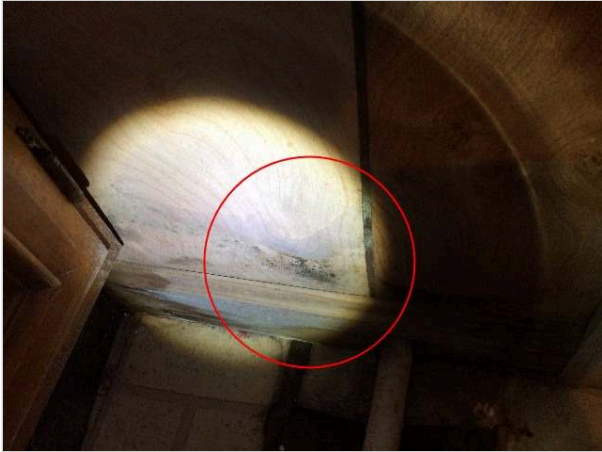
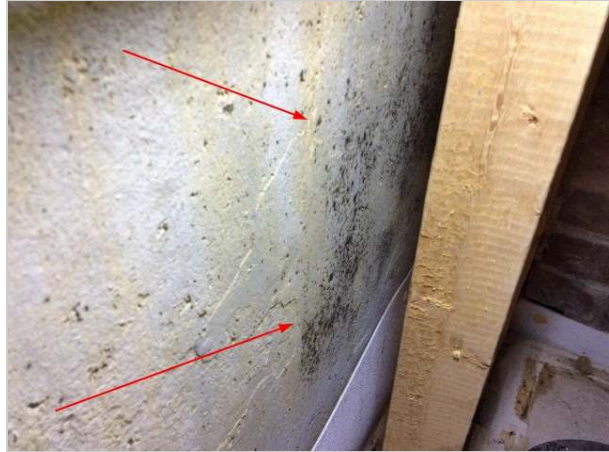
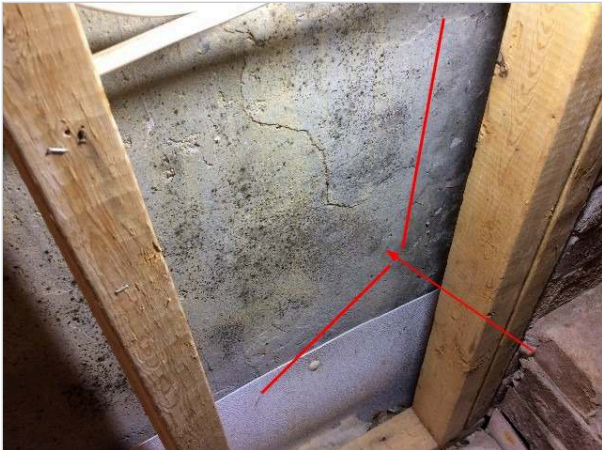
**Mold-like growth is visible in the structure.** The EPA has helpful information that may assist the buyer (<http://www.epa.gov/mold/moldresources.html>). HomeTeam recommends having the areas tested to determine presence, type and relative concentration of mold spores, and professionally remediated by a reputable mold remediation company, which may include removing and replacing affected segments. A mold remediation company may uncover additional areas or issues requiring repair or remediation.

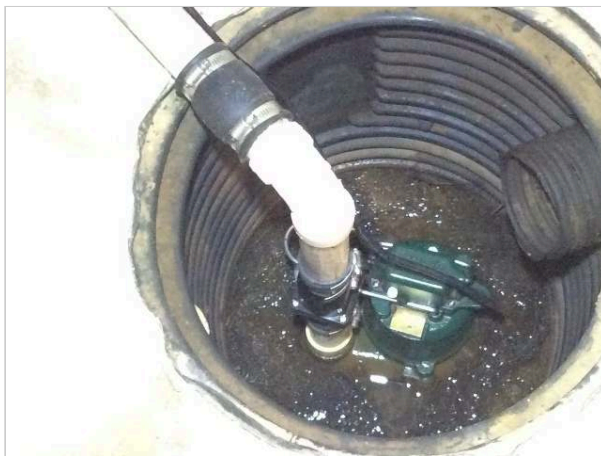
The sump pump primary pipe is 1.5 inches and flows into a reduced 1 inch pipe. This is contrary to sump pump operations and should be corrected by a licensed plumber or handyman. There is also excess loose sediment in the pump croc that should be removed to prevent damage to the pump.

HomeTeam recommends installing a battery backup system for the sump pump. A battery backup will provide electricity to the sump pump when the electrical system in the home has failed. A sample battery backup system can be found here: [LINK](#)

HomeTeam recommends installing an audible GFCI outlet where the sump pump or battery backup to the sump pump is located. The audible alarm will notify you if the power is out at that outlet and the battery backup or sump pump itself is no longer powered. [LINK](#)

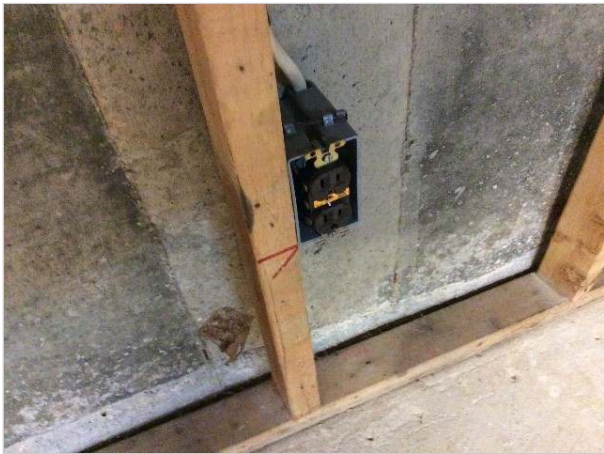
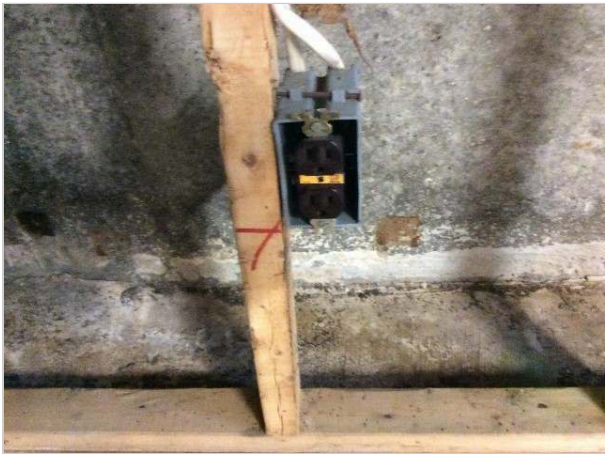
**Missing switch or outlet covers were observed in the basement.** All switch and outlet boxes should be properly covered to avoid a shock hazard. Electrical repairs should be performed by a qualified electrician.

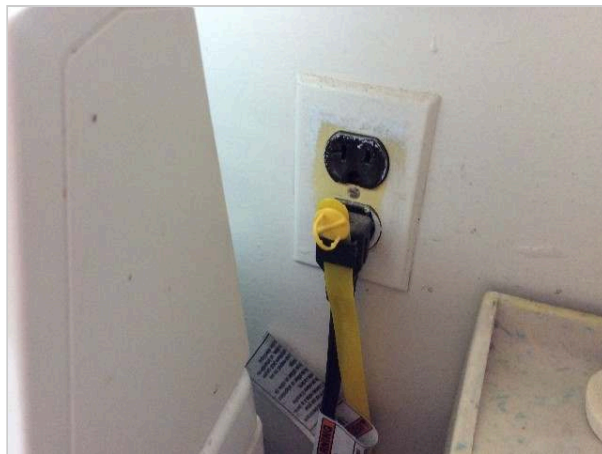
The laundry room lacks GFCI protection. HomeTeam recommends consulting a licensed electrician to install GFCI outlets in ALL "wet" areas.

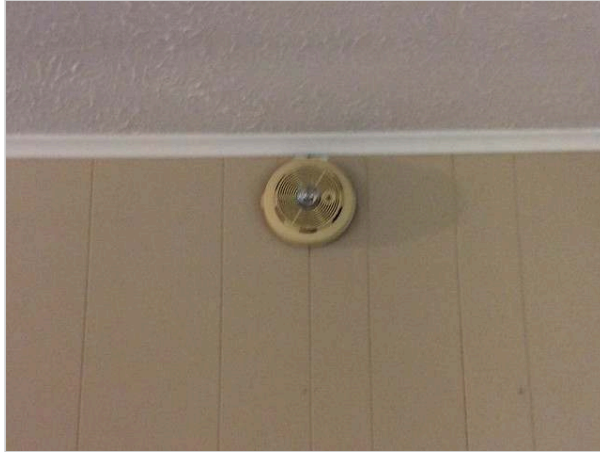
There were smoke alarms found in the house, but not in the recommended number and locations. The National Fire Protection Association (NFPA) recommends installing smoke alarms inside every bedroom, outside each sleeping area, and on every level of the home. For safety reasons, the smoke alarms should be tested upon occupancy. The batteries (if any) should be replaced with new ones when you move into the house, and tested on a monthly basis thereafter. The life expectancy of a smoke alarm is generally no more than 10 years, after which the sensors may lose sensitivity. Moreover, the test button only confirms that the battery, electronics and alert systems are working - it does not mean that the smoke sensor is working. Therefore, HomeTeam recommends replacing any smoke alarm that is 10 year old or older.

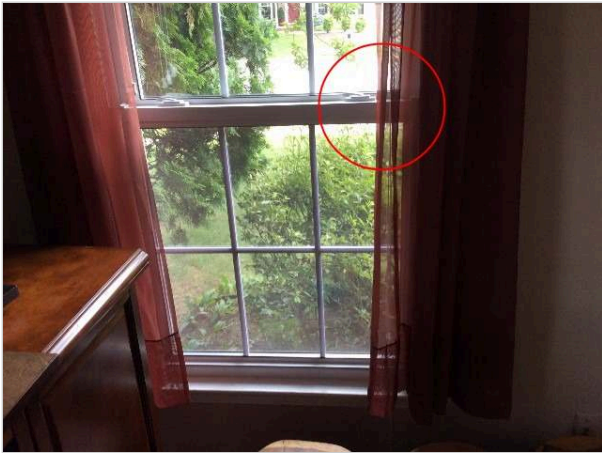
Corner Window - Front of Home

A minor crack was observed on the vinyl sash on one window in the living room, but did not appear to prevent the window from functioning properly. HomeTeam suggests monitoring the affected area for signs of continuous damage or consulting a handyman or licensed contractor for repairs. Marked with blue tape.

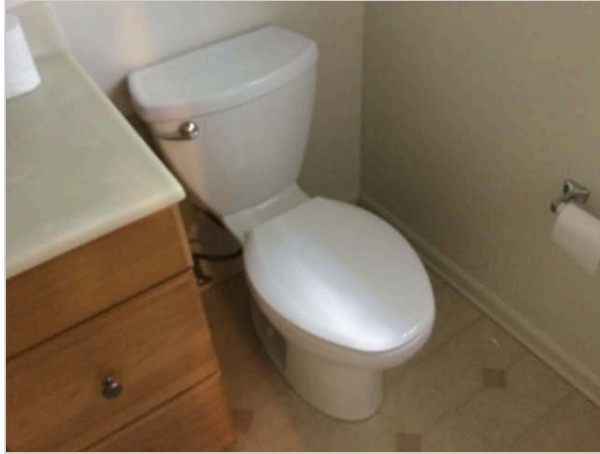
**The toilet in the master bath is loose.** Failure to secure the toilet may lead to leakage around the wax ring. The toilet should be secured.

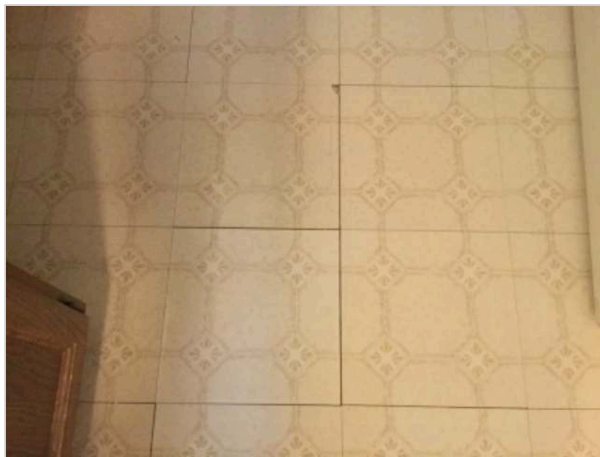
Vinyl flooring squares in the hallway bathroom have gaps between the tiles that could allow water into the subflooring. HomeTeam recommends consulting a flooring specialist for recommendations.

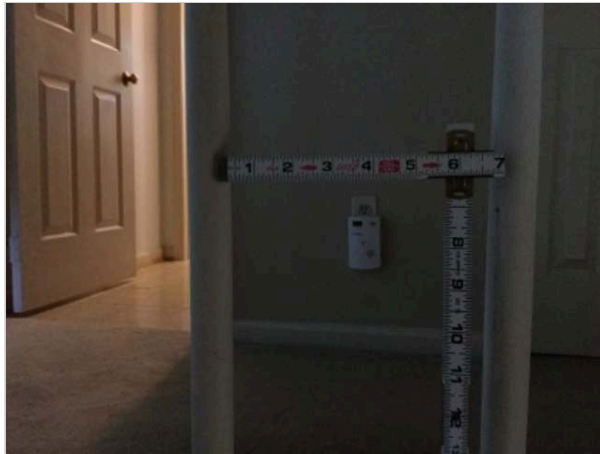
**The balusters on the second floor handrail were spaced greater than four inches apart, creating a potential safety hazard for small children.** Generally accepted construction techniques provide for balusters to be installed vertically and spaced no greater than four inches apart. Larger baluster spacing can also be a safety concern. Consult with a general contractor for cost estimates for additional balusters.

7 inches between balusters

For a less expensive alternative to replacing wide balusters, HomeTeam suggests visiting this sample solution here: [LINK](#)

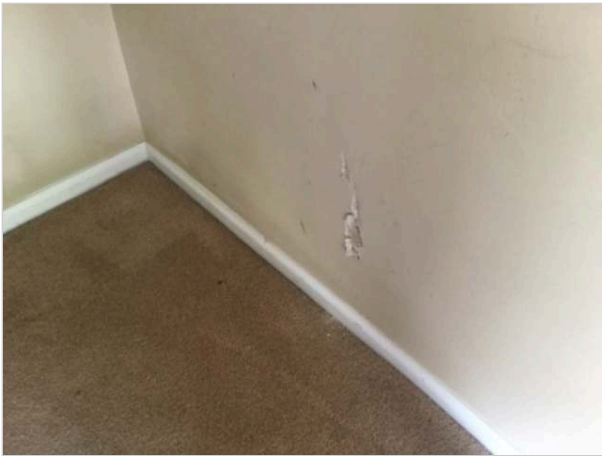
NOTE: Wall damage was identified in the main stairway.

Wall on the right at the first landing

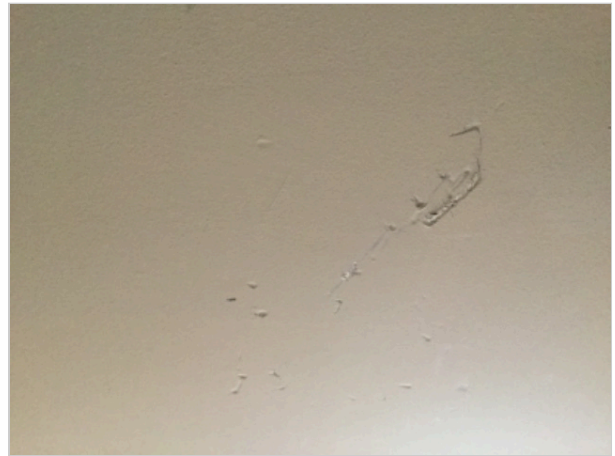
Overhead drywall at base of stairs

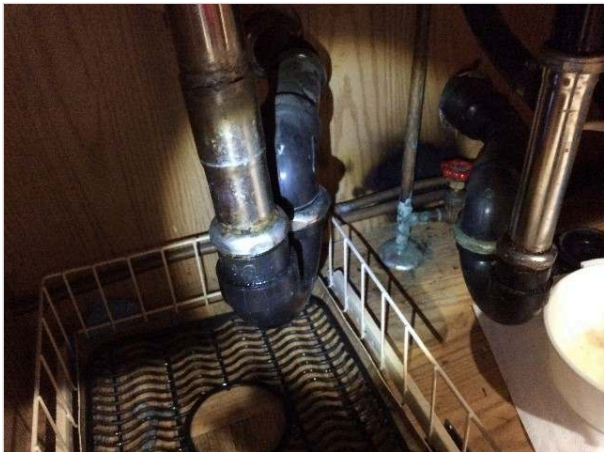
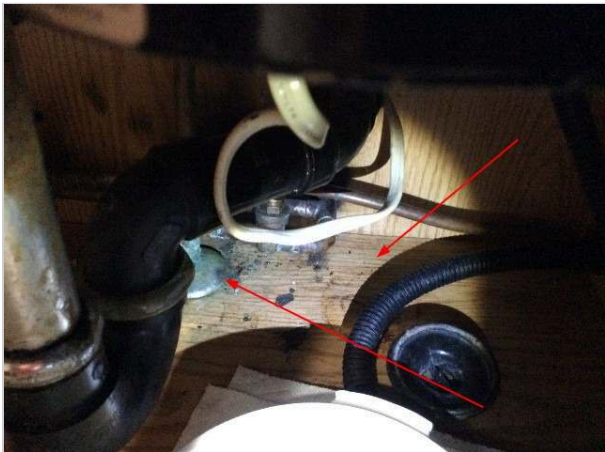
NOTE: Evidence of previous water intrusion is present under the kitchen sink.

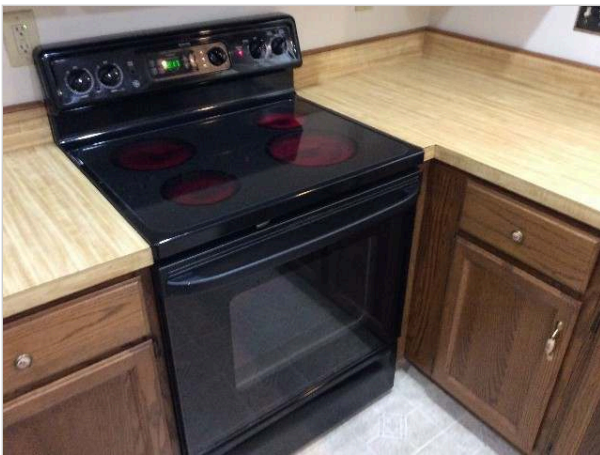
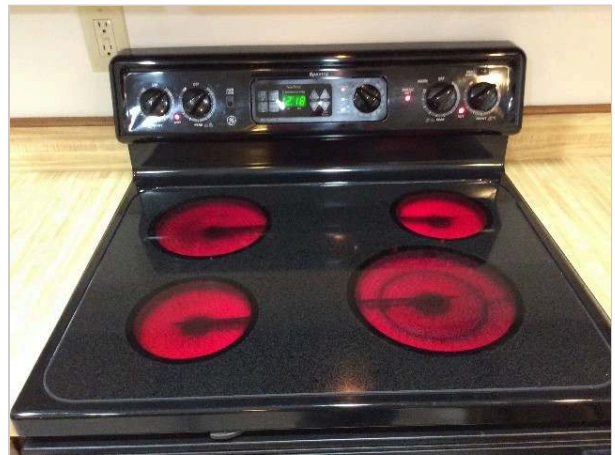
The range does not have an anti-tip device installed. This is a safety issue and should be corrected. HomeTeam suggests consulting a handyman to install an anti-tip device on the range.

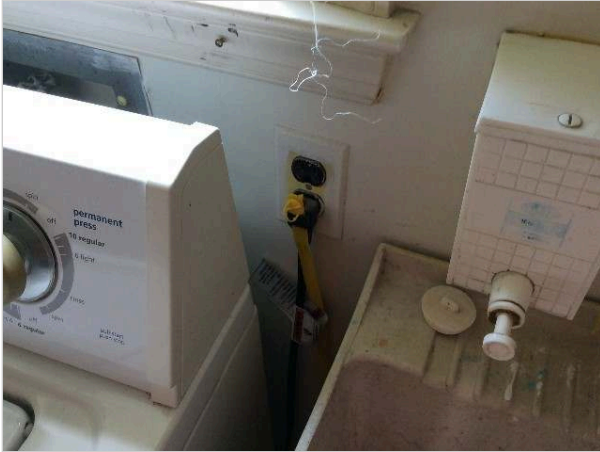
Dryer vent hose appears damaged and should be replaced

NOTE: Dryer vent hose appears to be damaged and may need to be replaced.

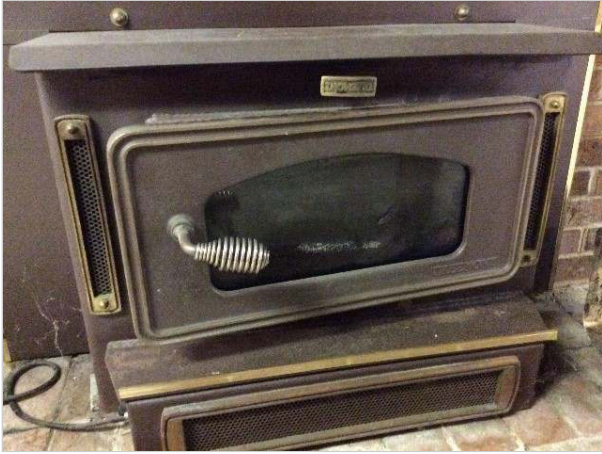
**Cracks were present in the firebox of the fireplace located in the basement.** Generally, firebox cracks are acceptable unless they are wide enough to fit a quarter into. The bricks and mortar inside the firebox are designed to act as a heat and spark shield and should be free of any voids. The firebox should be repaired and further assessed by a qualified chimney and fireplace service.

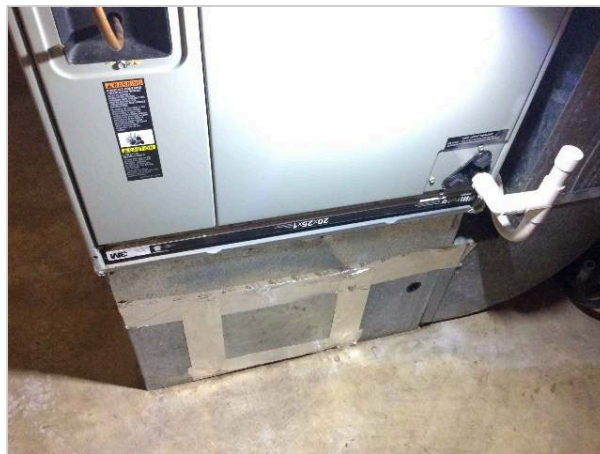
HomeTeam identified a manual damper in the HVAC ducting. The damper is designed to optimize heating and cooling in different seasons. HomeTeam recommends consulting a licensed HVAC service to identify the damper, ensure it is working properly and provide the homeowner with directions on its use.

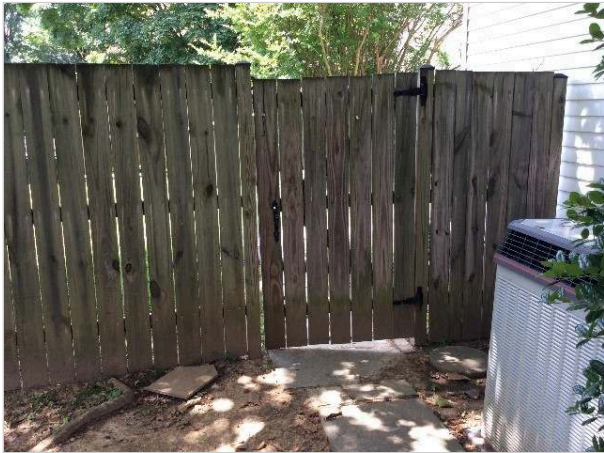
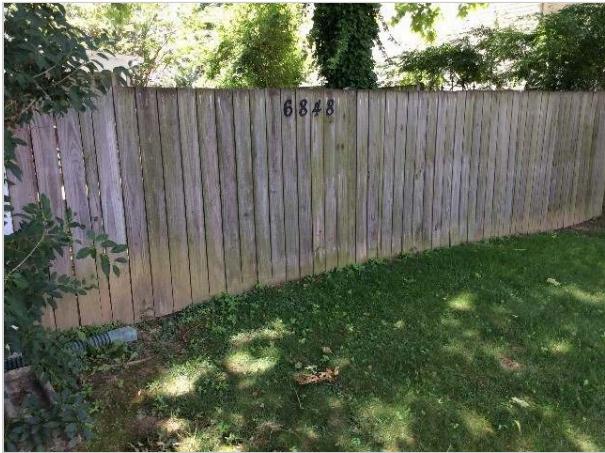
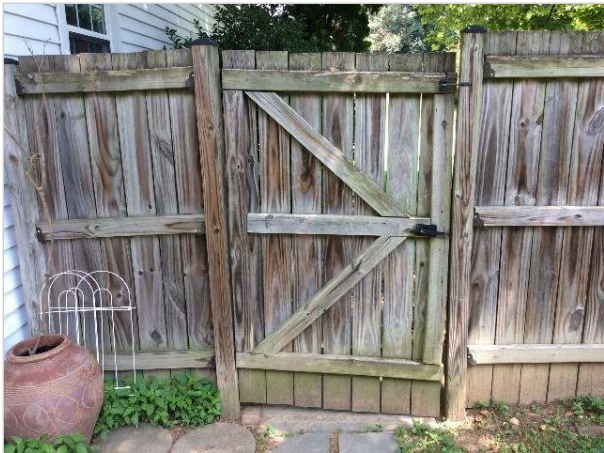
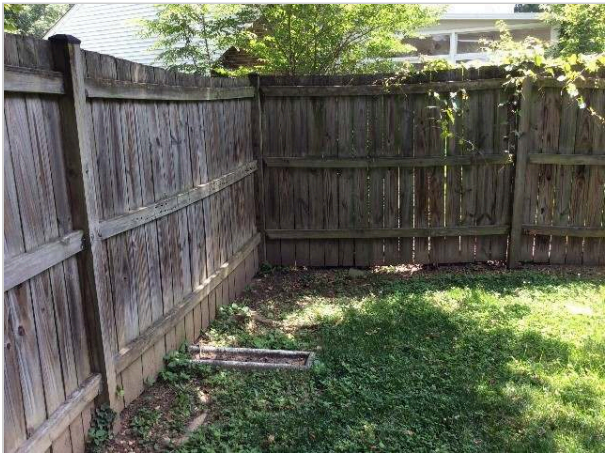
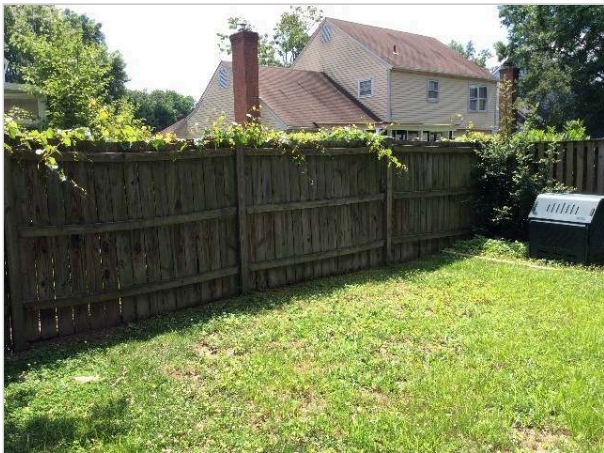
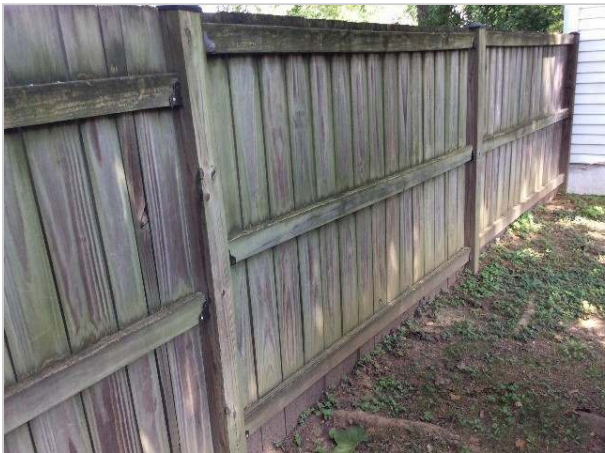
**FENCING AND GATING**

The fencing was in serviceable condition and the gating was functional at the time of the inspection.
