HomeTeam[®]
INSPECTION SERVICE

HOME INSPECTION REPORT

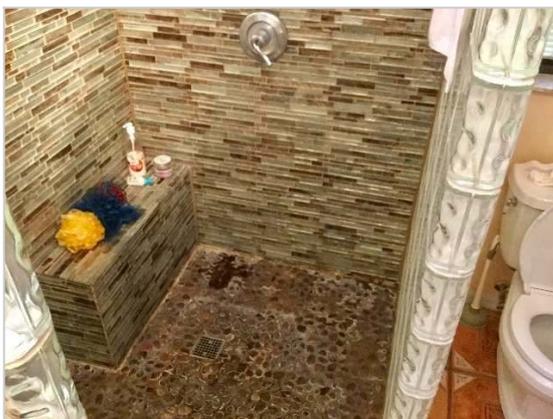
- **The rock floor in the master shower was not professionally done and not properly pitched. Although the shower appears to drain properly, caution should be used when entering the area.**

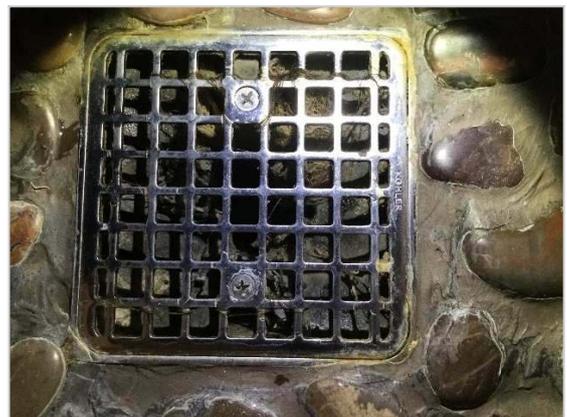
The master shower drain should be cleaned

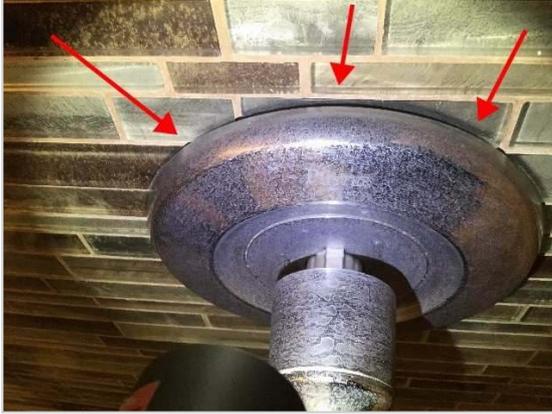
The master shower control plate should be sealed at the wall.

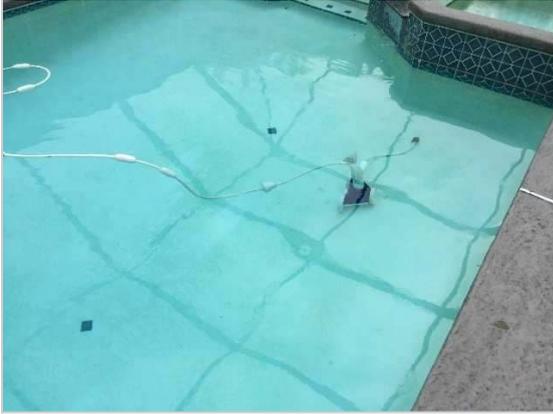
- The pool was originally designed to be used as a salt system but chlorine was being used. The salt equipment was disconnected and it is not known if it is functional. The pool surfaces were worn and pitted, indicating the pool will need to be re-surfaced later. A licensed pool company should be called to further evaluate the equipment.

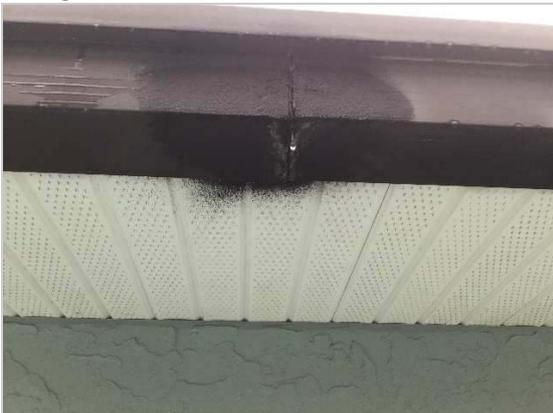
- The gutters in the rear of the home was damaged and should be repaired.

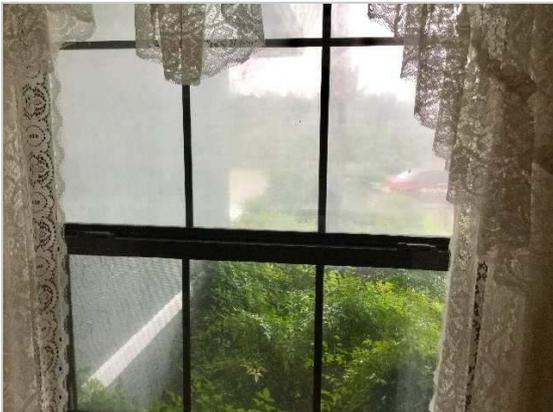
- One or more of the insulated window panes throughout the home had a defective thermal seal. A defective thermal seal can be identified when fogging is observed between the panes of glass. A defective thermal seal does not affect the performance of the window. Repair of the thermal seal can be accomplished by replacing the affected glass panel.

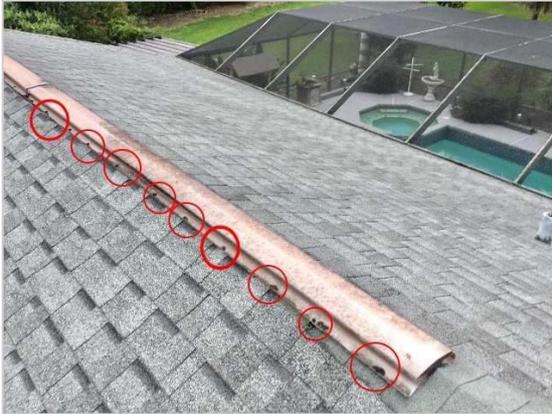
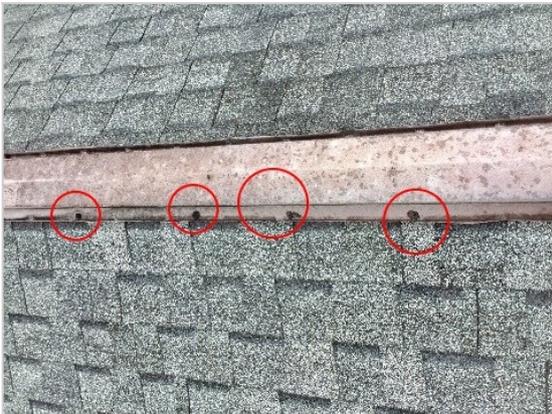
The nails securing the ridge vents were very rusted and a few have pulled through the metal. This

issue should be corrected ASAP to prevent water intrusions from blowing rains. A licensed roofing company should be called to address this issue.

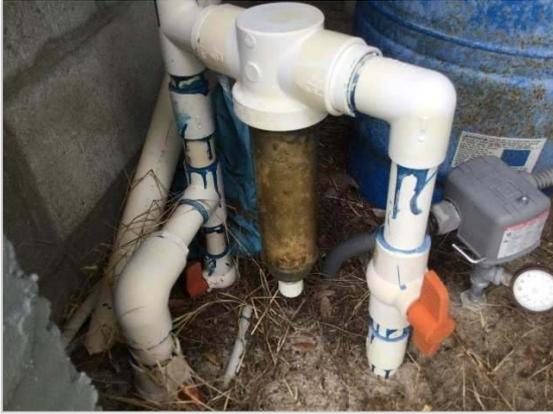
There was a filter at the well that needs monthly maintenance. The power box at the well was very rusted and should be monitored for failure. The equipment at the well is older but functional at the time.

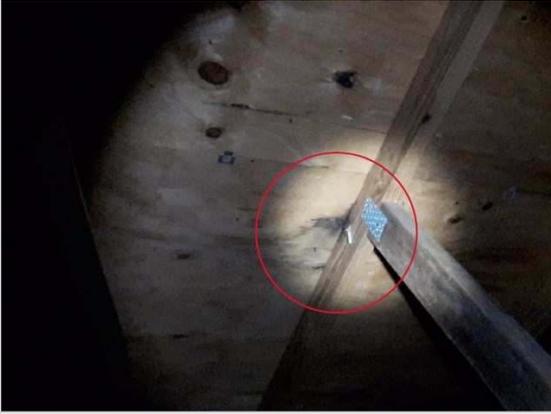
One of the screws securing the water heater panels to the roof.

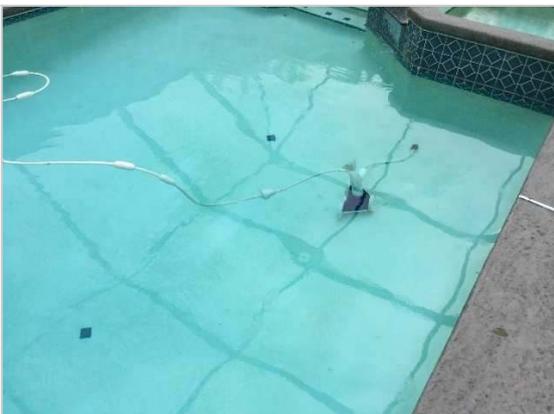
The pool was originally designed to be used as a salt system but chlorine was being used. The salt equipment was disconnected and it is not known if it is functional. The pool surfaces were worn and

pitted, indicating the pool will need to be re-surfaced later. A licensed pool company should be called to further evaluate the equipment.
