HOME INSPECTION REPORT

On November 19, 2016 The HomeTeam Inspection Service made a visual inspection of 123 Sample Road, Charlton, MA 01507. Enclosed please find a written, narrative report of our findings in accordance with the terms of our Inspection Agreement.

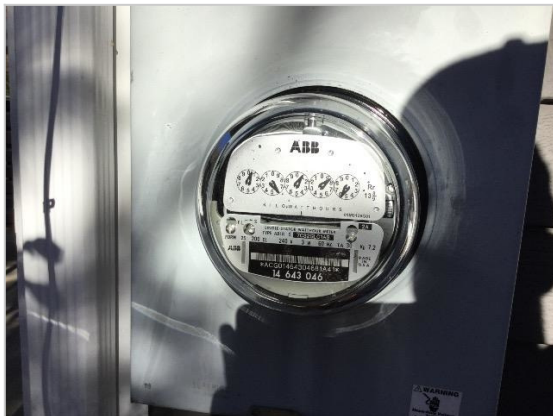
Photo 15

The underground electric service wire entered the structure on the right wall. The electric meter was located on the exterior wall.

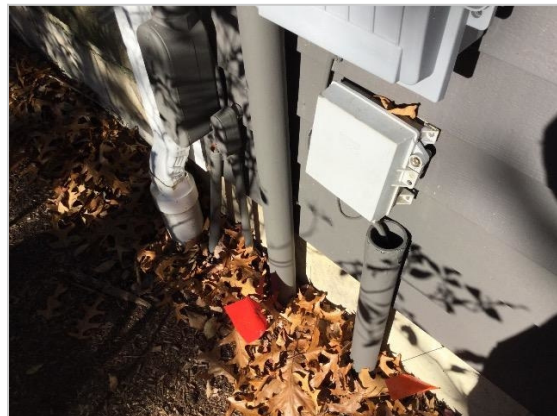
Photo 16

The service wire appeared to be 120/240 volt and 200 amp and entered a Square D service panel, located on the right basement wall. The main service disconnect was 200-amp rated and was located in the main panel. The branch circuits within the panel were copper and aluminum. These branch circuits and the circuit breaker to which they were attached appeared to be appropriately matched. The internal components of the service panel, i.e. main lugs, bus bars, etc were in good condition.
