HomeTeam[®]

HOME INSPECTION REPORT

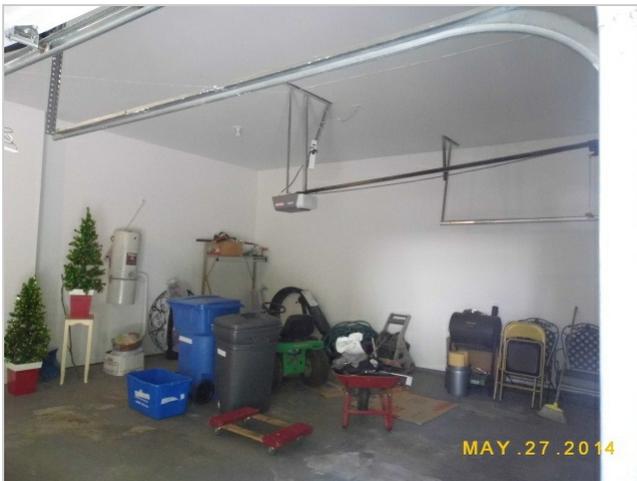
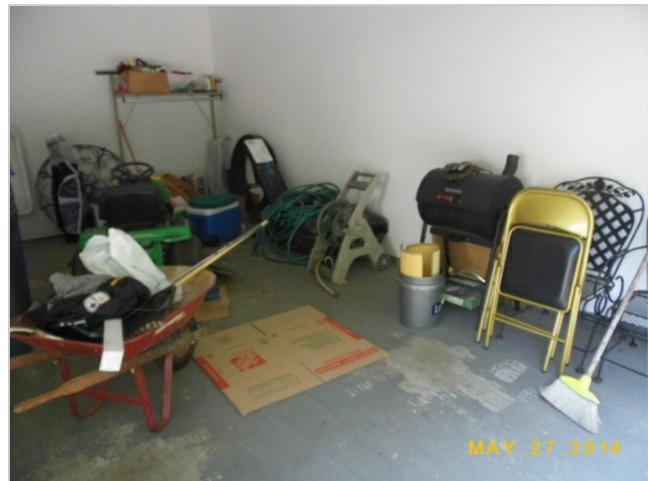
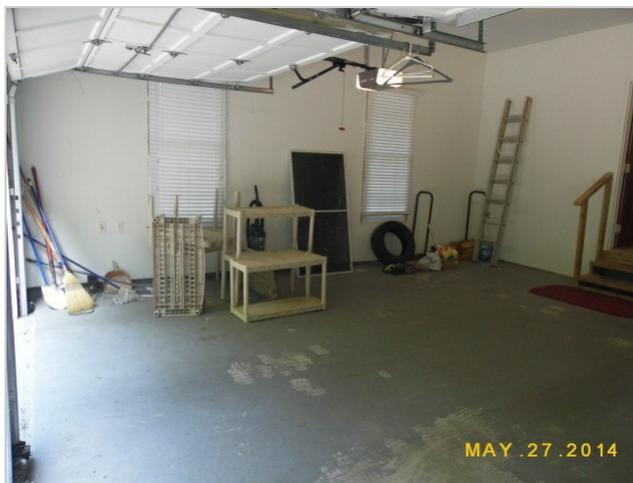
NOTE: The garage was full with stored items and/or shelves at the time of inspection; therefore several areas in the garage could not be viewed.

NOTE: The door between the garage and home was a wood door and not self closing. We recommend having the door replaced.

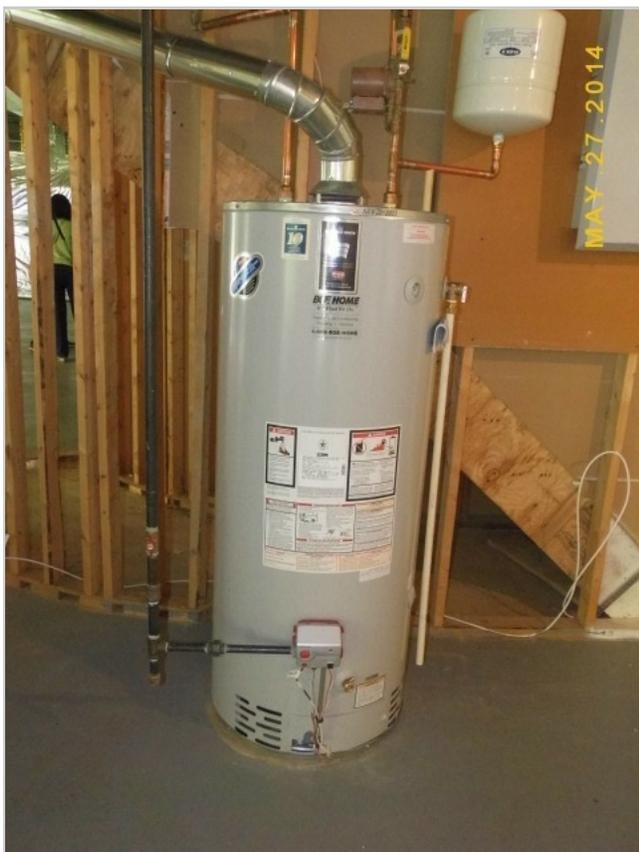
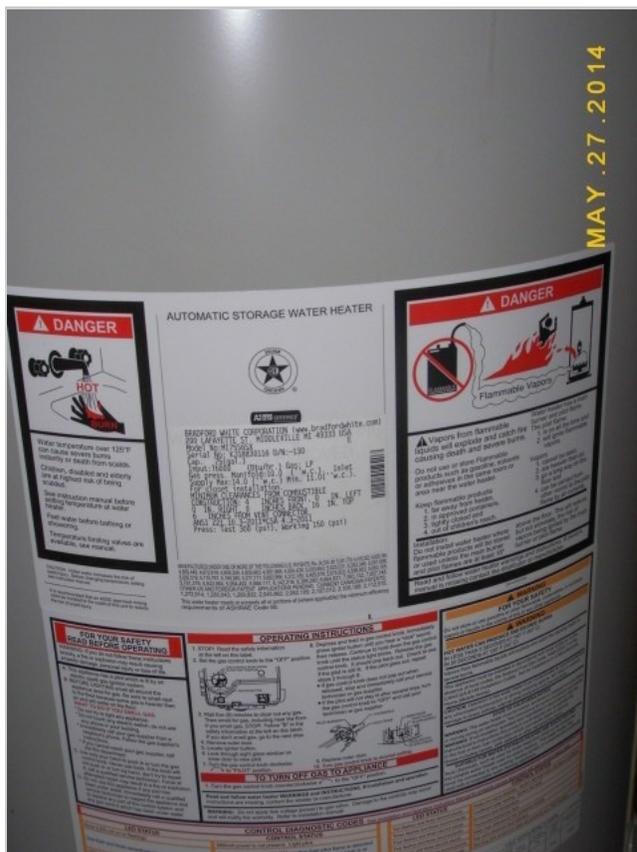
There was a 75 gallon capacity, propane gas water heater located in the basement. The water heater was manufactured by Bradford White, model # MI75S6SX and serial # KJ18830115. Information on the water heater indicated that it was manufactured one year ago. A temperature and pressure relief valve (T&P) was present. Because of the lime build-up typical of T&P valves, we do not test them. An overflow leg was present. It did terminate close to the floor. Your safety depends on the presence of a T & P valve and an overflow leg terminating close to the floor. There was an adequate venting system from the water heater to the exterior of the house. The water heater was functional.

NOTE: There was a gas odor at the water heater. We recommend consulting a licensed plumber to evaluate and correct as needed.

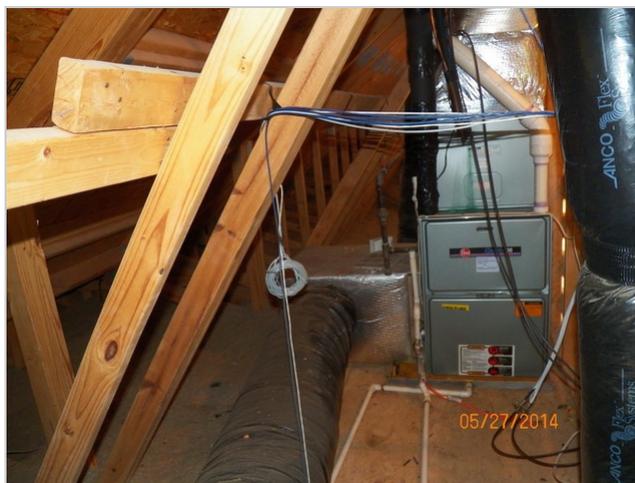
NOTE: The second level furnace cover could not be removed due to the screws not unscrewing. Therefore,

the data plate was not accessible and the unit could not be properly inspected. However, there were signs of rust in the pan and signs of a condensation leak at the top of the unit. We recommend consulting a HVAC technician to evaluate and correct as needed.

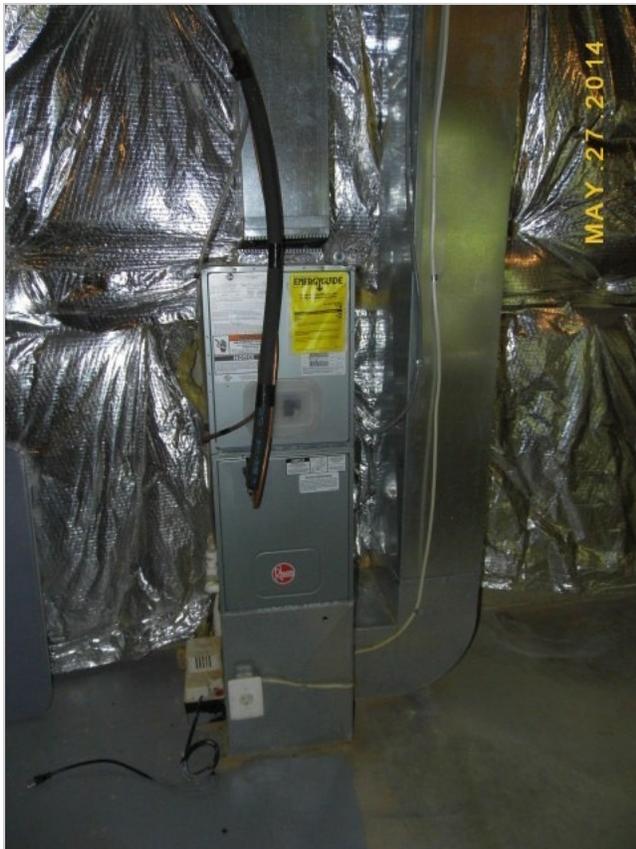
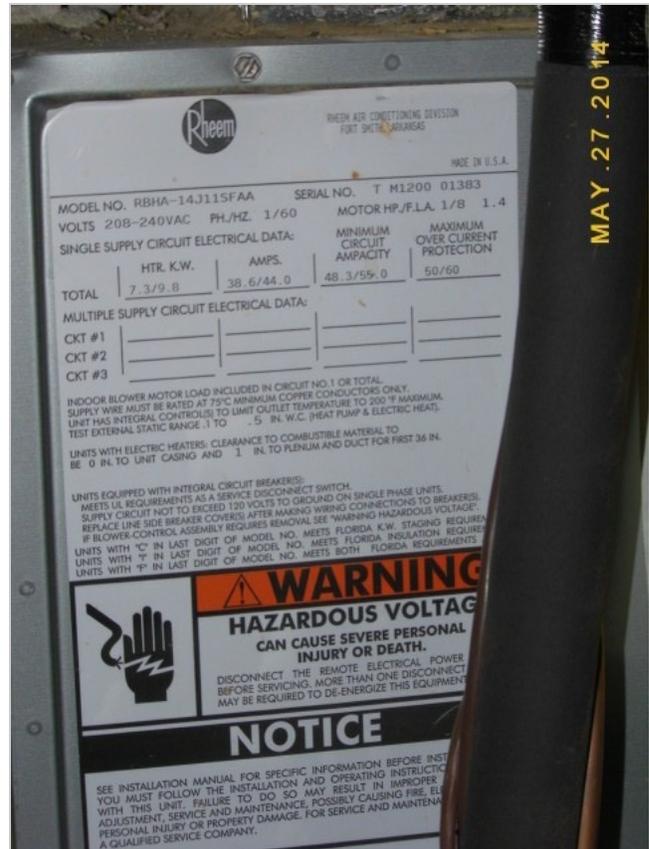
The heated and cooled air for the sun room was distributed by a Rheem electric air handler, serial # T M1200 01383, model # RBHA-14J115FAA. The unit was located in the basement of the home. This unit is approximately 14 years old. The unit was found to be non functional.

NOTE: The air handler was found to be nonfunctional. We recommend consulting a HVAC technician to evaluate the unit to determine the extent of repair required.

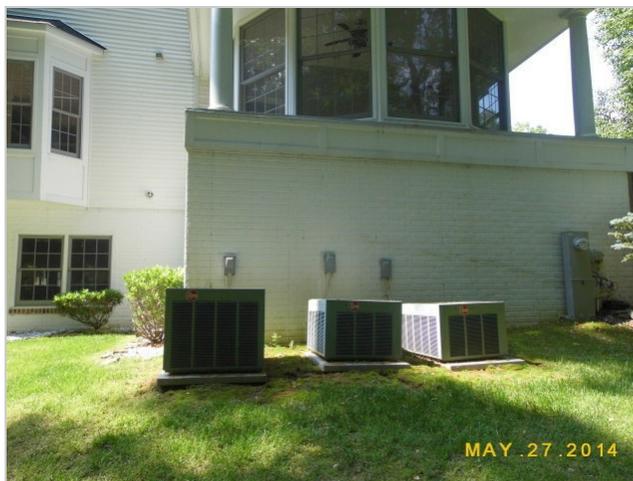
The electric outdoor air conditioner condensing unit for the basement and first level was a Rheem, model # RAMA-042JAZ and serial # 5461 M1700 06956. The unit was located at the left side of the home. This unit is approximately 14 years old. The cooling system was found to be nonfunctional.

NOTE: The air conditioner was nonfunctional at the time of the inspection. The electric circuit breaker for the

air conditioner would not re-set. We recommend consulting a licensed electrician to evaluate and repair as needed. After the circuit breaker has been corrected we recommend having the air conditioner checked for function.

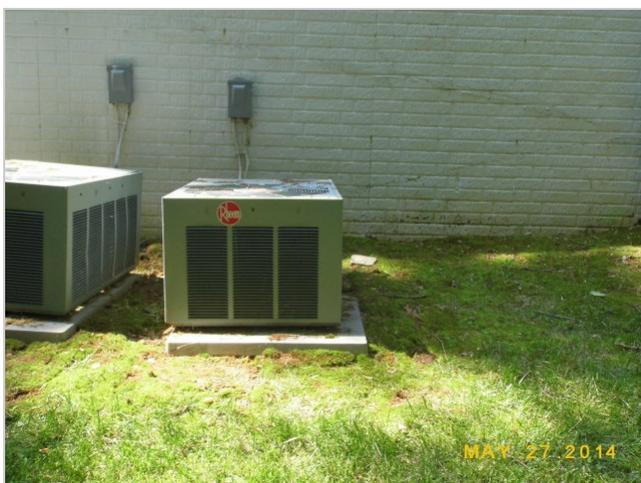
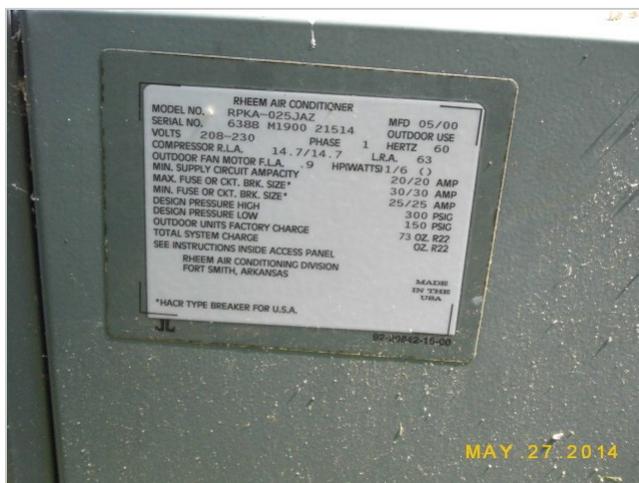
The electric outdoor heat pump condensing unit heating and cooling the sunroom was a Rheem, model # RPKA-025JAZ and serial # 6388 M1900 21514. The unit was located at the left side of the home. This unit is approximately 14 years old. The heating and cooling system was found to be nonfunctional.

NOTE: The heat pump was nonfunctional at the time of the inspection. We recommend consulting a HVAC technician to evaluate and repair or replace as needed.
