## **SAMPLE REPORT**

**SUMMARY:** The purpose of this summary is to provide a "quick view" of some results of the home inspection. **This summary is not intended to be comprehensive and does not include all findings of the inspection.** Please be sure to read the full body of the inspection report, as it contains much more detail about the home. The order in which the systems and components of the property are presented and the inclusion or absence of any defects from the summary is not intended to reflect the relative importance of any system or component of the property. Any recommendations for additional evaluation or estimates must be performed prior to the conclusion of the inspection contingency period. The following is a summary of the inspection performed at 1234 Fifth Street, HomeTown, ON A1B 2C3:

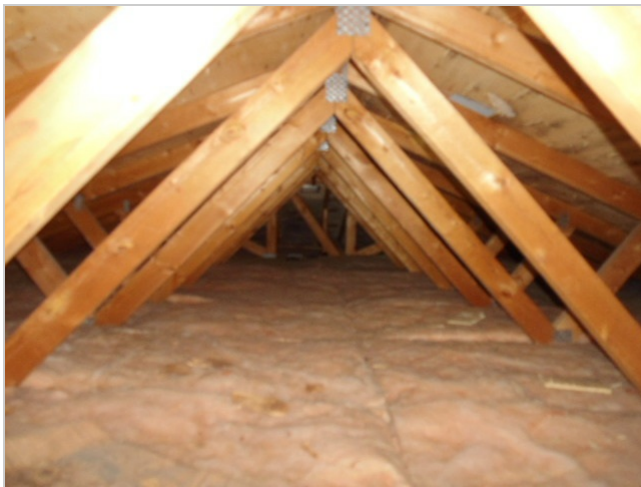
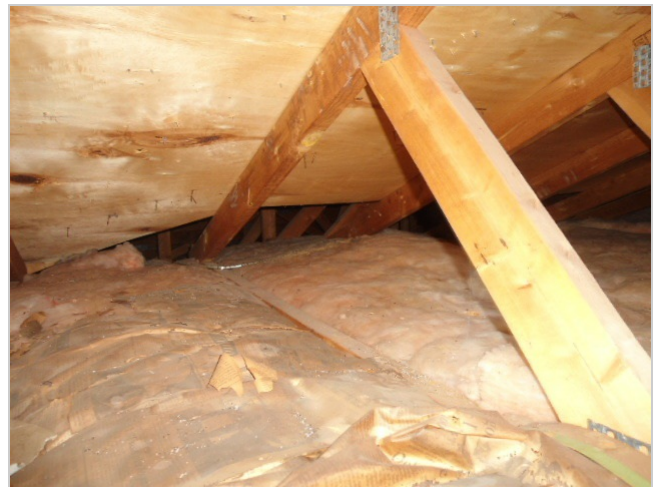
The attic was accessed through an access panel in the hallway and inspected from this location. The attic above the living space was insulated with fiberglass batted insulation, approximately 4-inches in depth. Insulation behind finished walls was not visible. Ventilation throughout the attic was provided by soffit and roof vents. The roof structure consisted of two-inch by four-inch wood trusses spaced 24 inches on center and plywood sheathing.

Because of the configuration of the framing and insulation, which limited access, it was not possible to inspect all areas of the attic. It is important that the inspector does not disturb the insulation during the inspection. There was no moisture visible in the accessible attic space at the time of inspection. There were no major visual defects observed in the accessible attic or roof structure.
