HOME INSPECTION REPORT

On Friday, June 7, 2019 The HomeTeam Inspection Service made a visual inspection of 123 Sample Drive, Anytown, NJ 08302. Enclosed please find a written, narrative report of our findings in accordance with the terms of our Inspection Agreement.

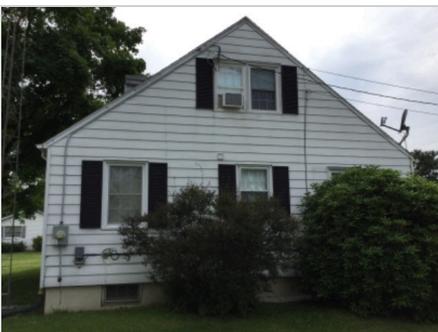
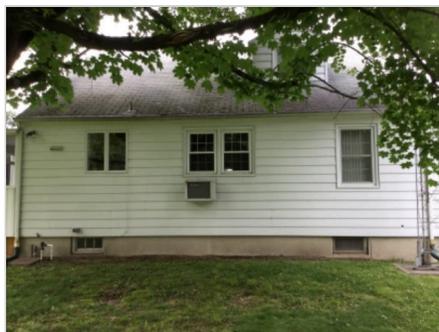
A hole was noted on the back of the structure's exterior. This condition does not have any effect on the structural integrity of the building. The areas should be repaired to prevent water intrusion.

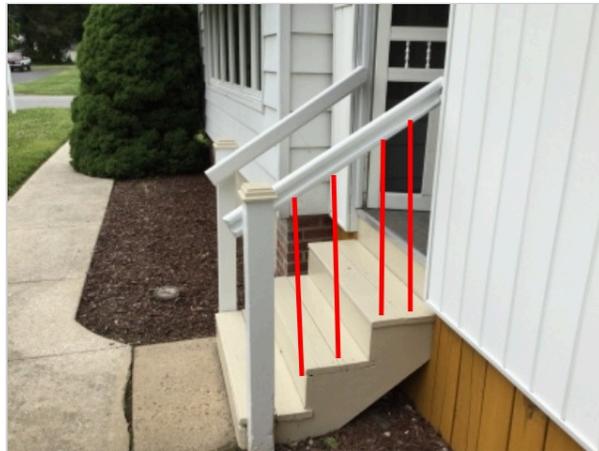
Photo 8

The steps to side door lack balusters.

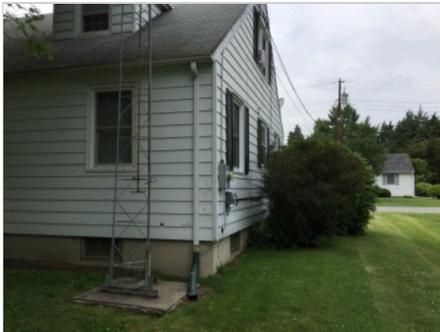
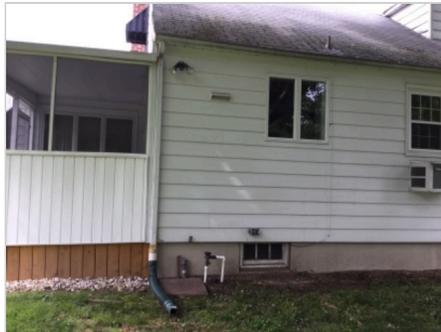
Some of the downspouts around the structure are draining into the ground with no conclusive termination point. HomeTeam recommends ensuring termination points for all downspouts is far enough from the structure and configured in such a way as to ensure water flows away from the foundation during periods of rain.

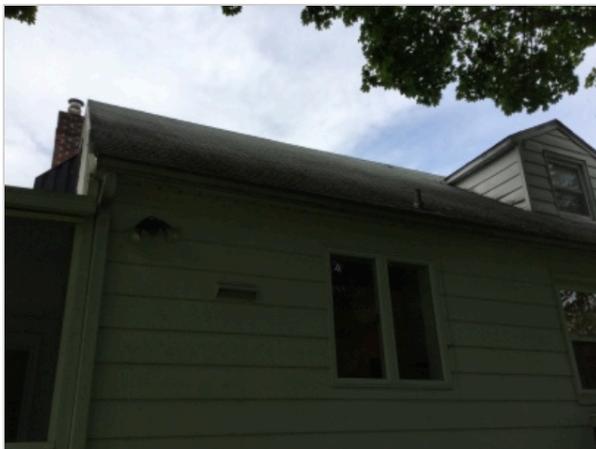
Photo 18

Gutters were in need of cleaning at the time of the inspection. Clogged gutters can cause roof drainage water to drain at the base of the foundation, causing basement water problems. Overflow from gutters can cause damage to fascia that is not visible or apparent at the time of the inspection. The gutters should be cleaned.

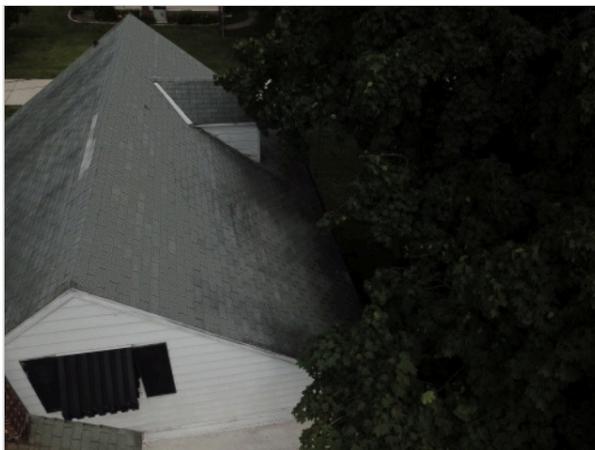
Photo 29

Tree branches were hanging over, or making contact with the roof. The trees should be cut back away from the roof to avoid damage to the roofing material.

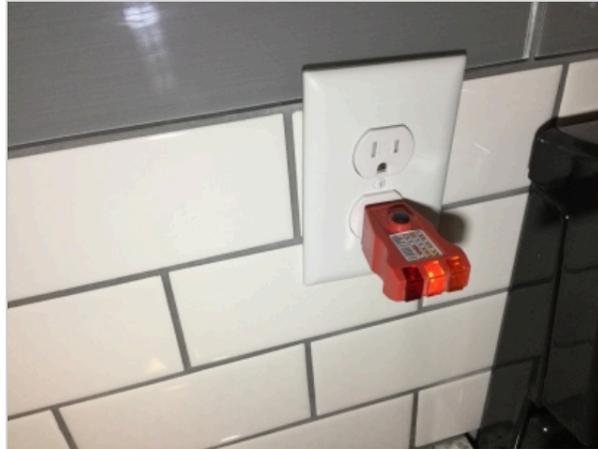
Photo 57

A loose outlet was observed in the kitchen. This could be a shock hazard due to exposed electrical contacts. The affected outlet(s) should be replaced by a qualified contractor.

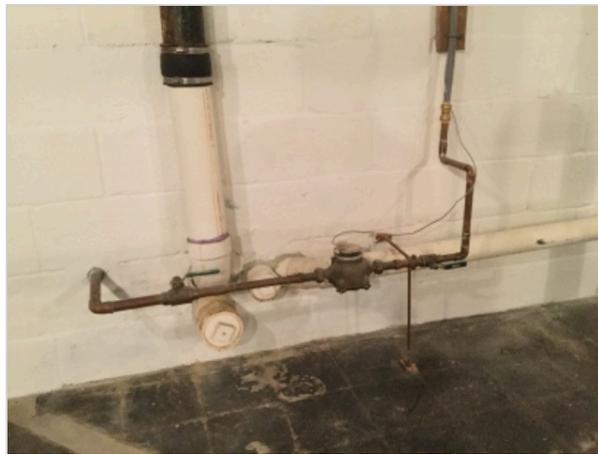
Photo 76

The water meter was located in the basement. The main water shutoff valve for the structure was located adjacent to the water service entry point in the basement. Water shutoff valves are visually inspected only. No attempt is made to operate the main or any other water supply shutoff valves during the inspection. These valves are infrequently used and could leak after being operated. The only exception to this policy is made when the main water supply valve is off upon arrival at the inspection. Since it is the buyers right to have all utilities operable for the home inspection, we will attempt to turn the main water valve on for the inspection. The HomeTeam is not responsible for leaks caused by operating the valve.

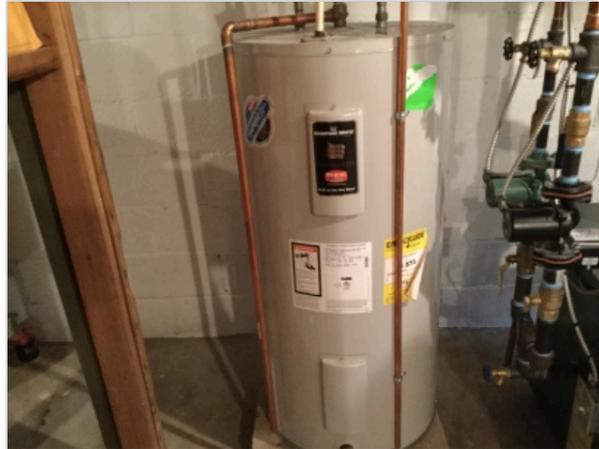
Photo 77

A 50 gallon capacity, electric water heater was located in the basement. The water heater was manufactured by Bradford White, model number M250S6DS-1NCWW and serial number LK35176554. Information on the water heater indicated that it was manufactured 5 years ago. Hot water temperature was approximately 110 degrees F.

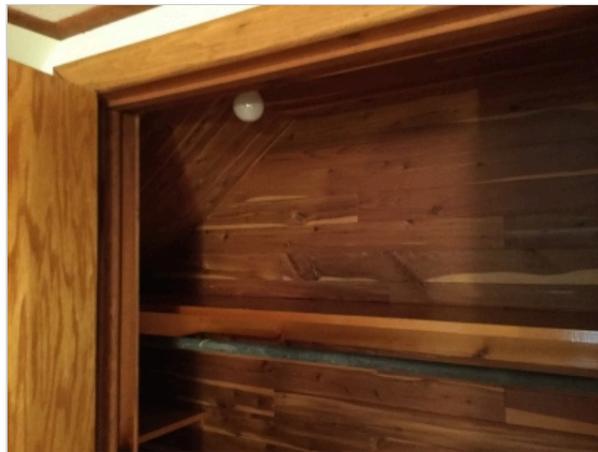
Photo 90

The structure has closets with overhead lights installed. Objects should be kept 12 to 18 inches away from any incandescent lights to avoid a potential fire hazard.

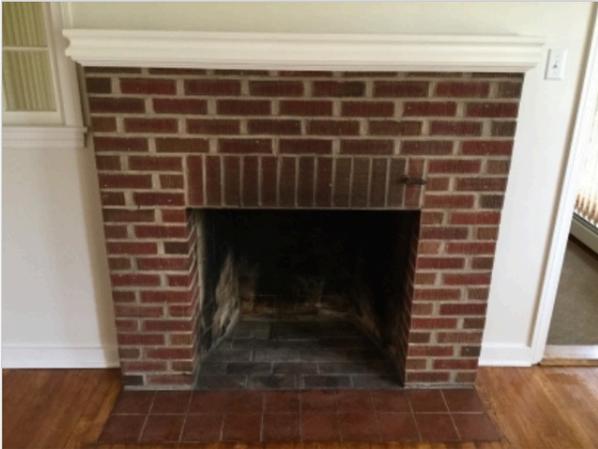
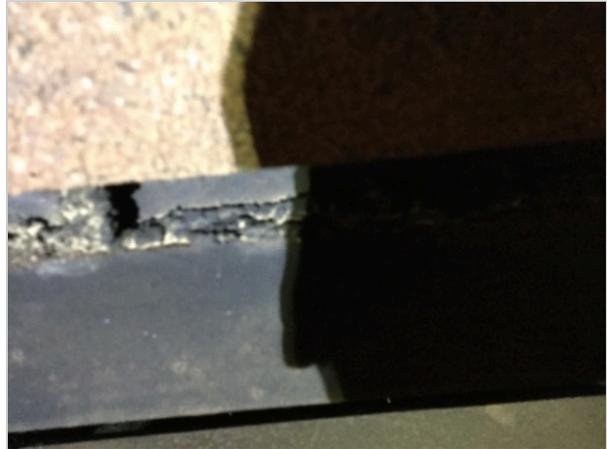
A masonry fireplace was located in the family room. A natural gas supply line was not present. The damper did appear to be functional. The chimney flue was masonry. There was no visual evidence of creosote buildup in the firebox and/or chimney.

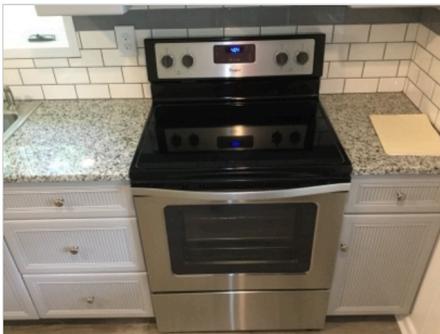
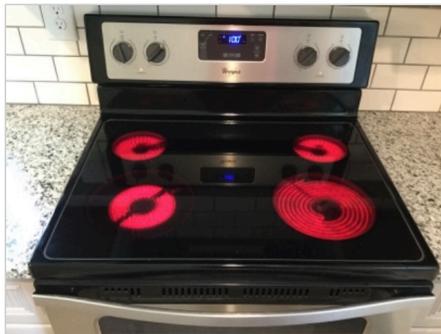
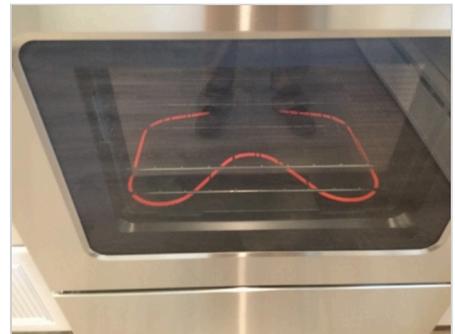
The electric oven and range combo was inspected and did appear to be functional. An anti-tip bracket was installed to secure the oven. The accuracy of the clock, timers and settings on ovens are not within the scope of this inspection.

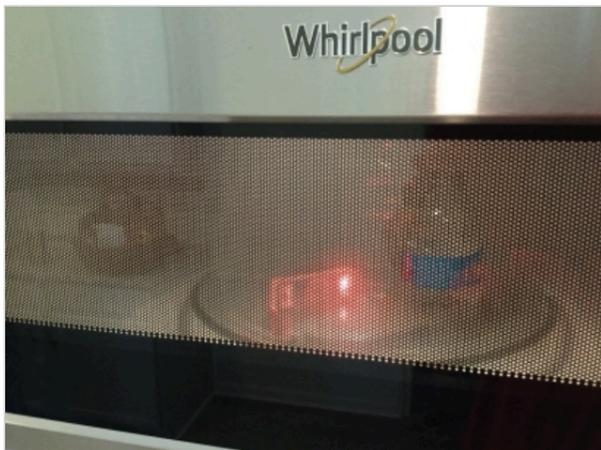
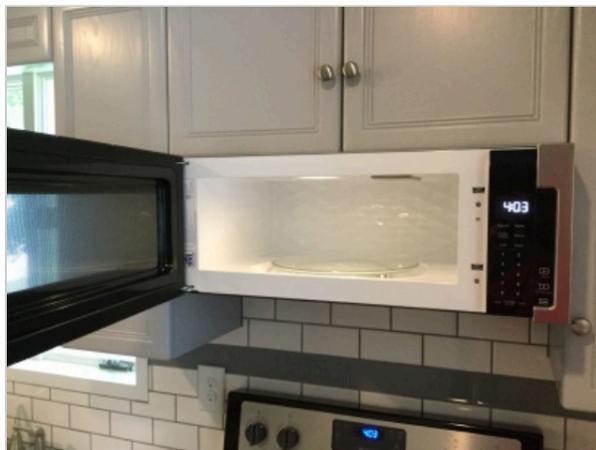
The range hood and microwave combination was inspected and did appear to be functional. The exhaust capacity is not within the scope of this inspection. Cleaning the fan and filter may increase the exhaust capability.

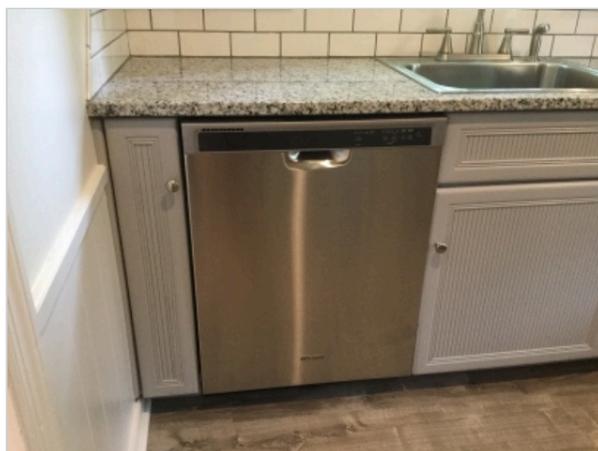
The dishwasher was tested and did appear to be functional.

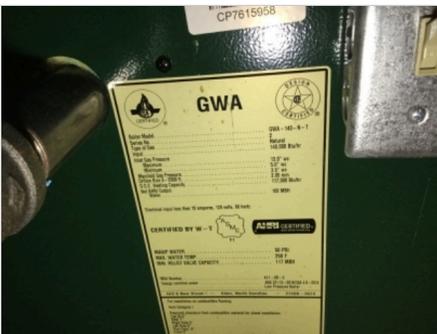
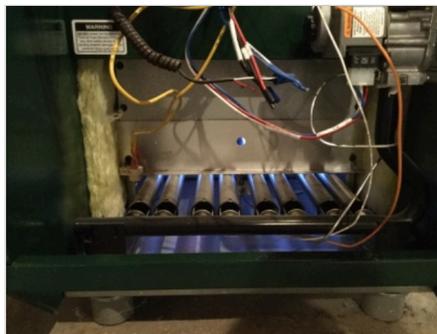
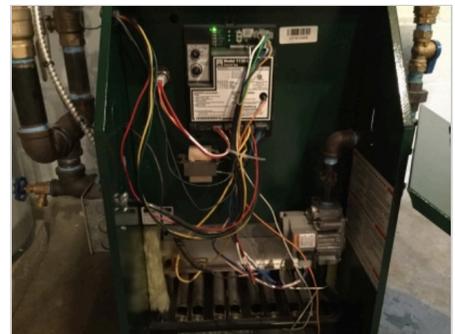
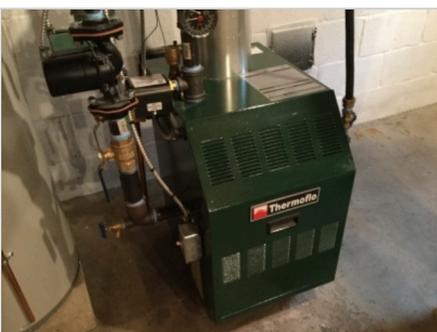
The structure was heated by a Thermoflo natural gas boiler, Model Number GWA-140-N-T and Serial Number CP7615958, which is 2 years old. The unit was located in the basement of the structure. It has an approximate net heating capacity of 117,000 BTUH. The automatic safety controls on the unit were tested and found to be functional at the time of the inspection.

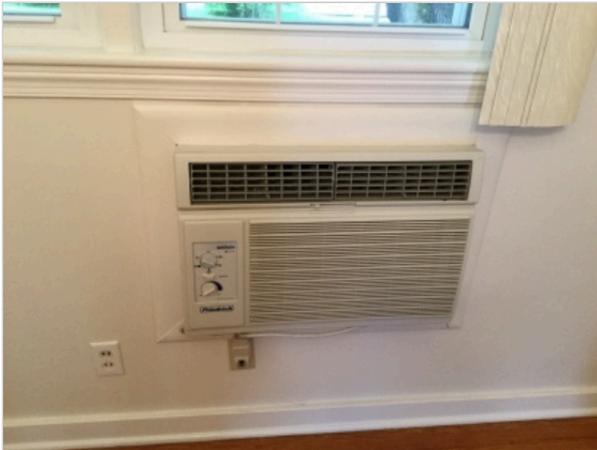
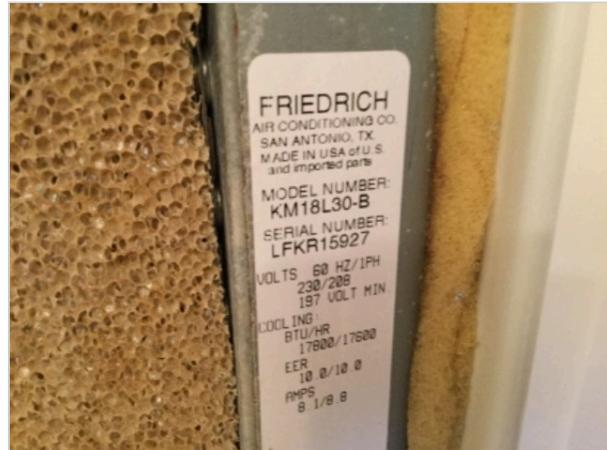
The electric outdoor air conditioner condensing unit was a Freidrich, Model Number KM18L30-B and Serial Number LFKR15927. The unit is located in the back of the structure. This unit is approximately 13 years old. Periodic preventive maintenance is recommended to keep this unit in good working condition. The cooling system was functional.

The temperature was measured at several locations. At the supply it was 57 degrees F, and at the return it was 73 for a difference of 16 degrees F, which is normal.

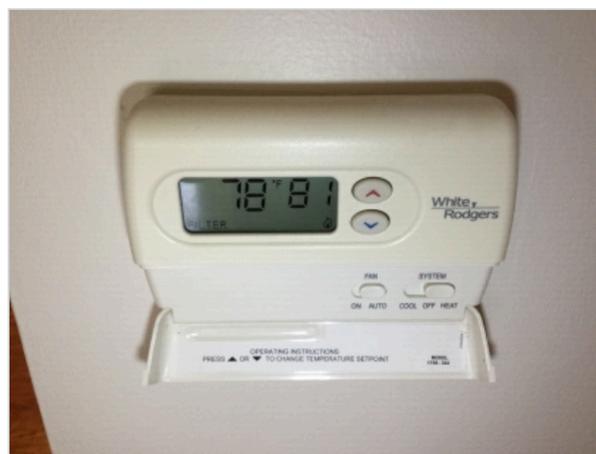
The control for the heating and air conditioning system was a 24 volt digital thermostat located on the living room wall of the home. The thermostat was manufactured by White Rodgers and was found to be in working order.
