HomeTeam[®]

HOME INSPECTION REPORT

The HomeTeam Inspection Service made a visual inspection of 123 Main Street, Anytown, USA 55555. Enclosed please find a written, narrative report of our findings in accordance with the terms of our Inspection Agreement.

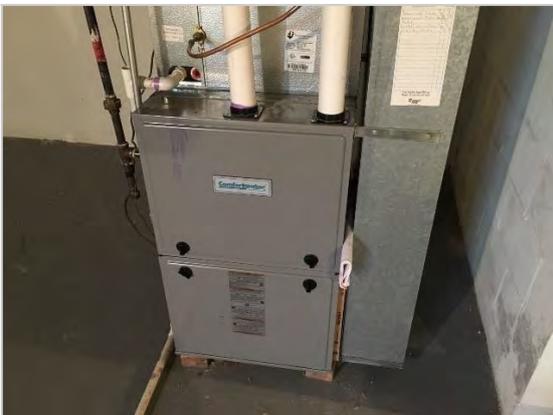
Photo 17

The unit was located in the basement of the structure.

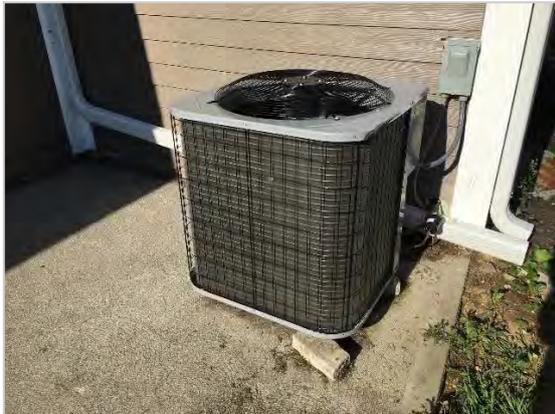
Photo 21

The second electric outdoor air conditioner condensing unit was a Comfortmaker, Model Number R4A348AKN100 and Serial Number X152462739. The unit is located in the back of the structure. This unit is approximately 1 years old. Periodic preventive maintenance is recommended to keep this unit in good working condition. The air conditioning system was tested and found to be functional.
