### HOME INSPECTION REPORT

XXXXXXXXXXXXXXXXXX  
2 Avenida La Promesa  
Coto De Caza, CA 92679

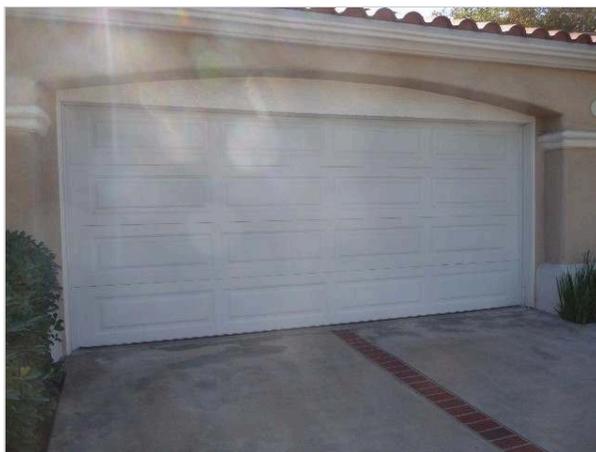
There was a concrete driveway in the front of the home which led to the attached garage. There were minor cracks noted on the driveway. Surface defects in driveways develop and progress with age and are considered normal as long as they do not create a safety hazard. There were no material defects observed in the driveway.

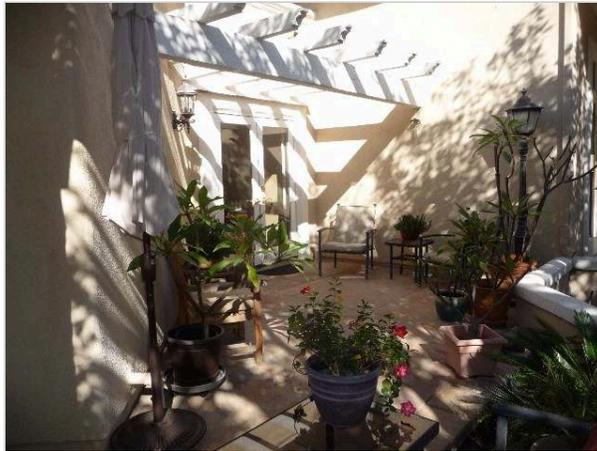
rear patio

There was a concrete patio located in the back of the home. There were no material defects observed to the patio.

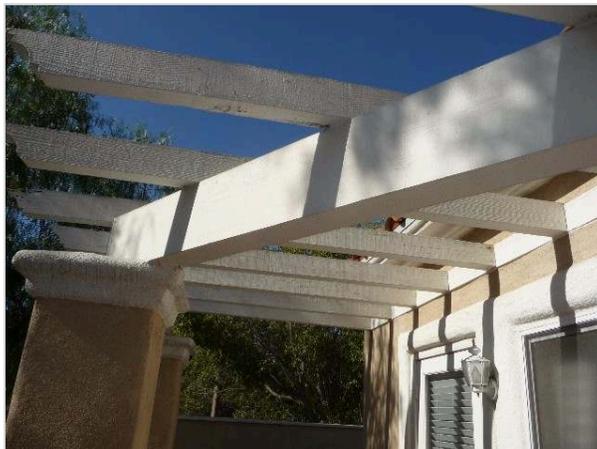
open patio cover

There was an open framework over the patio. There were no material defects observed on the patio cover or its supports.

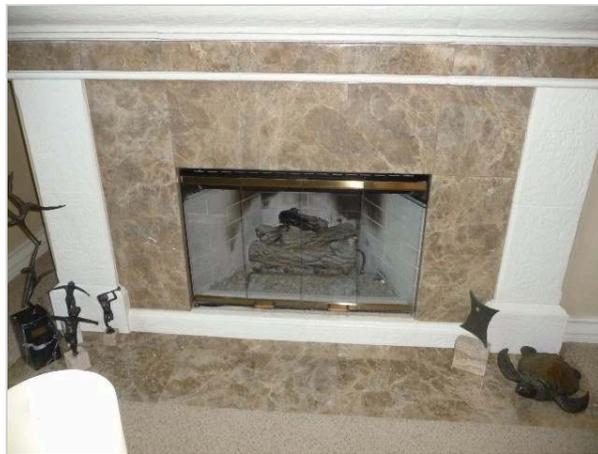
A wood burning fireplace was located in the living room. The damper did appear to be functional. There was visual evidence of creosote buildup in the firebox and/or chimney. There were cracks observed in the firebox or visible portions of the chimney.

Home inspectors are not certified chimney professionals. Only a Level 2 inspection performed by a CSIA (Chimney Safety Institute of America)-certified chimney sweep can determine the condition of the flue and whether the fireplace is safe to use. Recommend a Level 2 inspection and cleaning/servicing of the fireplaces and chimney flues by a qualified professional.

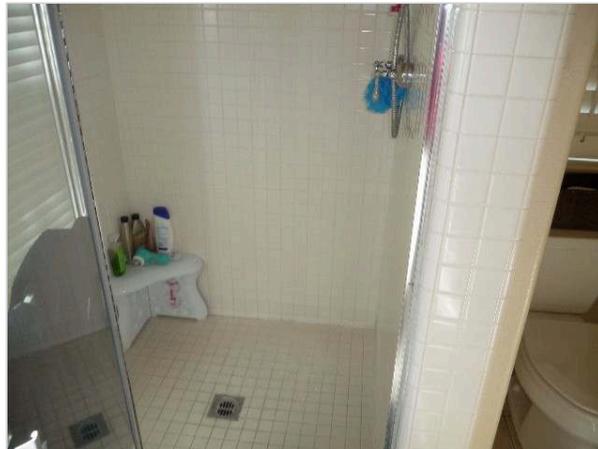
tile shower

A walk-in shower was located in the master bath. The base of the shower was constructed of ceramic tile. While no leaks were noted at the time of the inspection, this type of shower is more prone to leaks than a standard tub or precast shower base. The waterproof membrane or shower pan, which is the primary water proofing material is installed beneath the finished floor and is not visible from the interior of the shower or the subfloor below. We cannot verify the integrity of the shower pan or concealed portions of the drain. Additionally, our test of the unit cannot simulate an actual shower and therefore is not a guarantee that the unit is free of leaks. The cosmetic condition of the tile or grout is not considered during the inspection. The absence or presence of cracks in the tile or joints is not an indication of a leak free unit.

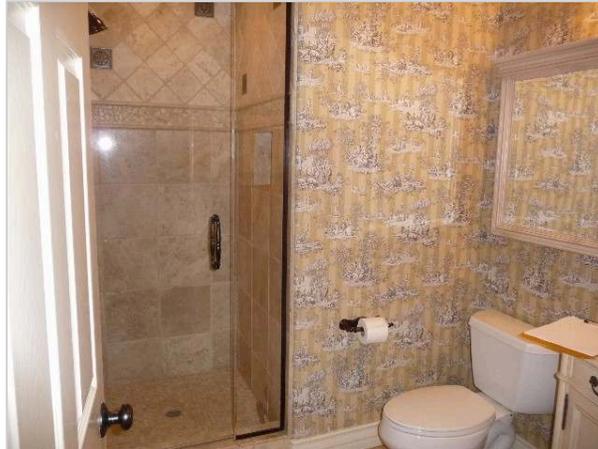
- Shower stall is functional.
- Toilet is functional.
- Exhaust Fan is not functional.
- Lights in the bathroom are functional.
- Receptacles tested were ground fault protected from a remote location.

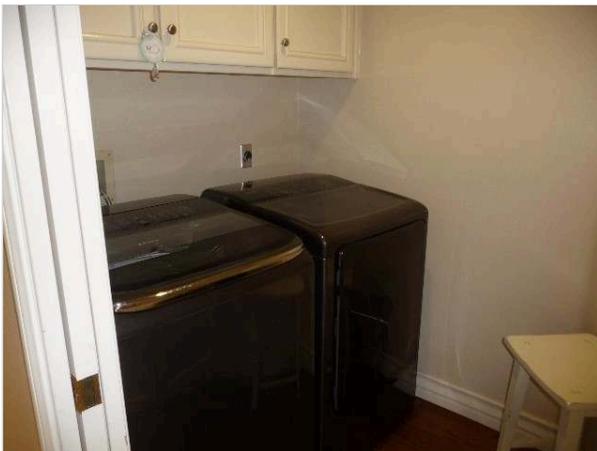
laundry

- Laundry door is found to be functional.
- The floor is wood with no floor drain visible. A containment pan not installed at the washing machine location.
- Walls and ceiling are acceptable.
- Cabinets are functional.
- Exhaust fan is functional.

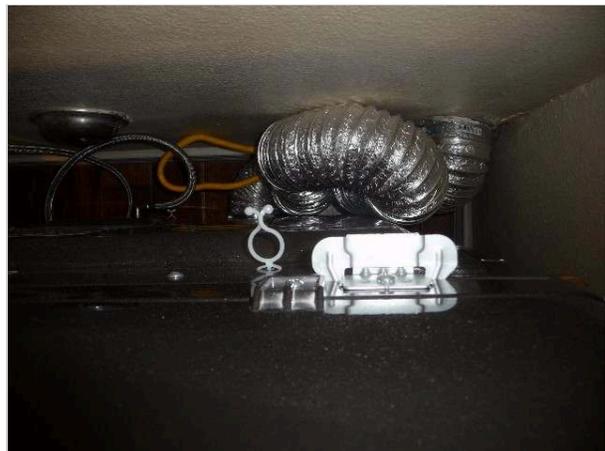
A dryer vent was installed. The visible portion of the dryer vent was inspected and appeared to be functional and adequate for venting to the exterior of the home.

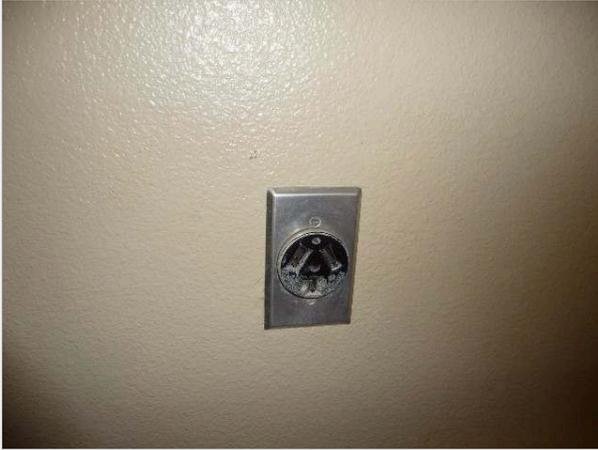
optional electrical outlet for dryer

This note is supplied for informational purposes only, as many clients want to know the type of dryer connections available to them. A 240 volt outlet for an electric clothes dryer was installed in the laundry area. For safety reasons, no attempt was made to verify that the electrical outlet is properly wired or that power is present. Consult with a qualified contractor if the desired type of connection is not available.

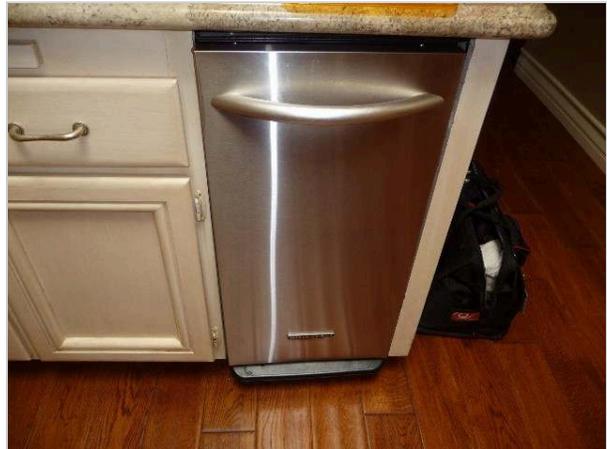
The visible portions of the kitchen cabinets and counter tops were in good condition. The appliances were turned on to check operational function only. No consideration is given regarding the age or components that may be worn or otherwise affected by wear and tear or use. No warranty, express or implied, is given for the continued operational integrity of the appliances or their components. The kitchen contained the following appliances: Note inspection and testing of the trash compactor is beyond the scope of the inspection.

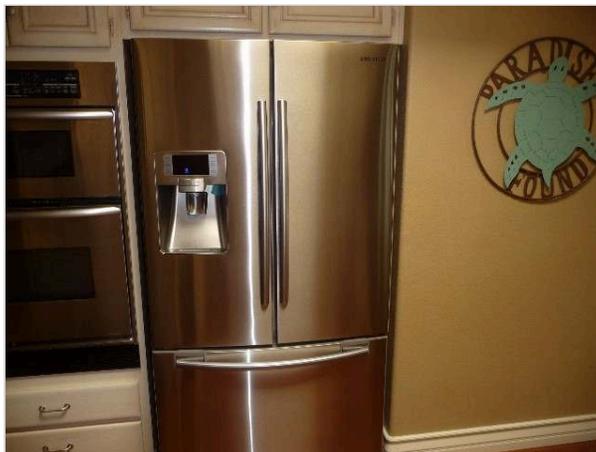
The Samsung refrigerator was inspected and did appear to be functional. The temperature setting and ice maker, if present, are not within the scope of the inspection.

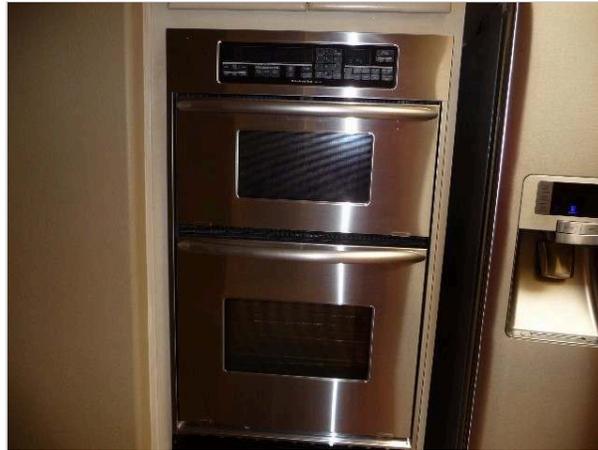
The Kitchen Aid electric wall oven and microwave was inspected and did appear to be functional. The accuracy of the clock, timers and settings on ovens are not within the scope of this inspection.

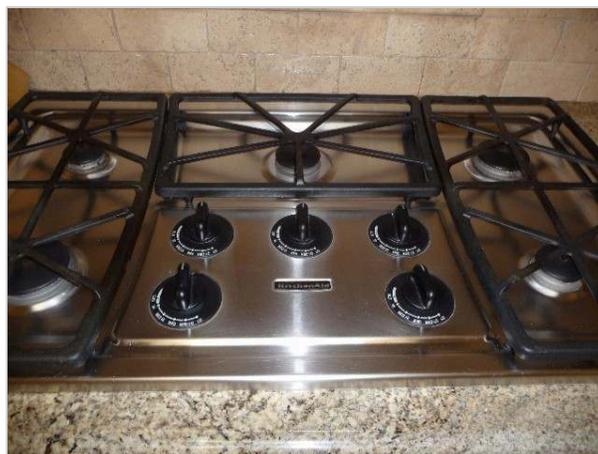
The Kitchen Aid built in gas cooktop was tested and found to be functional.

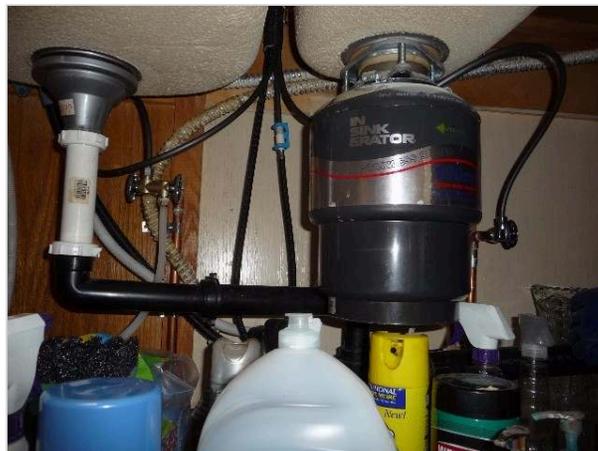
The In-Sink-Erator disposal was inspected and did appear to be functional. The efficiency rating and chopping / grinding ability of the unit is not within the scope of the inspection.

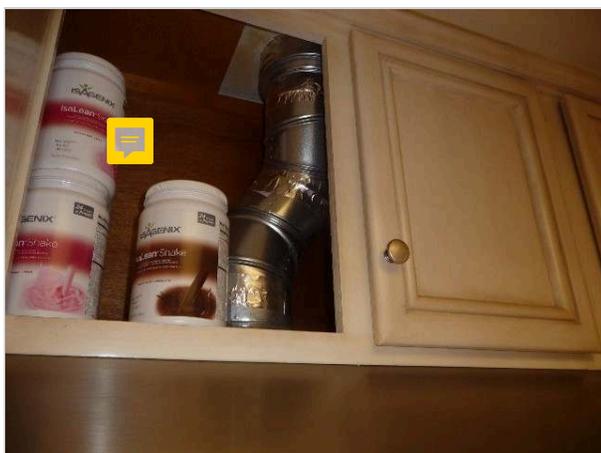
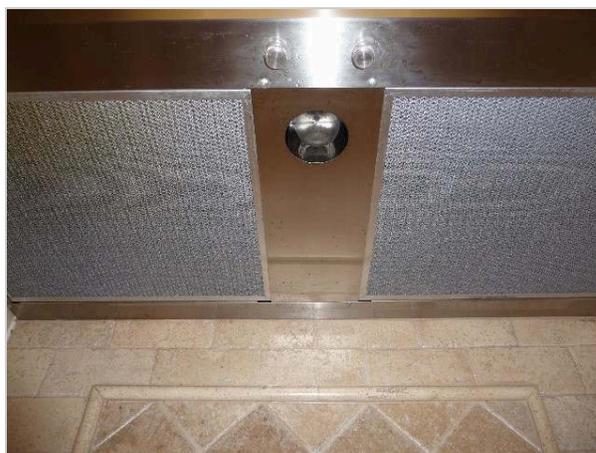
range hood vent duct

The vented range hood was inspected and did appear to be functional. The exhaust capacity is not within the scope of this inspection. Cleaning the fan and filter may increase the exhaust capability.
