### HOME INSPECTION REPORT

## **GENERAL DESCRIPTION**

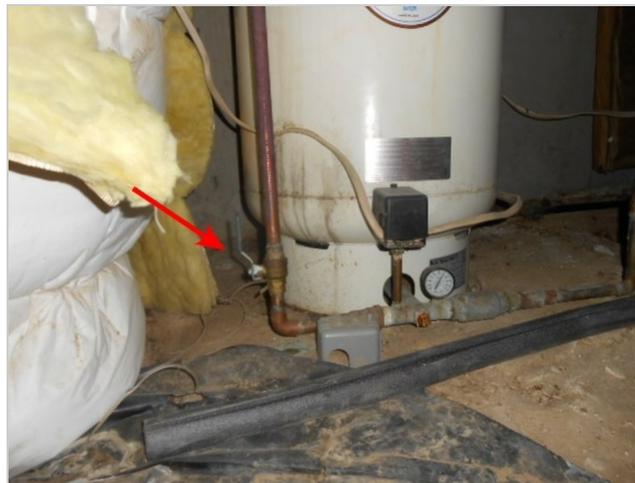
This is the main water shut off valve for the home.

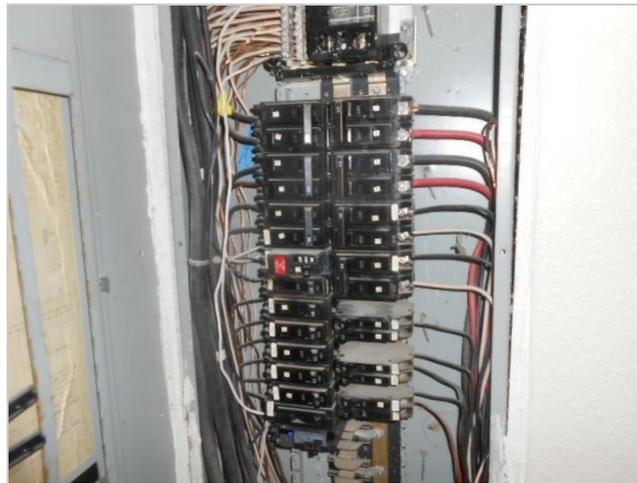
The branch circuits within the panel were constructed of copper wiring. These branch circuits and the circuit breaker to which they were attached appeared to be appropriately matched. The visible house wiring consisted primarily of the Romex type and appeared to be in overall good condition.

The electrical panel cover was removed for inspection of the house wiring, circuits and breakers.

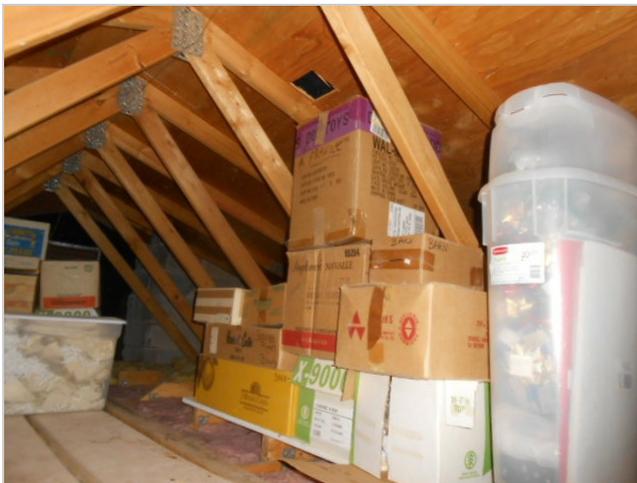
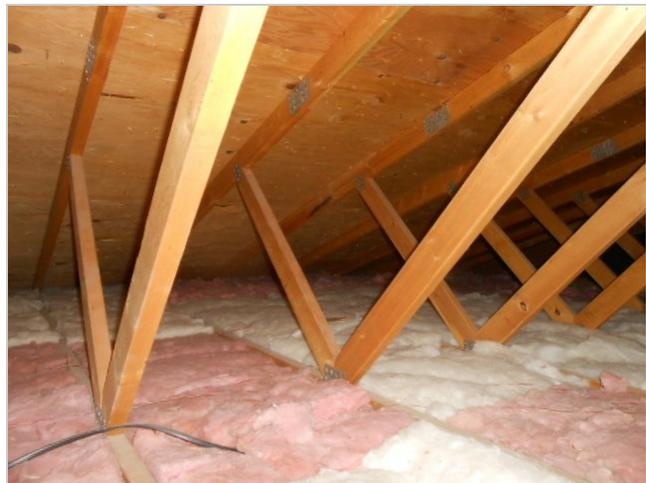
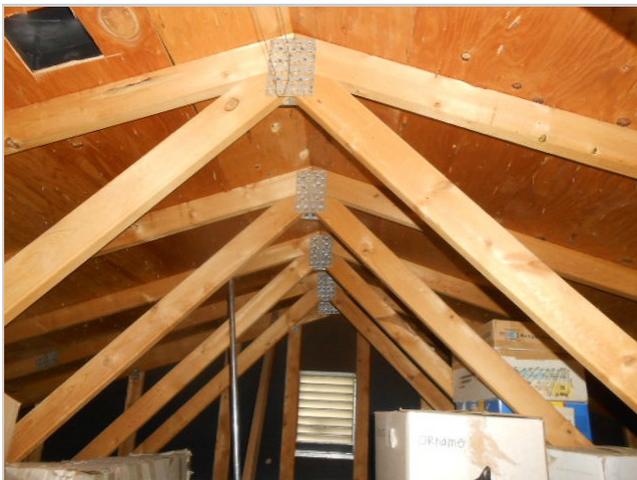
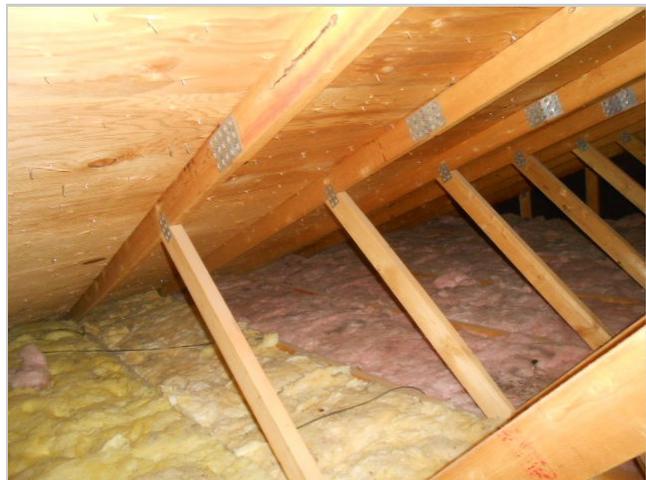
The roof structure consisted of two-inch by four-inch wood trusses spaced 24 inches on center and plywood sheathing. Because of the configuration of the trusses and absence of any catwalk, which limited access, it was not possible to inspect all areas of the attic. There was no moisture visible in the attic space. There were no major visual defects observed in the attic or roof structure.
