HOME INSPECTION REPORT

On Wednesday, August 1, 2018 The HomeTeam Inspection Service made a visual inspection of 123 Sample Drive, Anytown, MO 55555. Enclosed please find a written, narrative report of our findings in accordance with the terms of our Inspection Agreement.

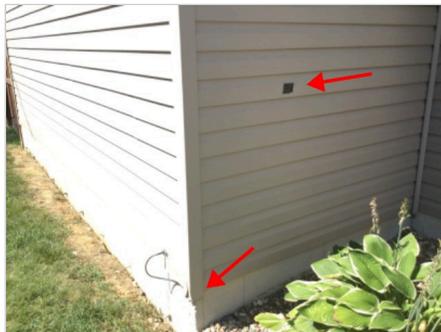
Photo 16

Holes were noted on the right, rear and left side of the structure's exterior. This condition does not have any effect on the structural integrity of the building. The areas should be repaired to prevent water intrusion.

Rear middle

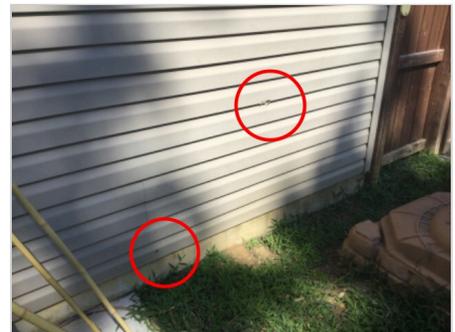
Photo 17

Back left

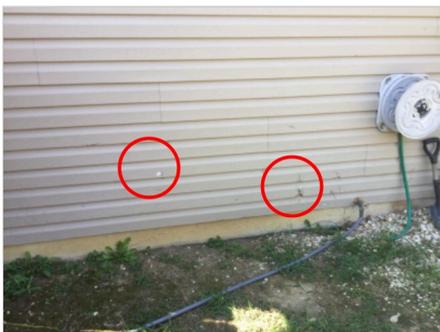
Photo 18

Left side

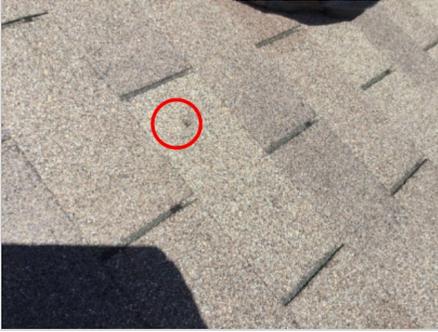
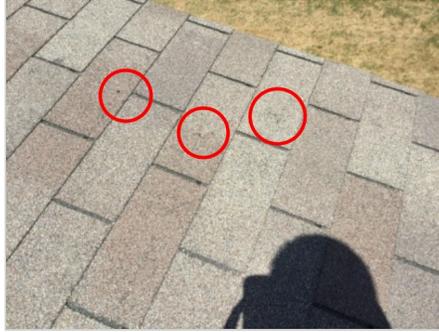
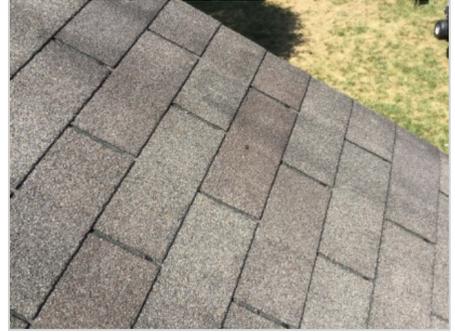
Evidence of a hail event is present on the roof (dents in metal materials and/or bruised shingles on or near roof). Consult with a professional roofer and/or the current owner to determine if the roof has been assessed or replaced since the hail event, and if not, have the roof assessed for replacement or repair by a professional roofer. Depending on the results of this consultation, this may be a material defect.

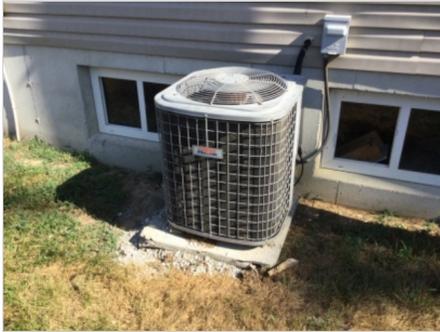
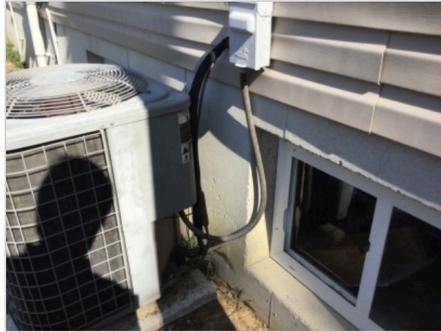
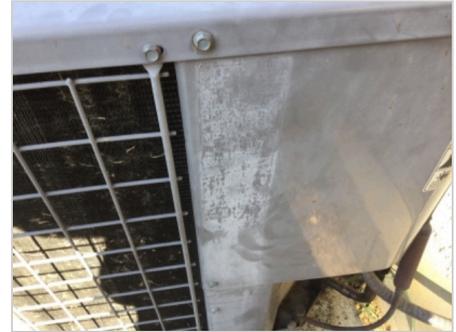
Because of its condition and performance at the time of the inspection, **the HVAC system requires cleaning and servicing by a professional HVAC technician.** At that time, the technician will test refrigerant levels, service the equipment to improve its performance, and perform other tests beyond the scope of the home inspection to assess and identify any additional areas that may require attention.

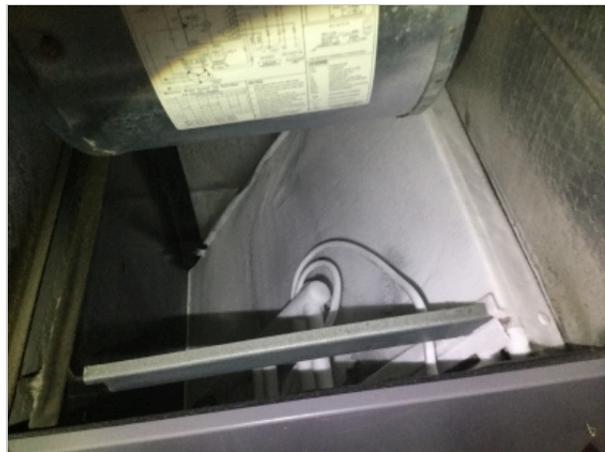
Photo 39

Low pressure line freezing

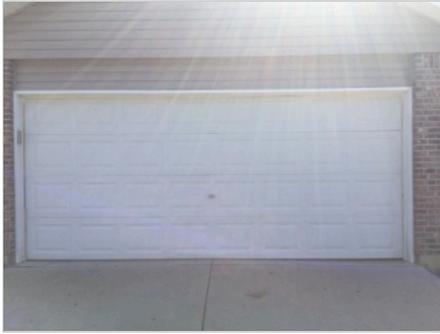
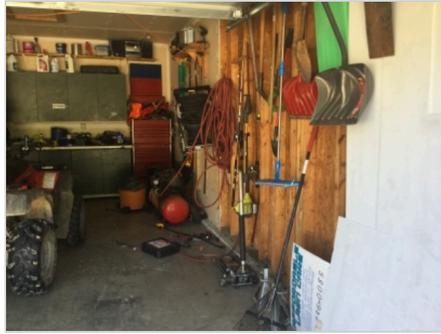
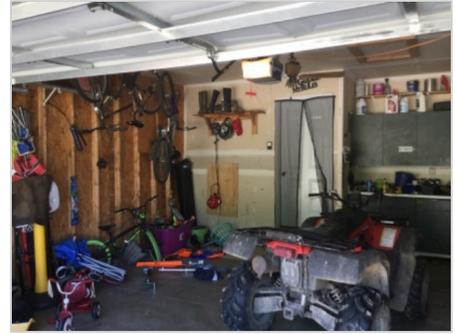
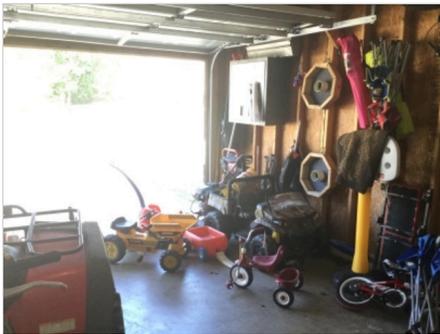
A light beam automatic safety reverse on the garage door opener was not present. This safety device is typically installed on either side of the garage door and is designed to reverse its movement when the light beam is interrupted in order to keep the garage door from harming pets and small children. Adding this safety feature as an upgrade may improve the overall safety of the garage door.

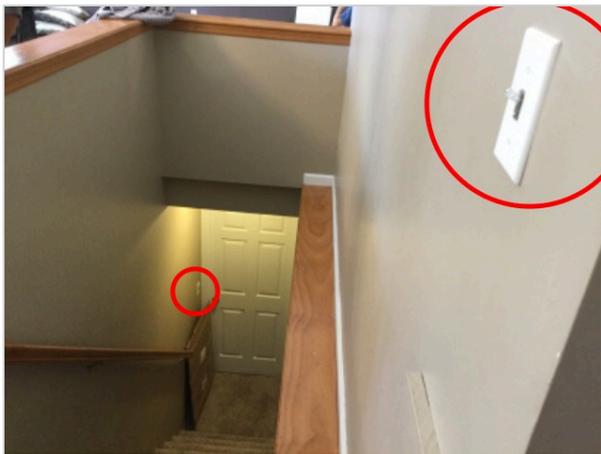
Photo 49

The three way switch that controls the stairs to the basement lights appears to be miswired. The switch will not turn the lights on and off from both locations. Consult with a qualified electrician for repair.

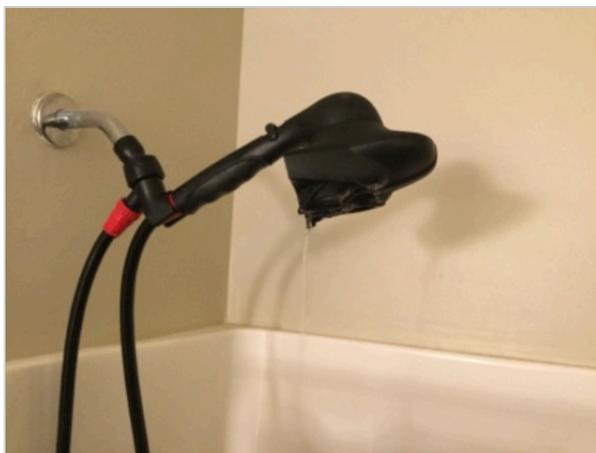
Photo 51

The fixture water pressure in the hall bathroom tub was low at the time of inspection

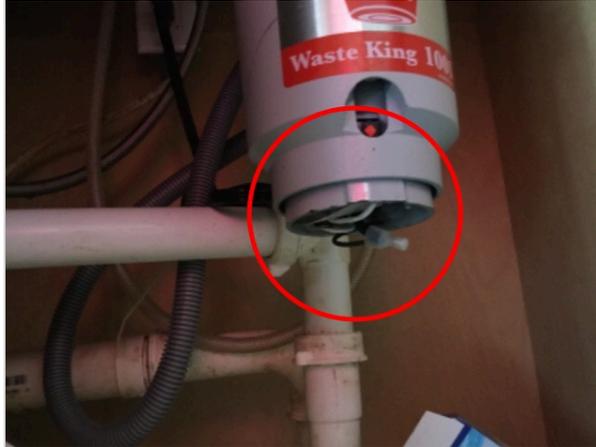
Photo 61

The garbage disposal is lacking a cable connector at the base of the unit. The purpose of the connector is to prevent pressure from the actual wire connection, which if disconnected, can lead to shock hazard.

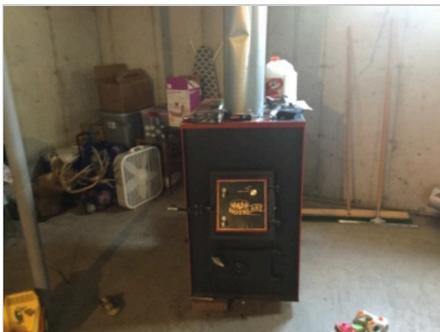
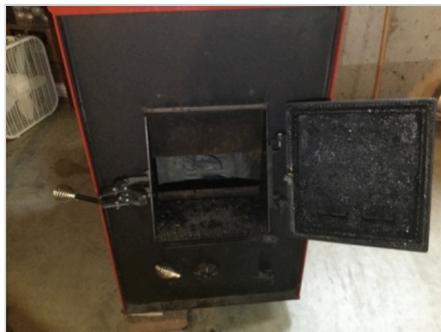
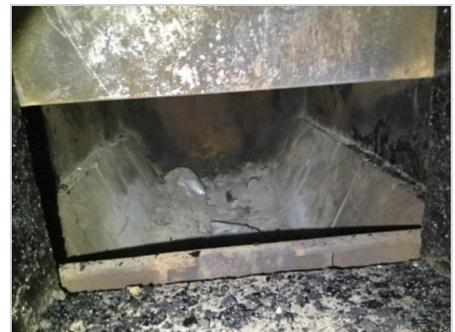
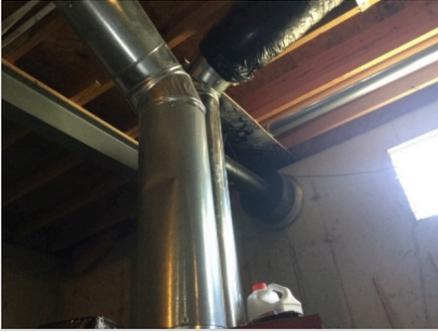
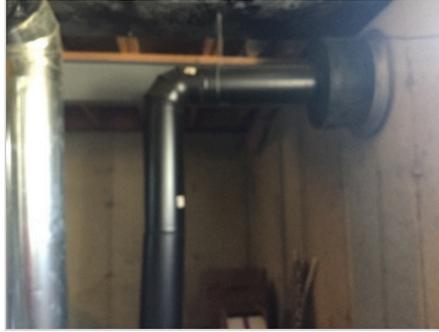
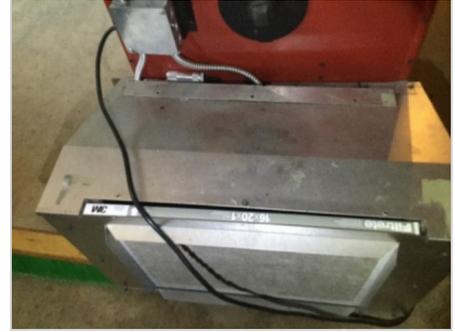
There was a wood-burning stove located in the basement. For safety reasons, the wood-burning stove and the chimney or pipe to which it is vented should be cleaned by a chimney sweep and then inspected before using as there may be hidden defects not fully visible at the time of the inspection. Be advised, due to the nature of such an inspection, additional defects or maintenance items may arise. There was not any visible creosote on the flue pipe. The stove appeared to have adequate clearances from combustible materials. The specifications for this make and model should be reviewed to insure safe operation. NOTE: If the wood stove has not received routine seasonal maintenance, it is possible deficiencies may be revealed once it is cleaned. Corrosive gas and moisture can collect on the interior of the flue pipe and cause deterioration or damage. Because of these potential problems, HomeTeam recommends having wood stoves cleaned and serviced.

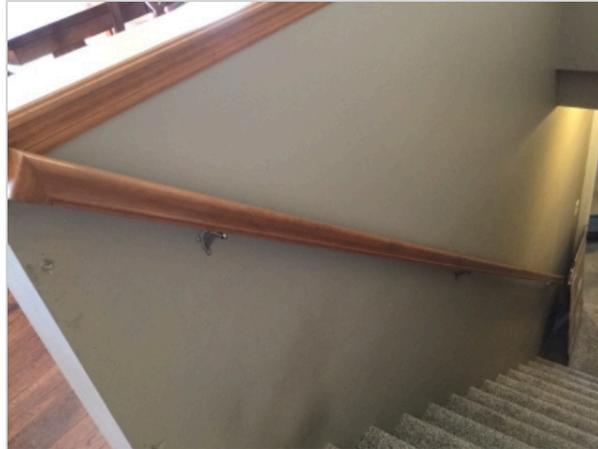
Photo 72

The stairs leading to the basement have a handrail that is loose or otherwise not secure. The handrail should be properly secured for safety.

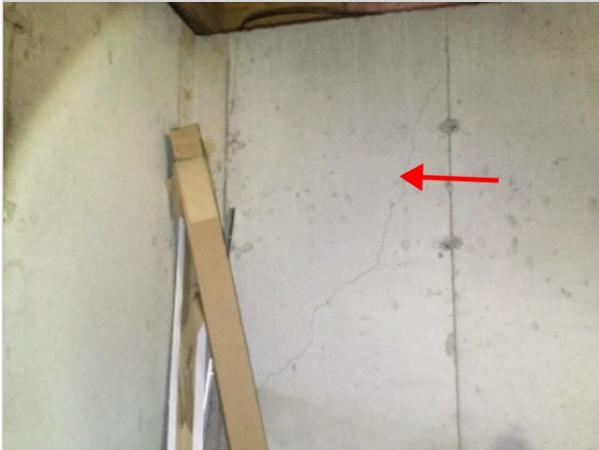
Photo 74

Small cracks were observed on the foundation. The cracks were 1/16th-inch or less in width. The homeowner should monitor these cracks for any changes, and if changes are noted, should contact a structural repair company for further analysis. Below-grade cracks are highly susceptible to water intrusion during times of heavy rain. Water staining from previous water intrusion was not visible. HomeTeam recommends sealing these cracks if a watertight basement is desired.

Rear right

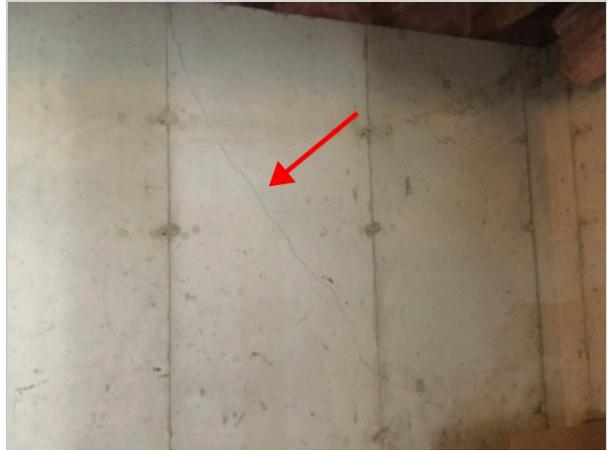
Photo 75

Right rear

Cracks in the basement show signs of previous water intrusion. Below grade cracks are highly susceptible to water intrusion during times of heavy rain. The cracks should be monitored to determine if they are active. If a waterproof basement is required, HomeTeam recommends having the cracks sealed to prevent water intrusion.

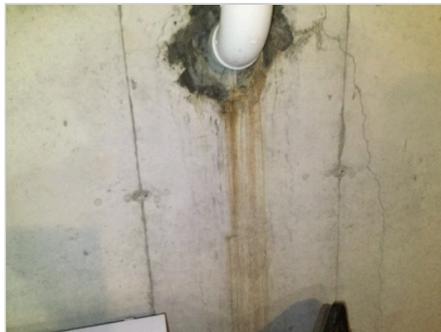
Photo 77

Right wall

A crack or several cracks in the foundation were found in excess of 1/16th of an inch. Though there is no water penetration noted, it is recommended that routine monitoring of the cracks be conducted to see if cracks widen, become offset or develops water penetration. If it is found that the condition worsens, consulting with a foundation specialist is recommended.

Because of the items discussed in the foundation, it is recommend that you consult a structural specialist for further evaluation.

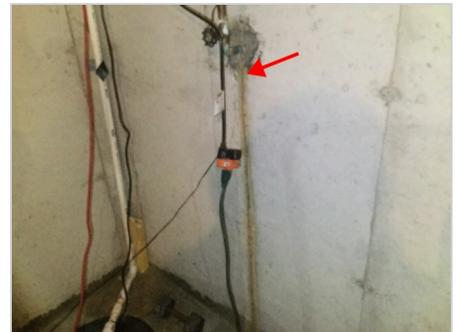
Photo 78

Front right

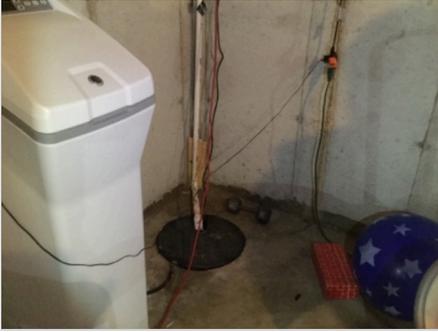
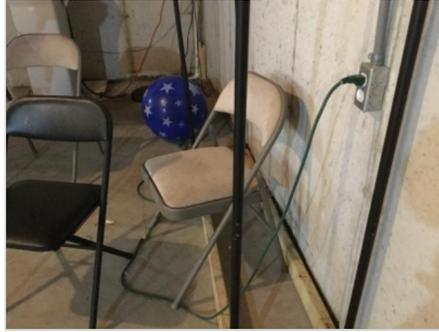
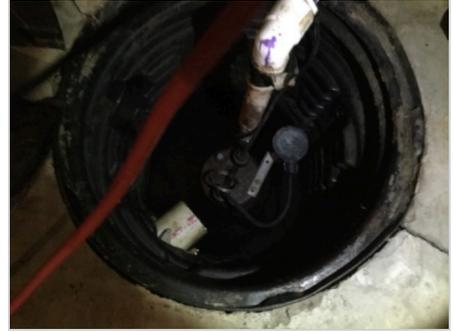
There was a sump pump located in the basement. The sump pump was functional. HomeTeam recommends all sump pumps be tested regularly. Backup pumps (battery and hydro) provide an added measure of protection and should be considered as an upgrade.

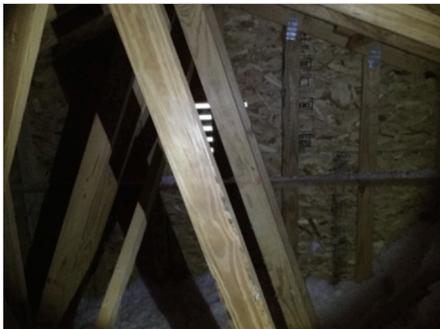
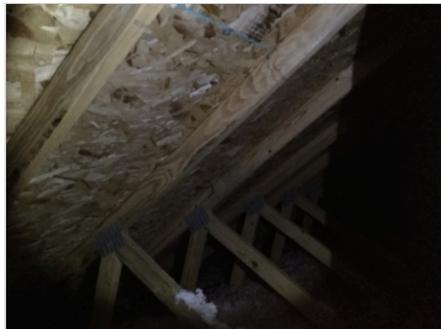
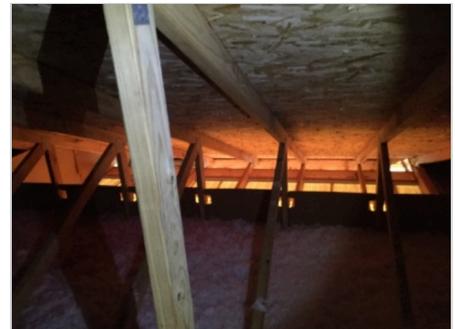
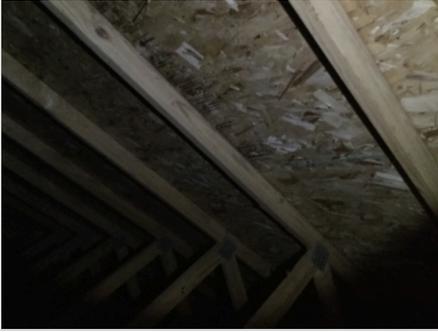
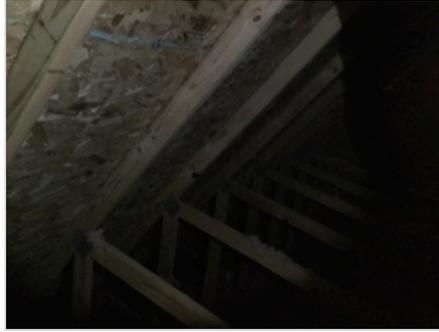
There was moisture visible in the attic space.
