HOME INSPECTION REPORT

On Monday, February 18, 2019 The HomeTeam Inspection Service made a visual inspection of 123 Sample Drive, Tacoma, WA 55555. Enclosed please find a written, narrative report of our findings in accordance with the terms of our Inspection Agreement.

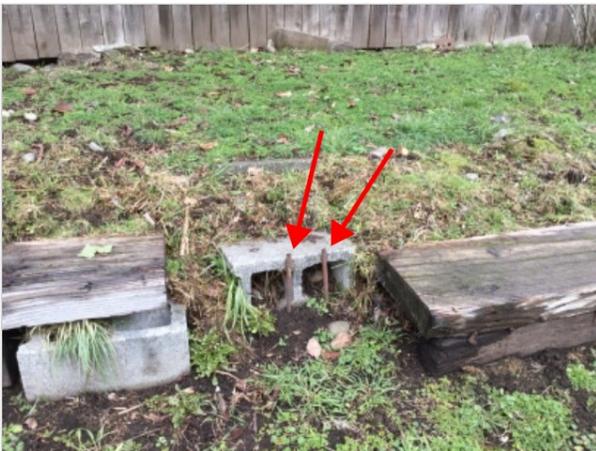
Photo 1

Multiple sharp objects sticking out of the ground around the perimeter of the house.

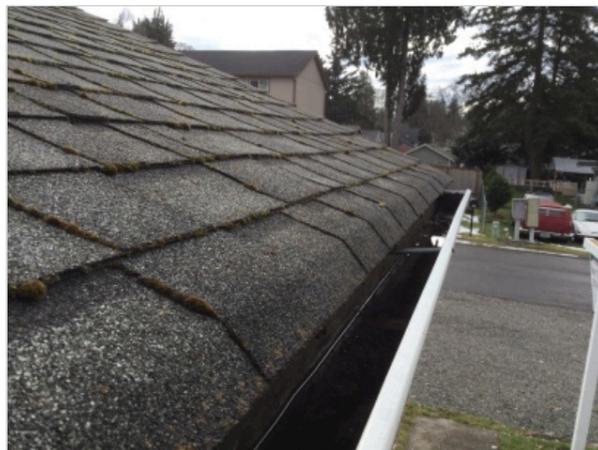
Photo 4

Some of the downspouts around the structure are draining into the ground with no conclusive termination point. HomeTeam recommends ensuring termination points for all downspouts is far enough from the structure and configured in such a way as to ensure water flows away from the foundation during periods of rain.

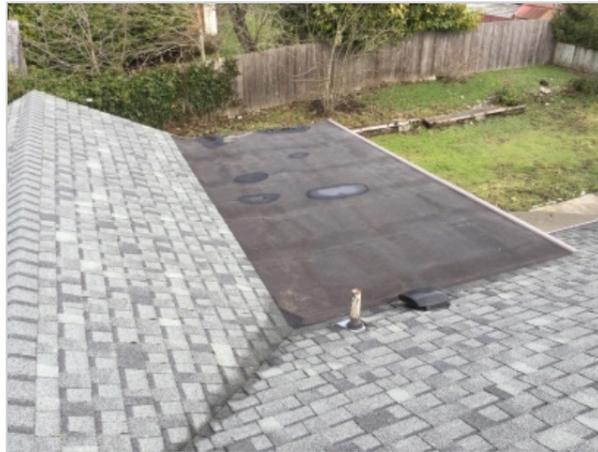
Photo 11

Nails securing shingles and/or roof ventilation flashing are uncovered. Any nails that penetrates the roof should be covered with shingles or roof tar in order to prevent possible water penetration into the sheathing of the roof structure.

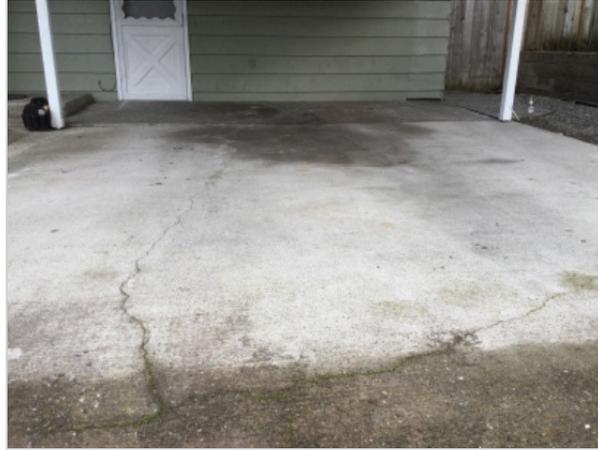
Photo 22

Areas of the driveway have settled. This condition indicates a possible void under the driveway. Driveway settling has led to potential tripping hazards. The areas should be monitored and repaired as needed.

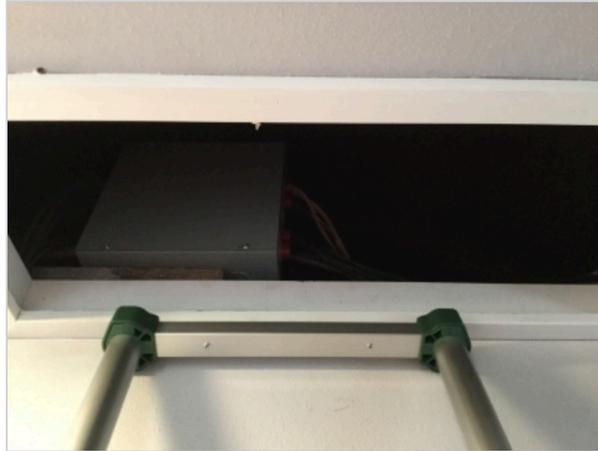
Photo 25

Evidence of an active roof leak was observed in the attic. Consult with a qualified roofer for evaluation and repair recommendations.

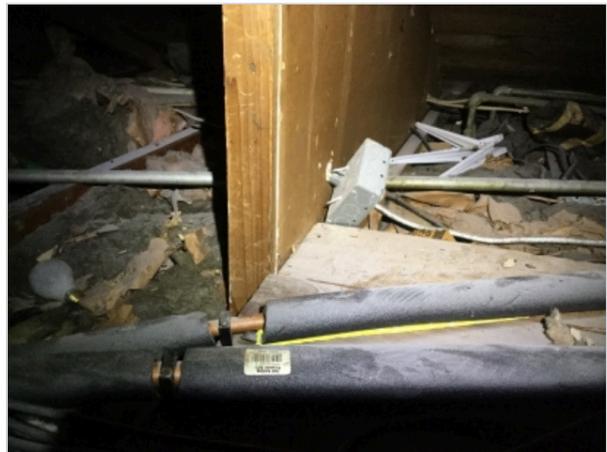
Photo 29

Electrical junction box not properly fastened.

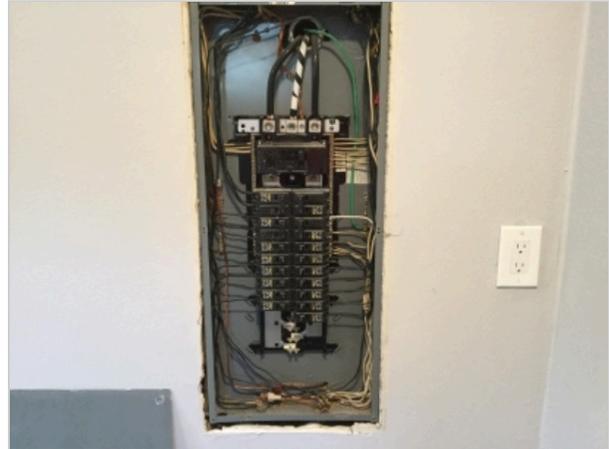
Photo 34

An open knockout was observed in the electric service panel, creating the potential for electric shock. All service panel openings should be covered to prevent access to high voltage and risk of electrical shock. Electrical related repairs should be performed by a qualified electrician.

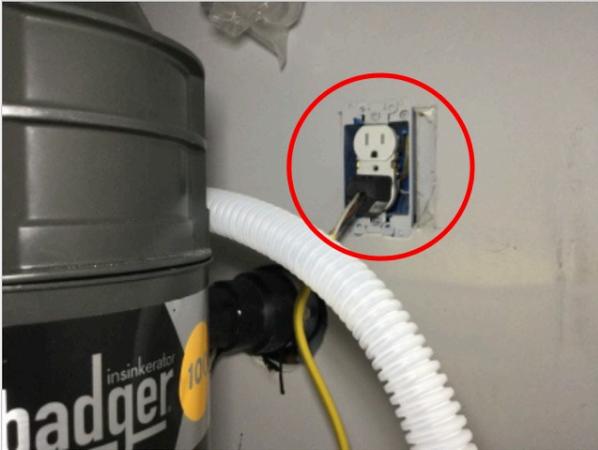
Photo 36

Dishwasher disposal outlet under kitchen sink

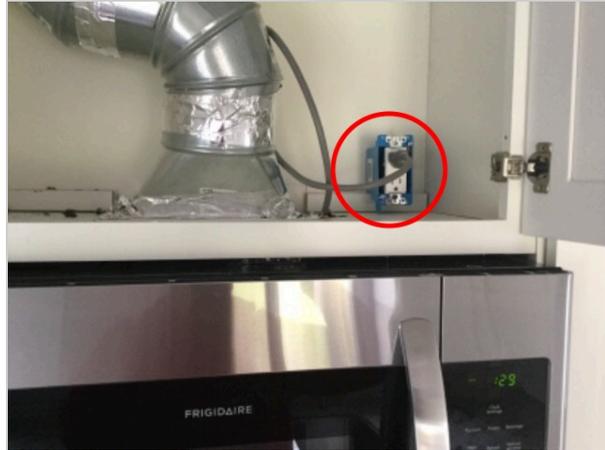
Photo 37

Microwave outlet above microwave

Multiple receptacles have hot and neutral wires reversed. This is a safety concern and should be repaired and further assessed by a licensed electrician. Please note that we only test outlets that are visible and readily accessible at the time of the inspection.

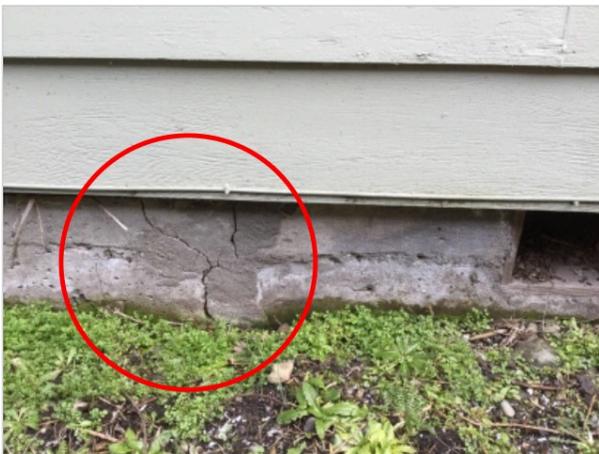
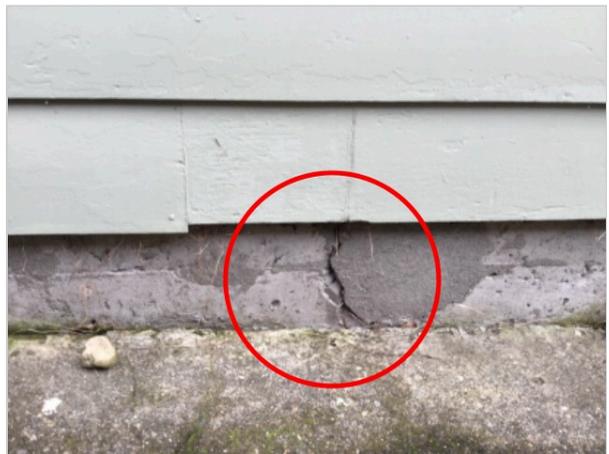
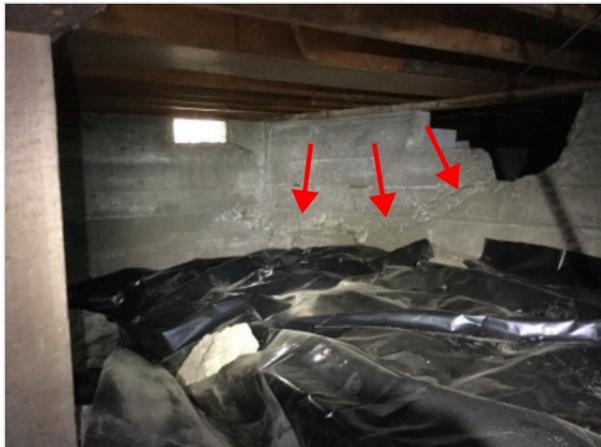
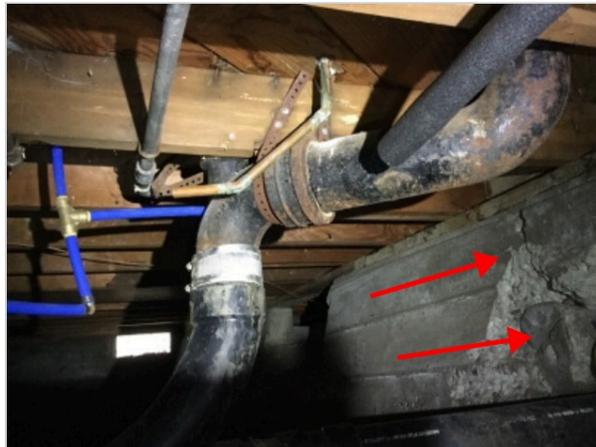
There were multiple vertical earth-pressure type cracks observed on the left side foundation wall. Consult with structural engineer for further evaluation. This condition is most often associated with soil and/or water pressures. The displacement occurs incrementally as the wall yields to horizontal earth pressure. This may be a material defect.

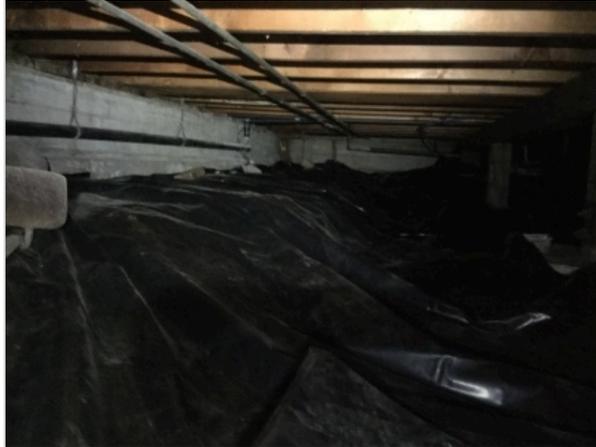
Photo 48

A section of floor structure is damaged from previous water intrusion. It was not clear whether the water intrusion has ceased. Monitor the area for any additional water intrusion, and repair as needed.

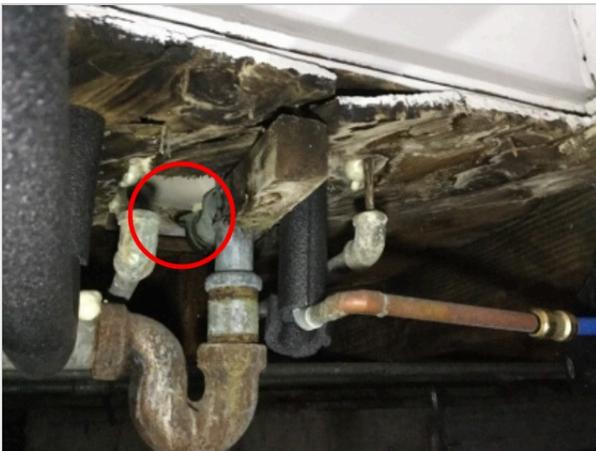
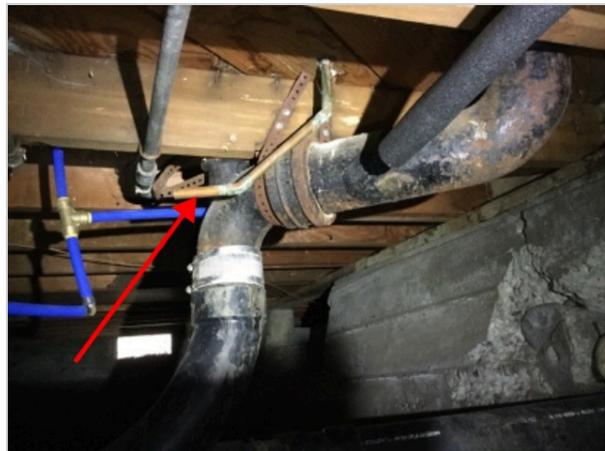
A leak was observed at multiple drain lines in the crawl space. The drain line or seals should be repaired or replaced to prevent water intrusion and should be further assessed at the time of repair.

Underneath bathroom left side of house

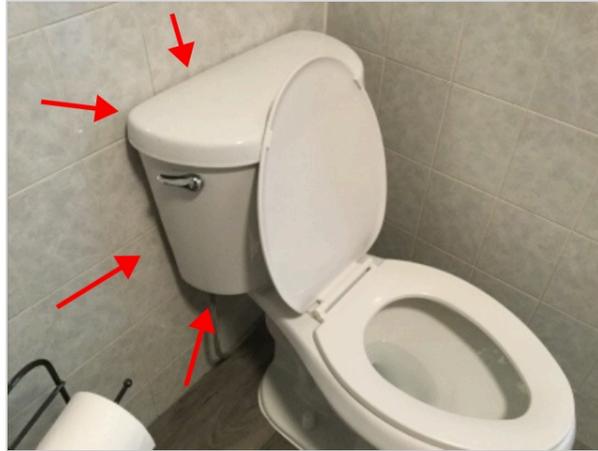
Photo 52

The toilet tank in the master bath is loose. Failure to secure the toilet may lead to leakage. The toilet should be secured.

Master bath

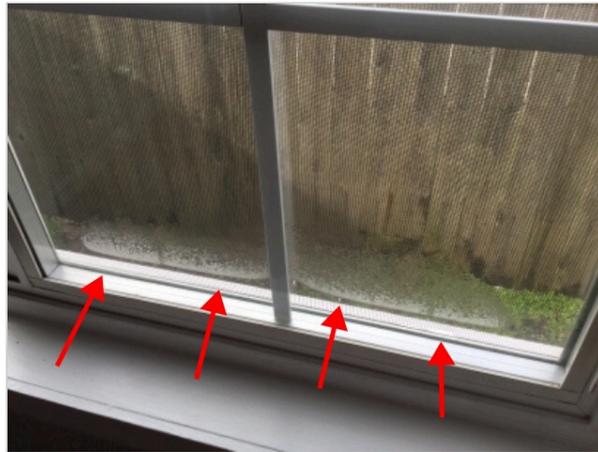
Photo 61

Drive affected glass panel.

End of hall bedroom

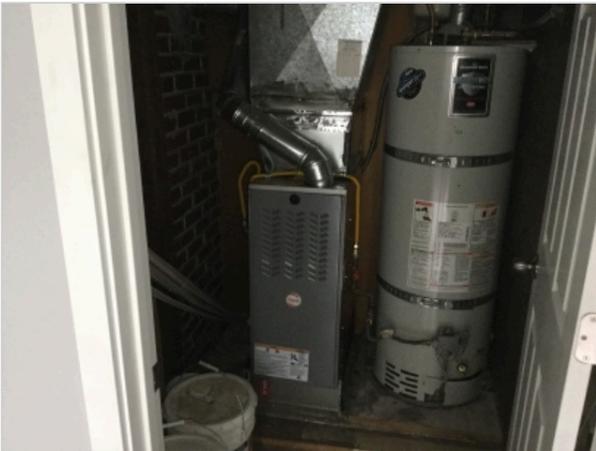
Photo 73

The HVAC condensate line was not visible. The heating system was found to be functional.

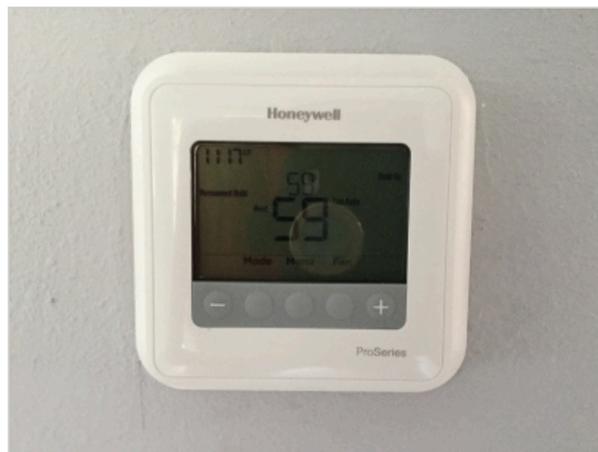
Photo 75

The control for the heating and air conditioning system was a 24 volt digital programmable thermostat located on the hallway wall of the home. The thermostat was manufactured by Honeywell and was found to be in working order.

Thermostat settings at beginning of inspection
