### *HOME INSPECTION REPORT*

The inspected property consisted of a one and a half story wood-framed structure with hard coat stucco exterior and stone veneer that was vacant at the time of the inspection. The estimated date of construction, as reported by the seller was said to be 2007.

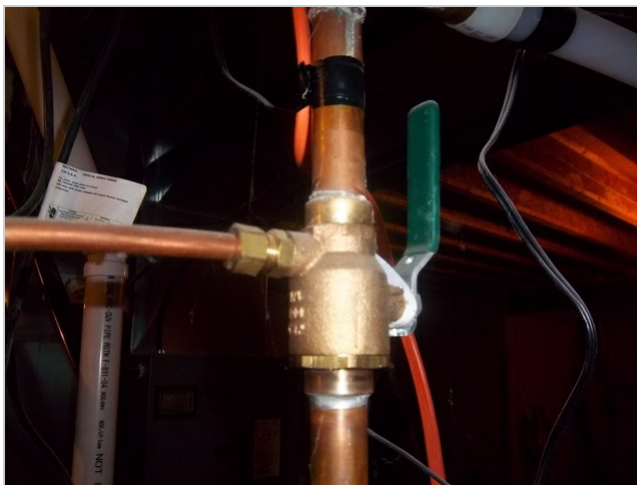
There was an 80 gallon capacity, electric water heater located at the south end in the basement. The water heater was manufactured by Kenmore;model number 153 321841 and serial number G07A028199. Information on the water heater indicated that it was manufactured in 2007. A temperature and pressure relief valve (T&P) was present. Because of the lime build-up typical of T&P valves, we do not test them. A drip leg was installed on the T&P valve. It did terminate close to the floor. Your safety depends on the presence of a T&P valve and a drip leg terminating close to the floor. The water heater was functional.

The water heater is equipped with an expansion valve. As water is heated within the water heater, pressure is created and the water expands as it warms. The expansion valve is an adjustable relief valve that will allow excess pressure to safely equalize pressures that are created by the heating and cooling cycles of the hot water system.

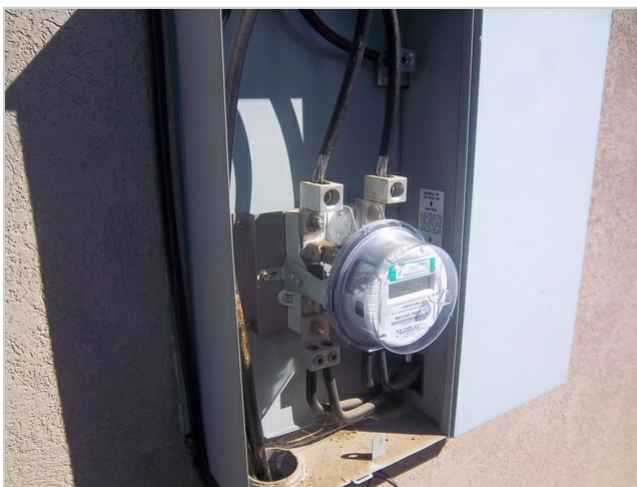
The electrical service equipment was inspected by a licensed electrician. The underground electric service wire entered the property on the right side. The electric meter was located on the right exterior wall. The service wire entered a Siemens weather tight main disconnect, located on the exterior wall near the meter base with 400 amps of capacity. The exterior disconnect consists of a pair of 200 amp main breakers side by side and next to the meter.

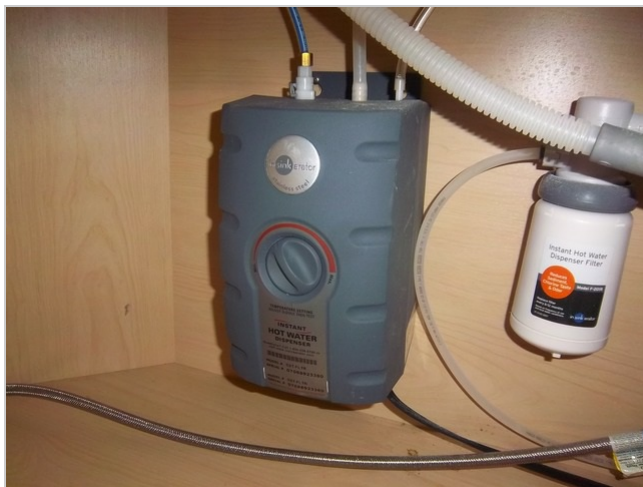
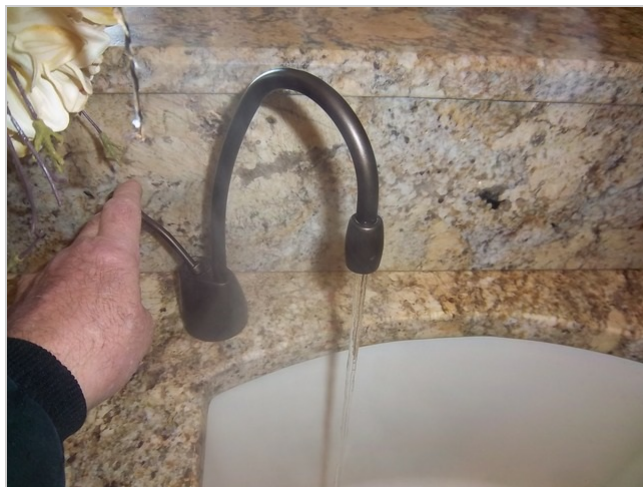
Both of the Kenmore disposals were inspected and did appear to be functional. The efficiency rating is not within the scope of the inspection.

The ISE instant hot water appliance beneath the kitchen sink and beneath the master bath wet bar sink dispenses instant hot water through a small tap at the sink. They were tested and was found to be functional.

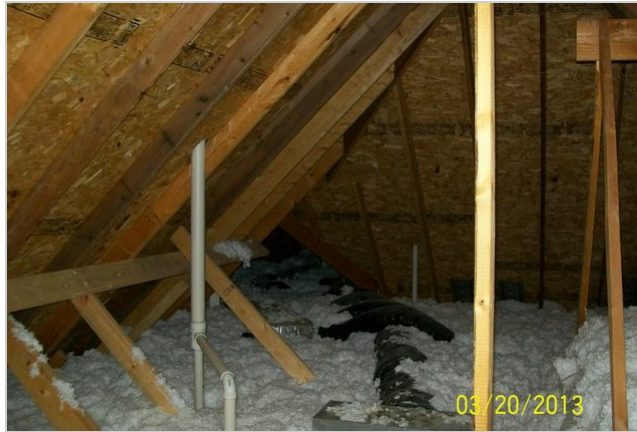
The attic was accessed through a scuttle in the 2nd floor bedroom closet. The attic above the living space was insulated with loose-fill insulation, approximately 16-20 inches in depth. The roof structure consisted of two-inch by eight inch wood rafters spaced 24 inches on center and OSB (waferboard) sheathing. Because of the framing and absence of a cat walk, access was limited. Most attic observations are made from near the access opening. Some attics are traversed depending upon accessibility and necessity. There was no moisture visible in the attic space. The absence of visible indications of moisture is not necessarily conclusive evidence that the roof is free from leaks. The only way to be sure a roof does not leak is to inspect the underside of the roof during a heavy rain. There were no major visual defects observed in the attic or roof structure.
