HomeTeam[®]

INSPECTION SERVICE

HOME INSPECTION REPORT

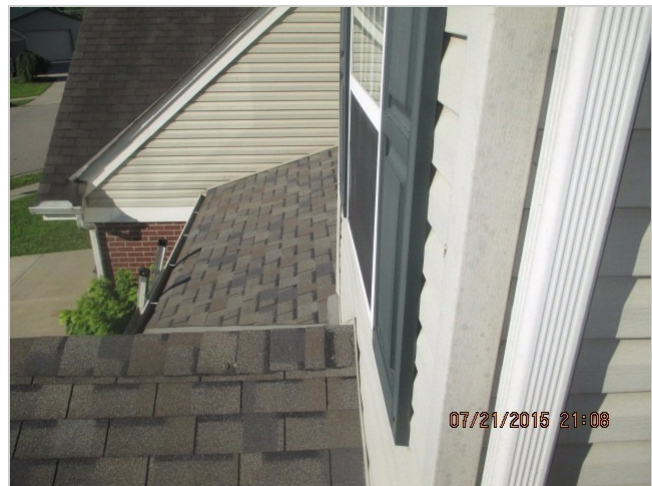
Porch roof

There was an area of loose flashing above the porch roof that should be secured to prevent water intrusion.

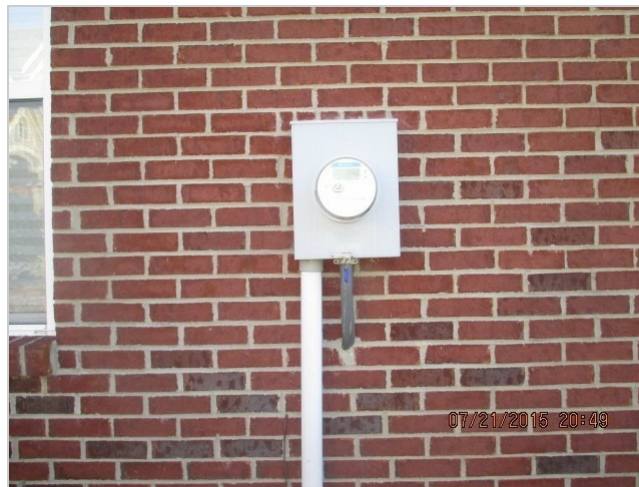
Meter base

The underground electric service wire entered the home on the left side wall. The electric meter was located on the exterior wall.

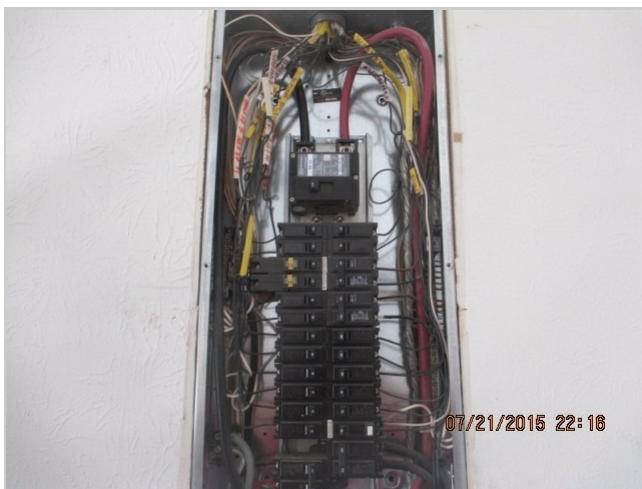
Electric panel

The service wire entered a Cutler Hammer service panel, located on the garage wall with a 200 amp and 120/240 volt rated capacity. The branch circuits within the panel were copper. These branch circuits and the circuit breaker to which they were attached appeared to be appropriately matched. The visible house wiring consisted primarily of the Romex type and appeared to be in good condition.

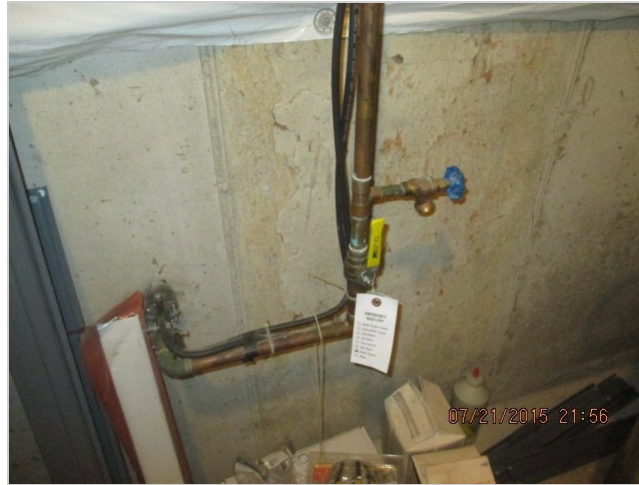
The water meter was located in the front yard. The main water shutoff valve for the home was located adjacent to the water service entry point in the basement.

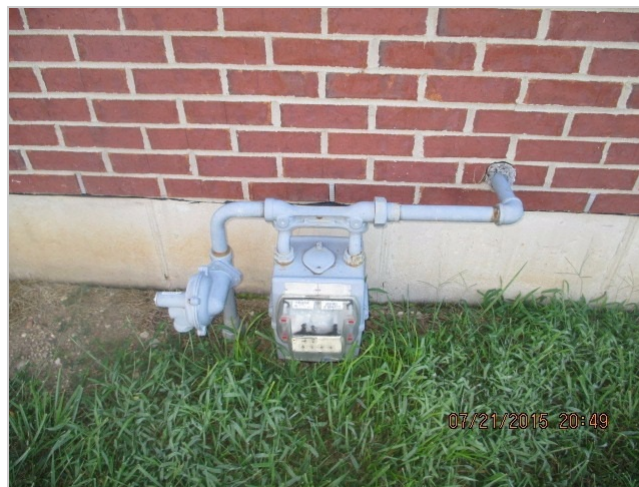
The gas meter was located on the left exterior wall. Although no actual testing was performed to detect the presence of gas fumes, there was no noticeable odor of gas detected at the time of the inspection.
