# HomeTeam<sup>®</sup>

### HOME INSPECTION REPORT

**GENERAL DESCRIPTION**

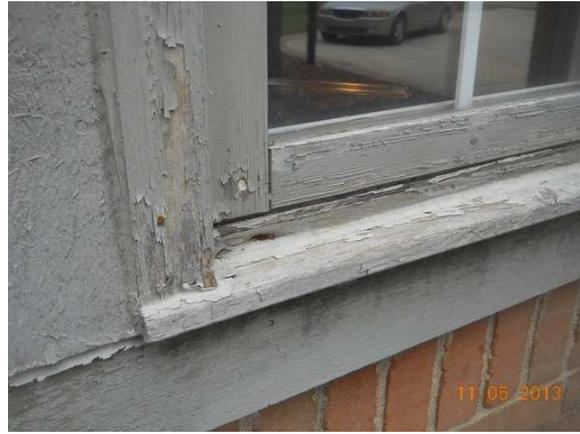
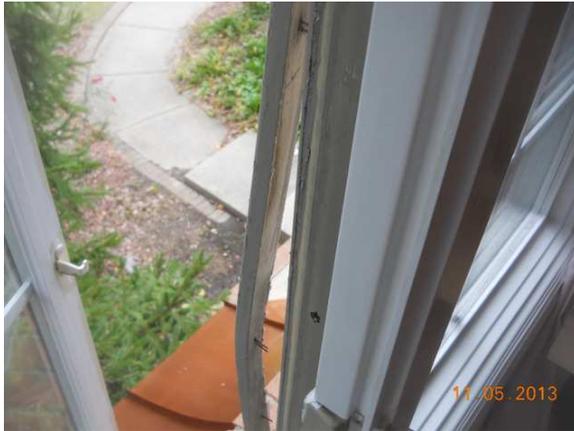
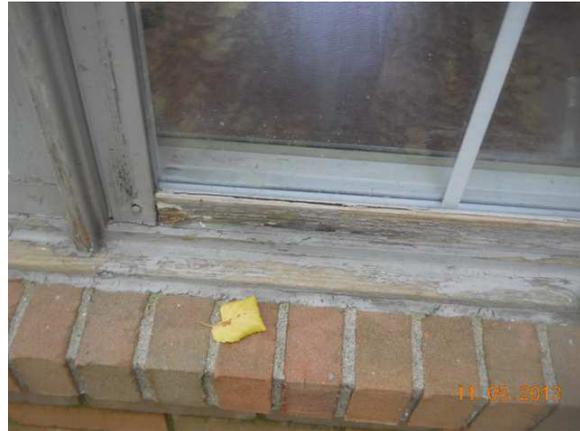
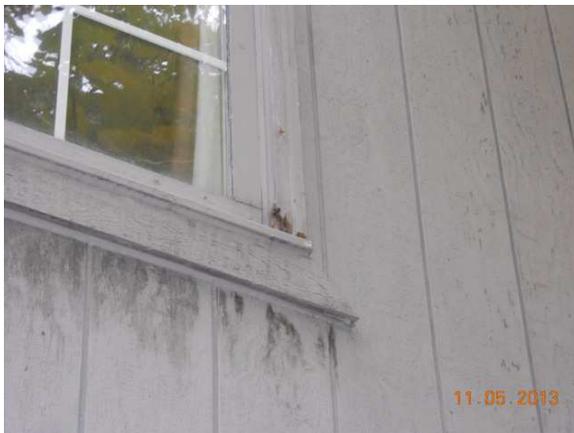
Missing cover

- Peeling paint and weathered/deteriorated wood was noted in multiple areas of the windows, trim and siding. Recommend consulting with a qualified contractor to gain an understanding of options and costs for repair or replacement.
- The exterior caulking around the is cracked or missing in one or more areas. The caulking should be replaced to ensure the exterior of the home remains weather and water tight.
- One or more of the steel lintels above the windows on the exterior of the home were noted to be rusting. lintels support masonry materials above the doors and windows. keeping the lintels sealed and painted will prevent rusting and expansion. expanded lintels lead to cracks ion the masonry on the outside of the home.
- One or more outlets were not properly covered. Outlet covers designed for use in wet locations should be installed on all exterior outlets.
